DATE October 5, 2015

REFERENCE No. 1411734-047-TM-Rev2-11000

FOREST CONDITIONS AND DIE BACK IN AREAS OF THICKER TAILINGS DEPOSITION

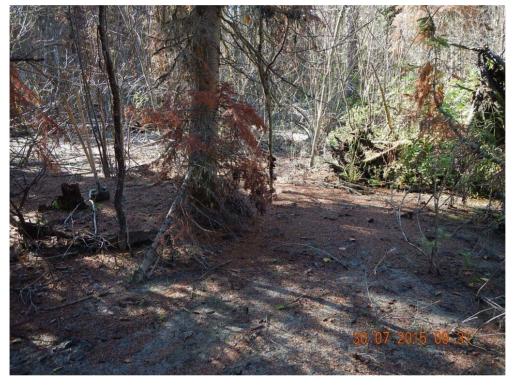
Results available from the field program to date indicate that the pattern of tree mortality and subsequent sampling at Mount Polley was caused by the hypoxic or anaerobic environment of the tree roots created by the thick deposit of fine silty material over the forest floor (Photograph 1). This deposit would have immediately blocked soil pores and reduced oxygen reaching the roots of the trees. A distinct anaerobic odour was evident in the root zone for the plots excavated in the halo area. The plots in the halo zone were saturated leading to a perched water table; the cause was likely due to the small particle size of the deposited material that trapped water. Dissolved oxygen concentrations and the oxidation-reduction potential were lower, confirming a significant difference in the oxygen conditions in the root zone (Table 1).

Photograph 1: Site conditions and the pattern of tree mortality suggest that the mortality was caused by the anaerobic environment of the tree roots created by the thick deposit of fine silty material over the forest floor.

In the spring of 2015, the trees in the deeper deposits of the outflow area rapidly turned brown and died. Two factors likely contributed to their death at this time. First, snow melt and spring rains would have increased the water content of the deposits, thus creating fully saturated and anoxic (oxygen depleted) soil conditions. The shift from hypoxic to anoxic conditions would have amplified root mortality. Second, the dying tree roots would have been unable to acquire sufficient water to meet demands for photosynthesis and transpiration at the time winter dormancy broke in spring. As trees flushed and soils warmed, the foliage would have continued to transpire while dead roots were incapable of acquiring and transporting sufficient water to the crown via the xylem. Without sufficient water conductance to the crowns, the trees died rapidly over a period of 1-2 months.

By early August, 2015, trees whose roots were subject to prolonged or temporary anaerobic conditions following the breach were dead or dying. Core samples of affected trees also revealed sap rot (decay) initiating in many stems. The fine deep deposits in most areas have remained saturated well into the summer, resulting in a perched water table that continues to block gas exchange with the soil. This saturation, combined with the dead root systems and sap rot, indicate that the dead trees are at risk of blowing over in a wind. In other areas, coarser textured tailings are drying quickly as the summer progresses, but unfortunately the anoxia damage to the trees has already occurred and is irreversible. The dead trees in these conditions will eventually blow over or collapse. Harvesting of the dead trees will remove the risk of blowdown and create more suitable site conditions for rapid reclamation of the forest. The felled trees, along with planting of native species, can be used to create ecological structure and function as part of the reclamation strategy. Golder has made area-specific recommendations with assigned priorities for falling trees and Mount Polley is acting on these recommendations.
