May 9, 2016

Geotechnical Review of LOM Cariboo Pit and Springer Pit Slope Designs

Mount Polley Mine
PO Box 12
Likely, BC
V0L 1N0

Reference Number: 051413027-111-R-Rev0-2115

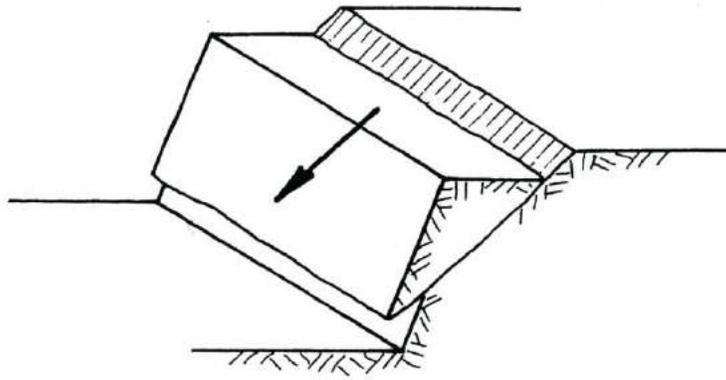
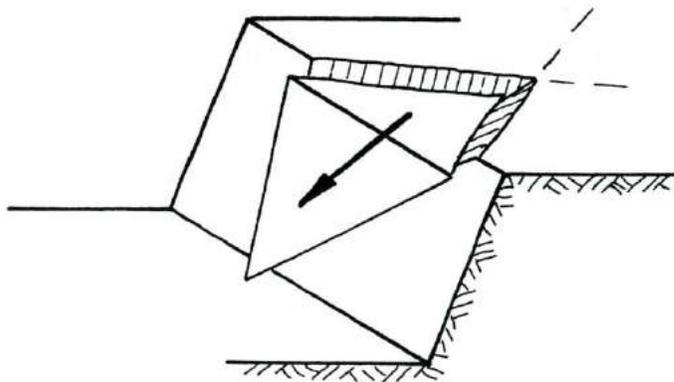
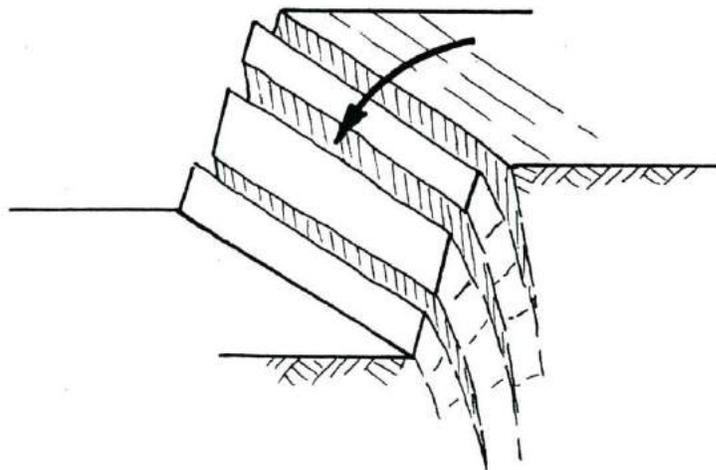
The three basic mechanisms of structurally controlled failure in rock slopes are plane failures, wedge failures, and toppling failures, as described below. These mechanisms are shown schematically in Figure 10.

Planar failures may occur when a geologic discontinuity dips out of a rock slope at an angle that is shallower than the inclination of the slope, but steeper than the effective angle of friction along the discontinuities. Planar failures typically only develop to a significant extent if the azimuth of the geologic discontinuity is within ± 20 to 30 degrees of the strike of the rock slope.

Wedge failures may occur when two or more geological discontinuities intersect to form an unstable wedge. In order for wedge failure to occur, the line of intersection of the wedge must dip out of the slope at an inclination that is shallower than the inclination of the slope face, but steeper than the effective angle of friction along the discontinuities. Wedge failures will only develop to a significant extent if the azimuth of the line of intersection is within ± 45 degrees of the azimuth of the slope face.

Toppling failures may develop when a rock mass contains multiple, parallel, steeply dipping, continuous geologic structures, such as bedding or continuous joints or foliation planes, that strike nearly parallel to the strike of the face of the rock slope. Toppling failures will generally only develop when the strike of the structures is within ± 20 degrees of the azimuth of the slope face. Kinematically, the potential for toppling failure is determined by the slope angle, and by the spacing, inclination, and continuity of the toppling blocks. Widely spaced and/or discontinuous structures mitigate the potential for toppling, while closely spaced, continuous structures have the potential to develop into multi-bench, shallow-seated failures, which could result in overall wall failure.

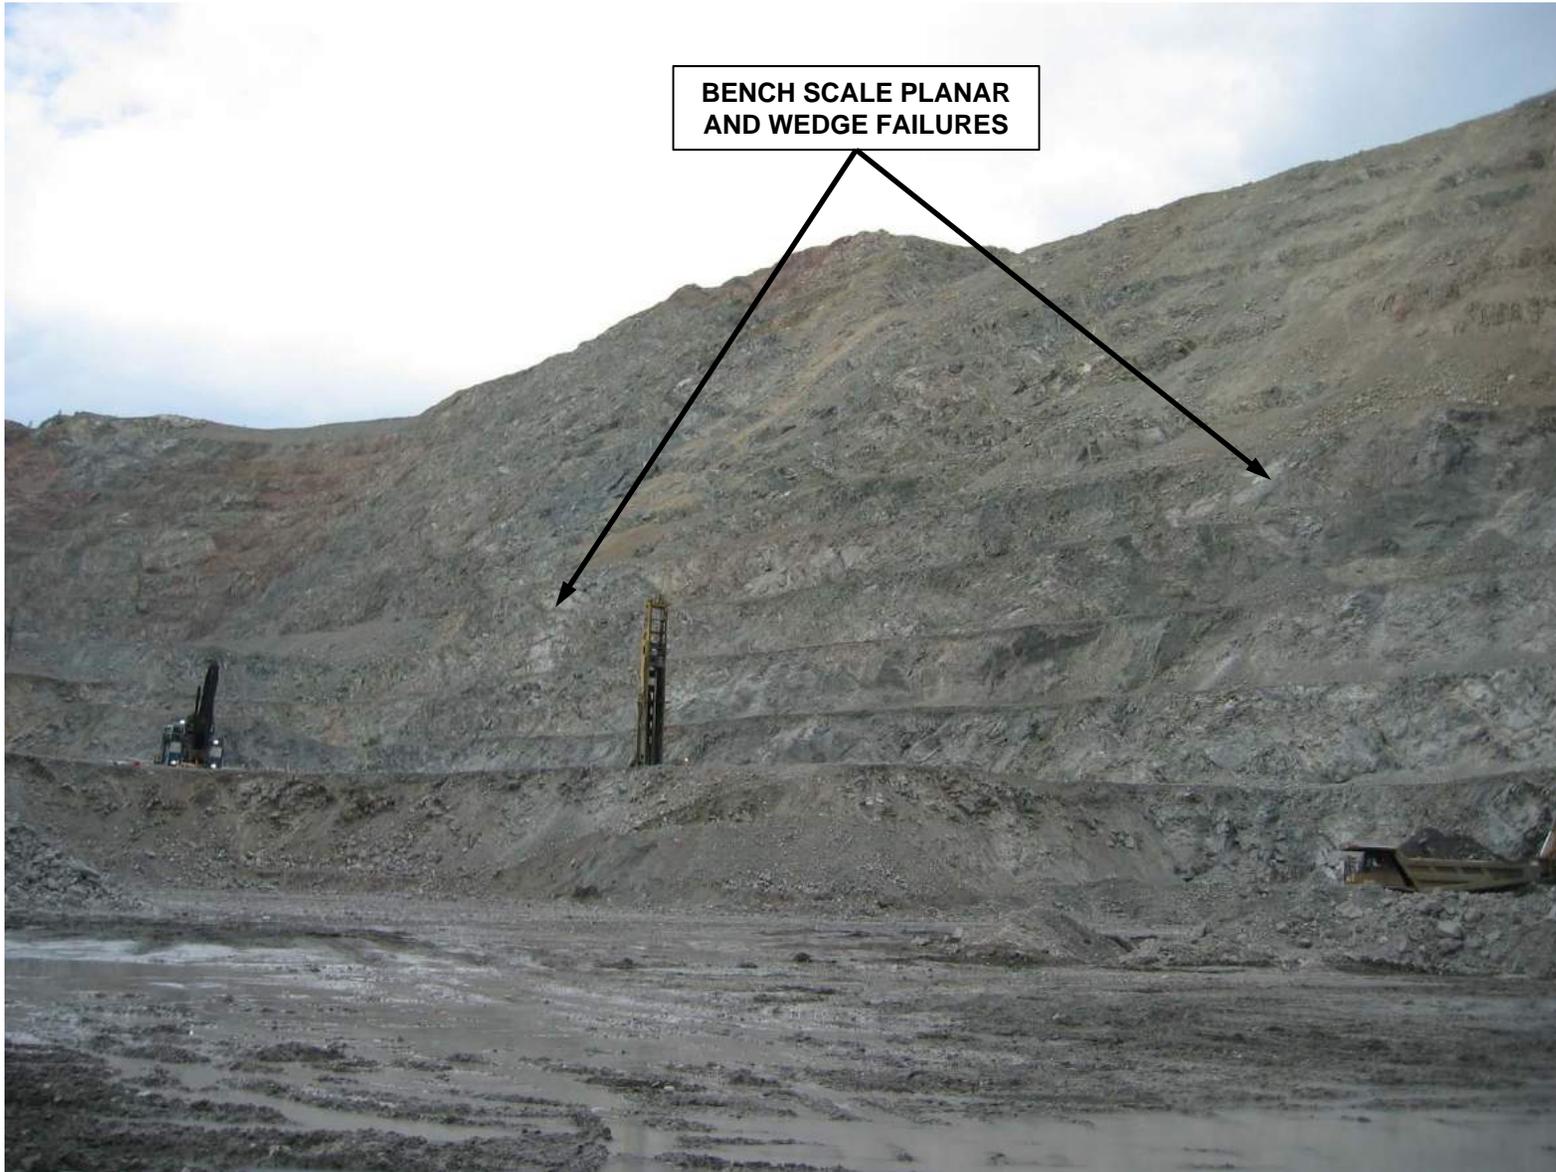
Localized bench scale planar failures have occurred along the lower portion of the East Wall. The planar failures are occurring along discontinuous joint sets that dip toward the northeast at moderate inclinations (Photograph A-7). The bench scale failures have reduced the amount of available catchment on the East Wall. These structures will need to be taken into consideration for the design of the ultimate East Wall.

Localized multi-bench scale planar failures have occurred along the South Wall, along continuous faults and joint sets that dip toward the north at steep inclinations (Photograph A-7). These structures have resulted in the localized loss of catchment on the benches. However, there is adequate catchment along the slope.

PLANAR FAILURES ALONG
LOWER EAST WALL

PLANAR FAILURES ALONG
SOUTH WALL

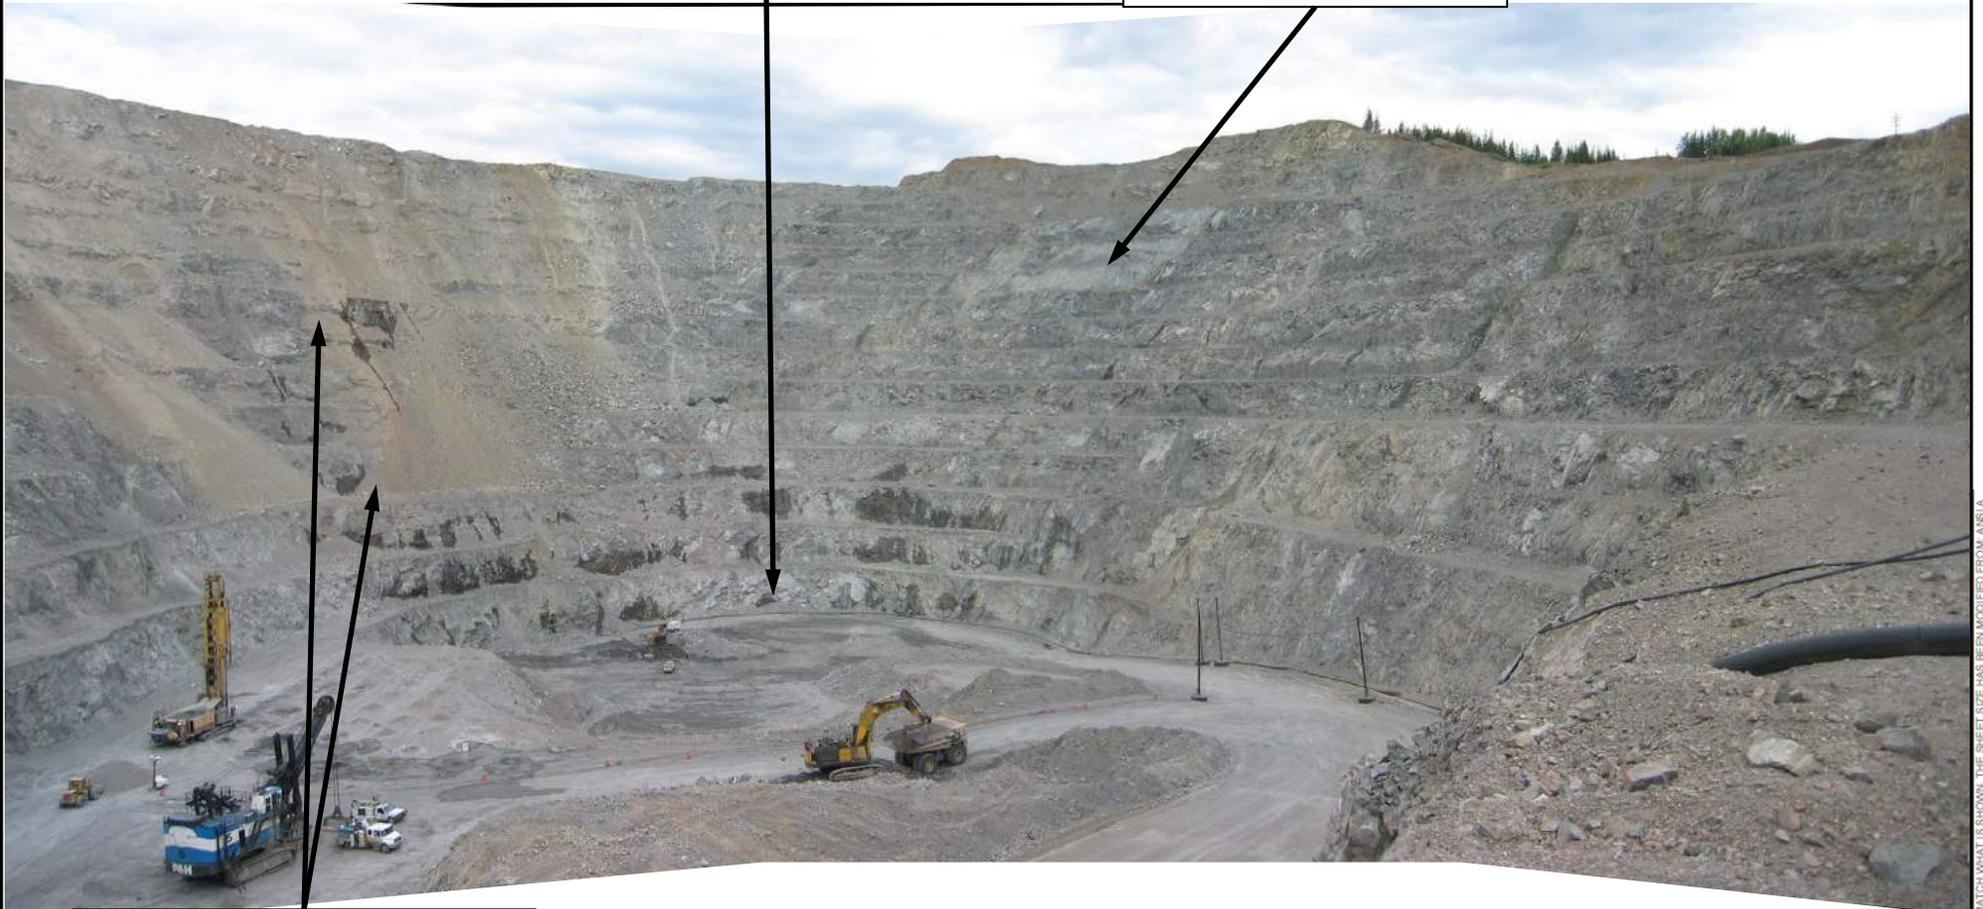
OVERSPILL FROM CARIBOO PIT
MINING IS BEING CONTAINED ON
SOUTH SEGMENT OF
NORTHEAST WALL

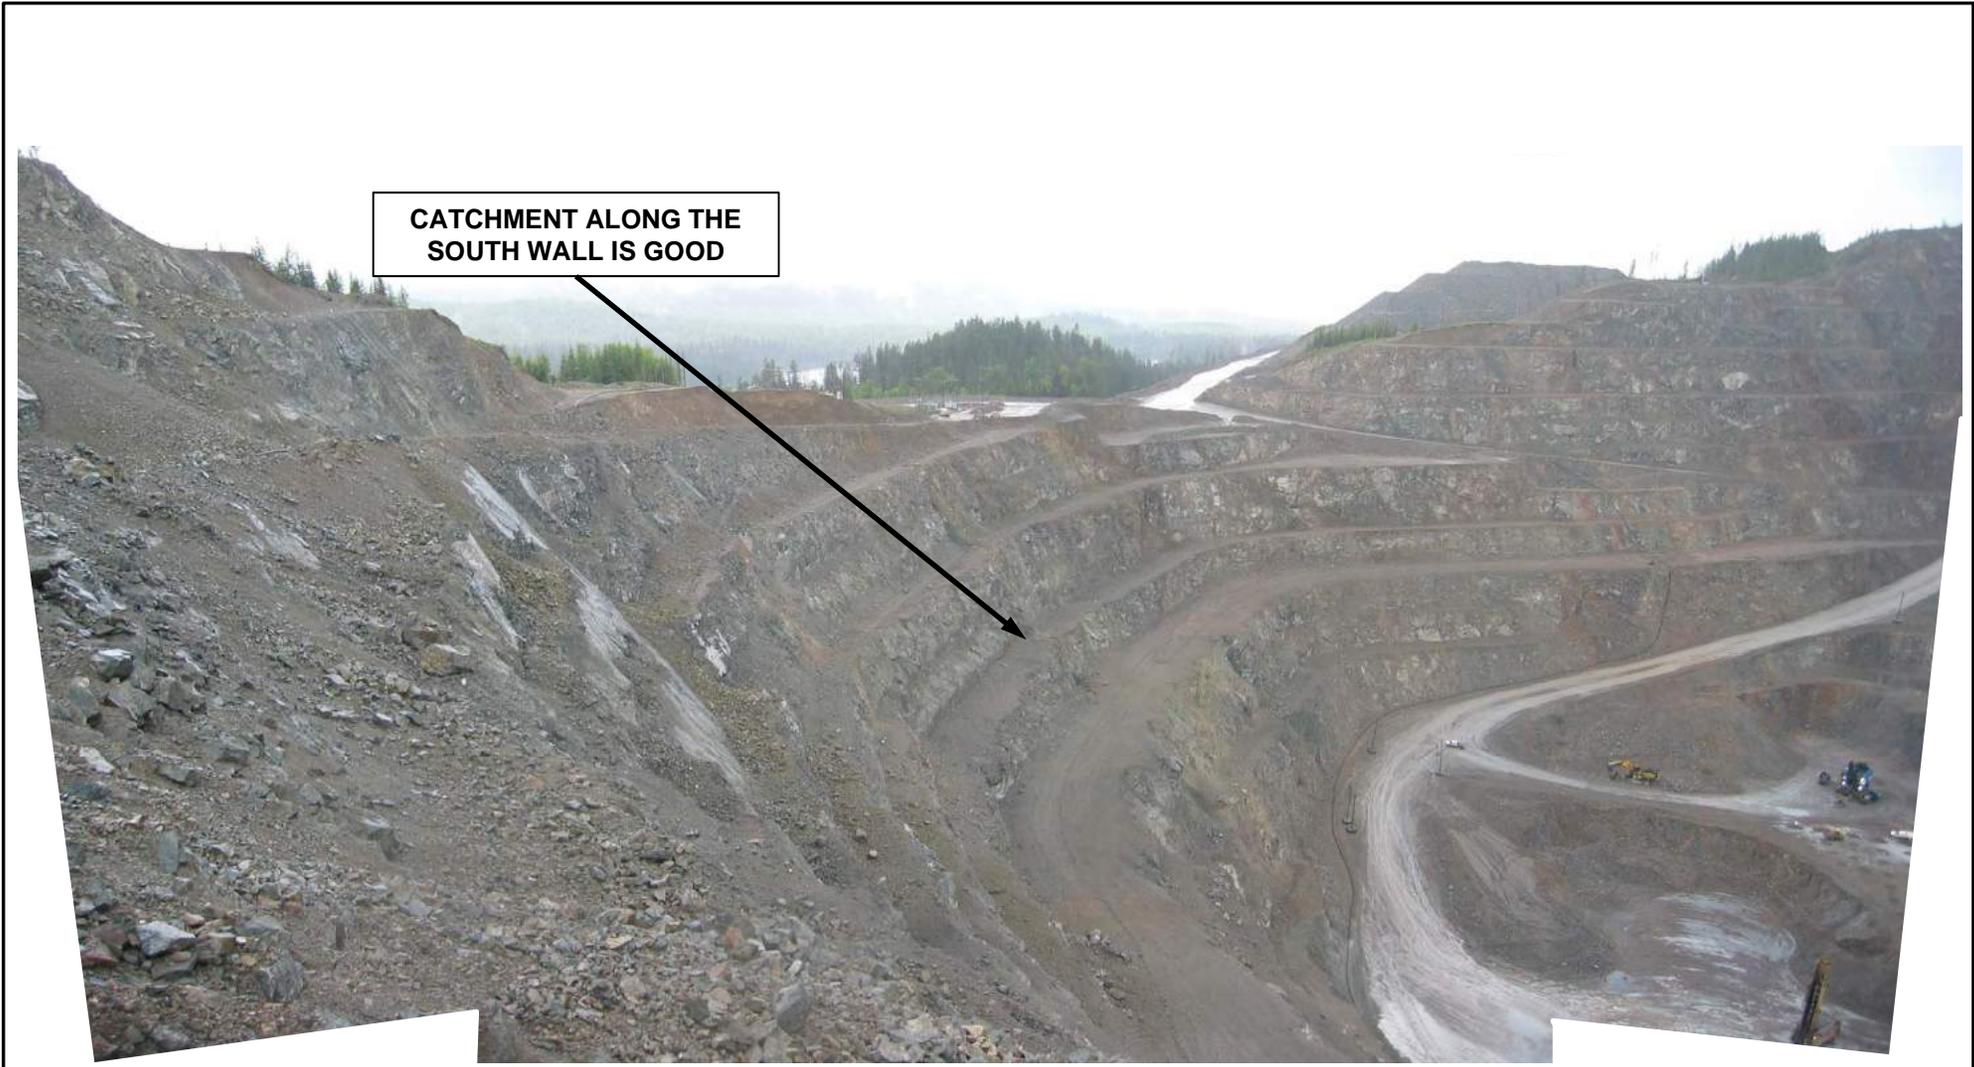
CATCHMENT ALONG THE SOUTH WALL IS GOOD

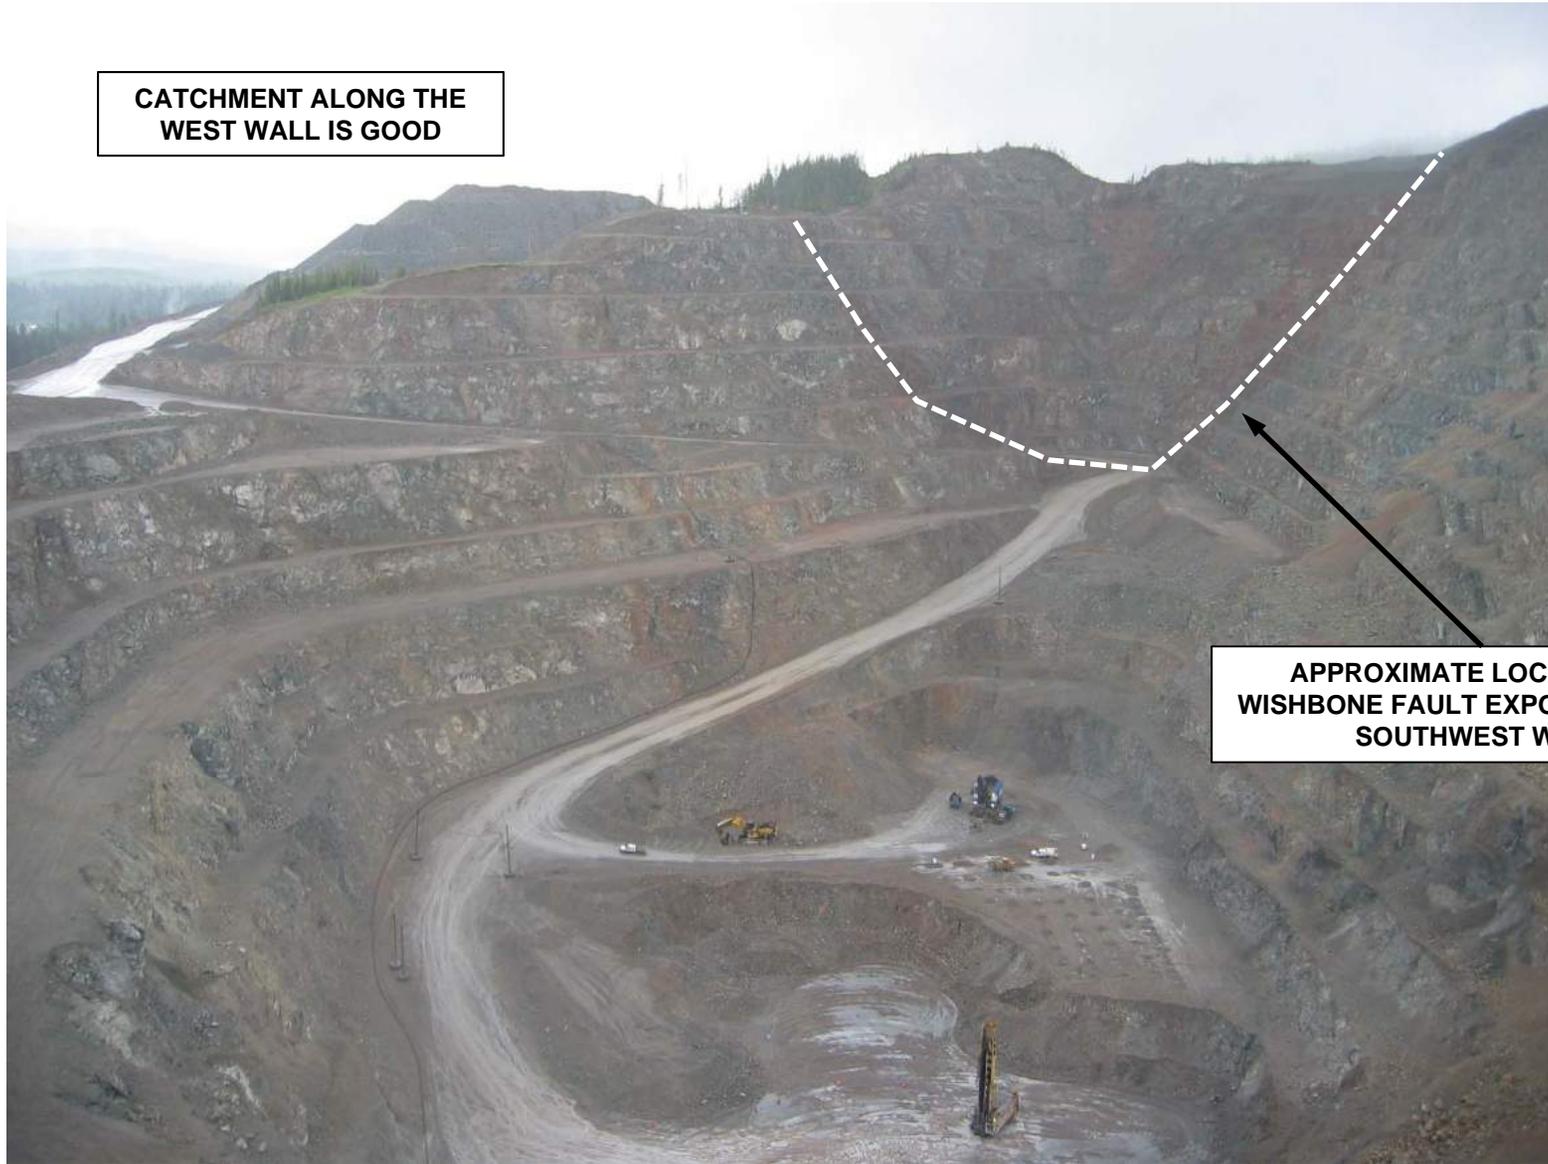
CATCHMENT ALONG THE WEST WALL IS GOOD

APPROXIMATE LOCATION OF WISHBONE FAULT EXPOSURE IN THE SOUTHWEST WALL

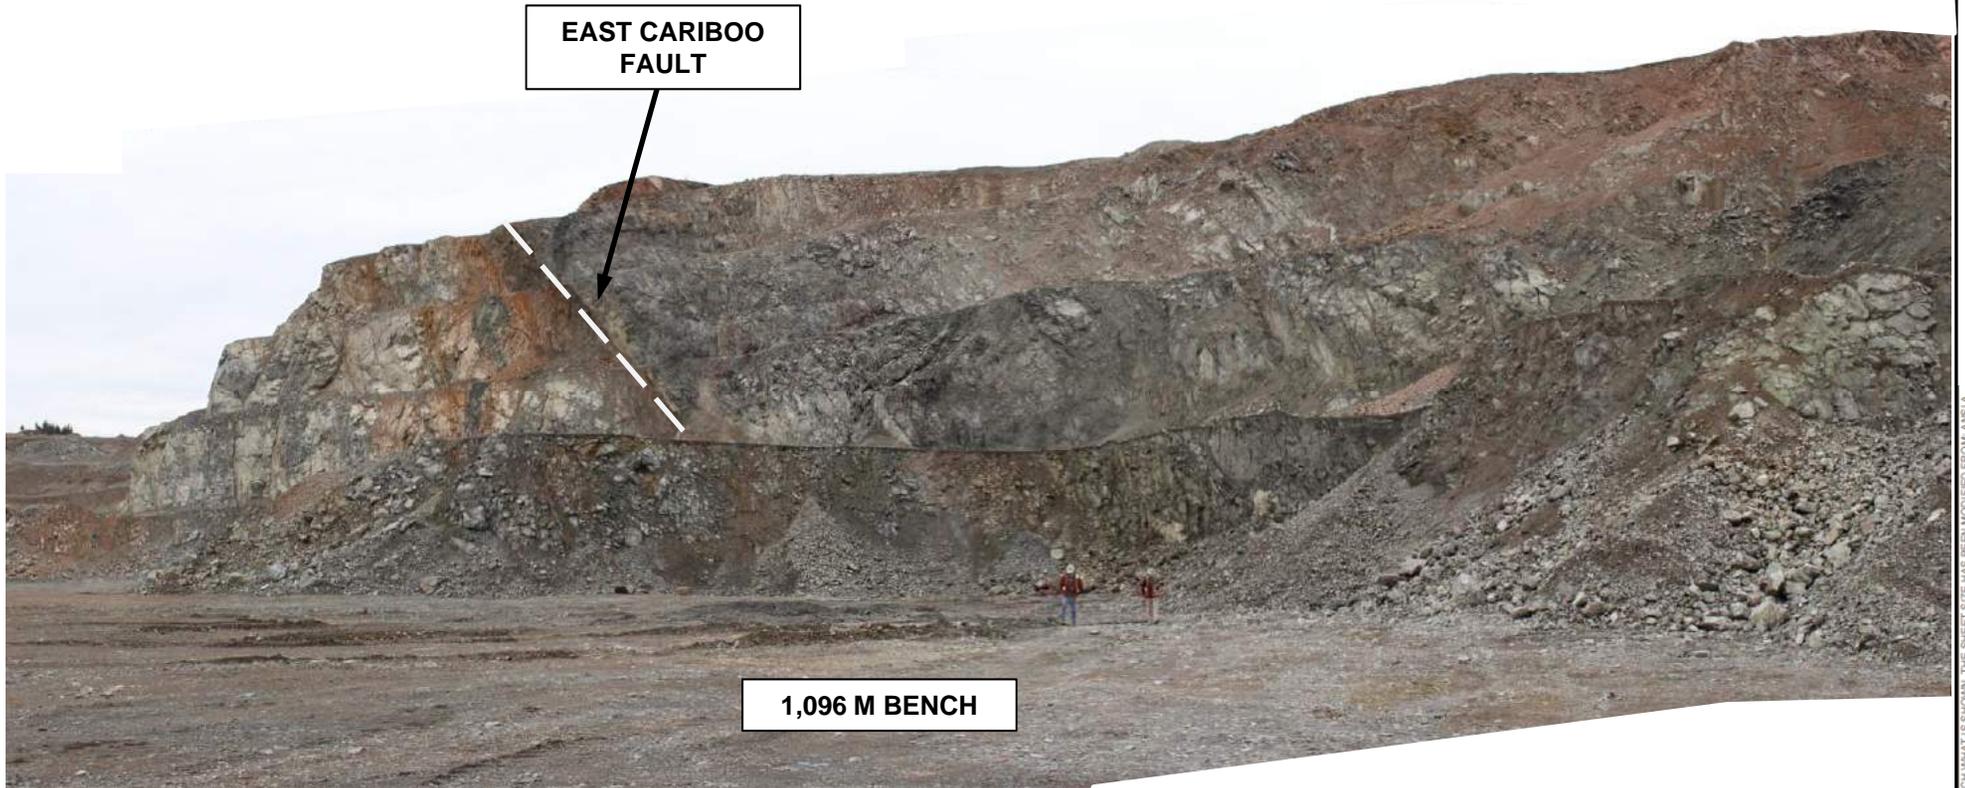
Cracking at the crest and bench scale toppling instability has developed along the Northeast Wall of the existing pit. The toppling is occurring along the East Cariboo Fault and sub-parallel faults that dip into the wall at approximately 60 degrees (Photograph A-13).

**EAST CARIBOO
FAULT**

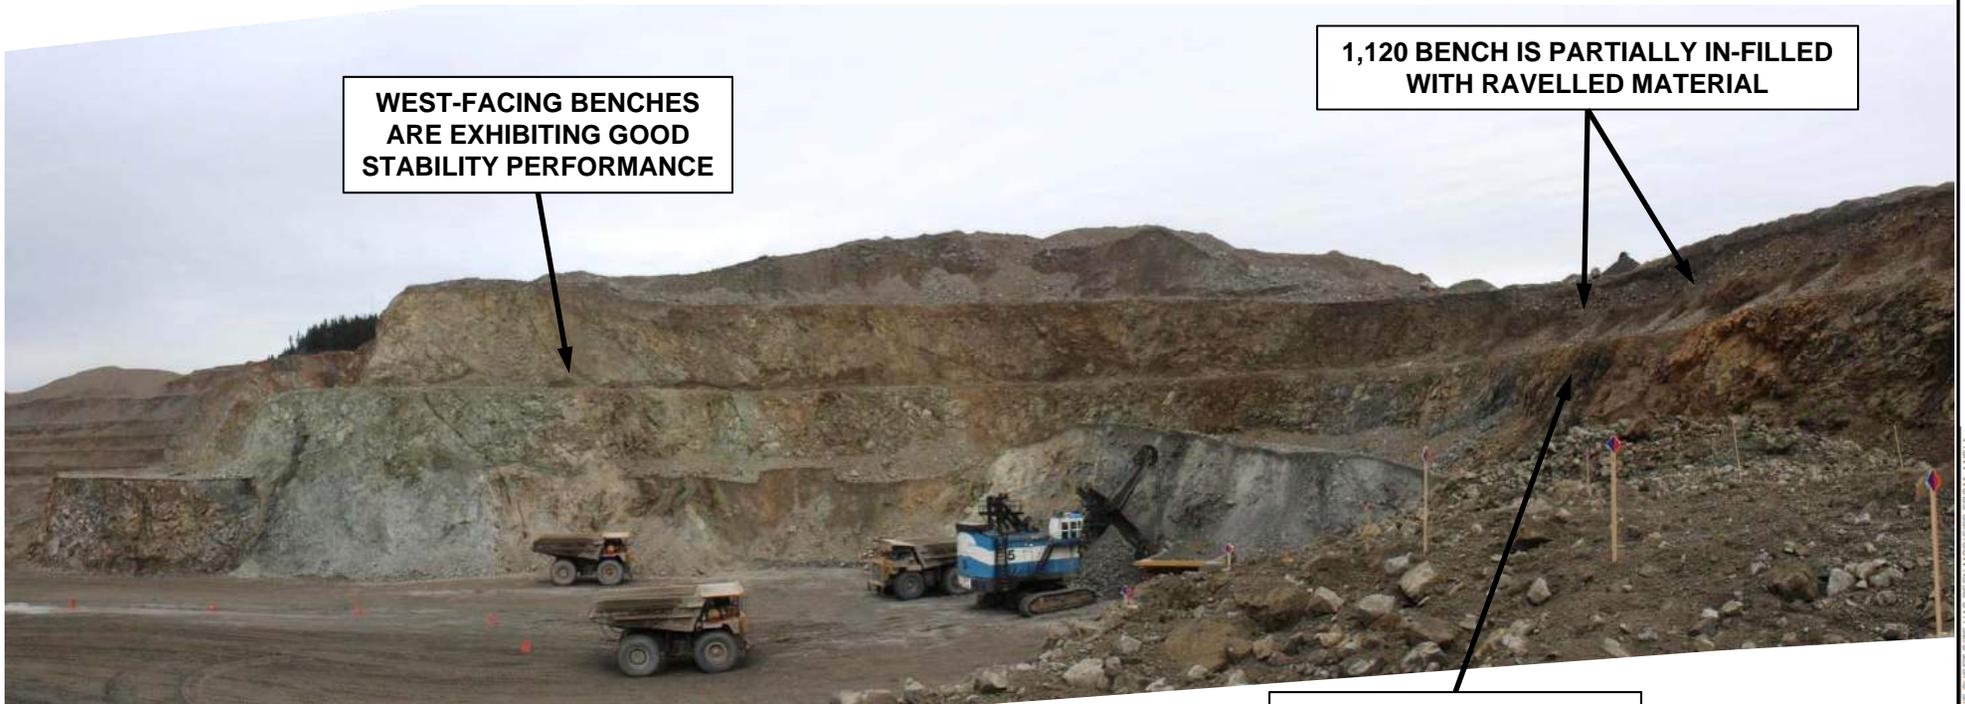
**WEST-FACING BENCHES
ARE EXHIBITING GOOD
STABILITY PERFORMANCE**

**1,120 BENCH IS PARTIALLY IN-FILLED
WITH RAVELLED MATERIAL**

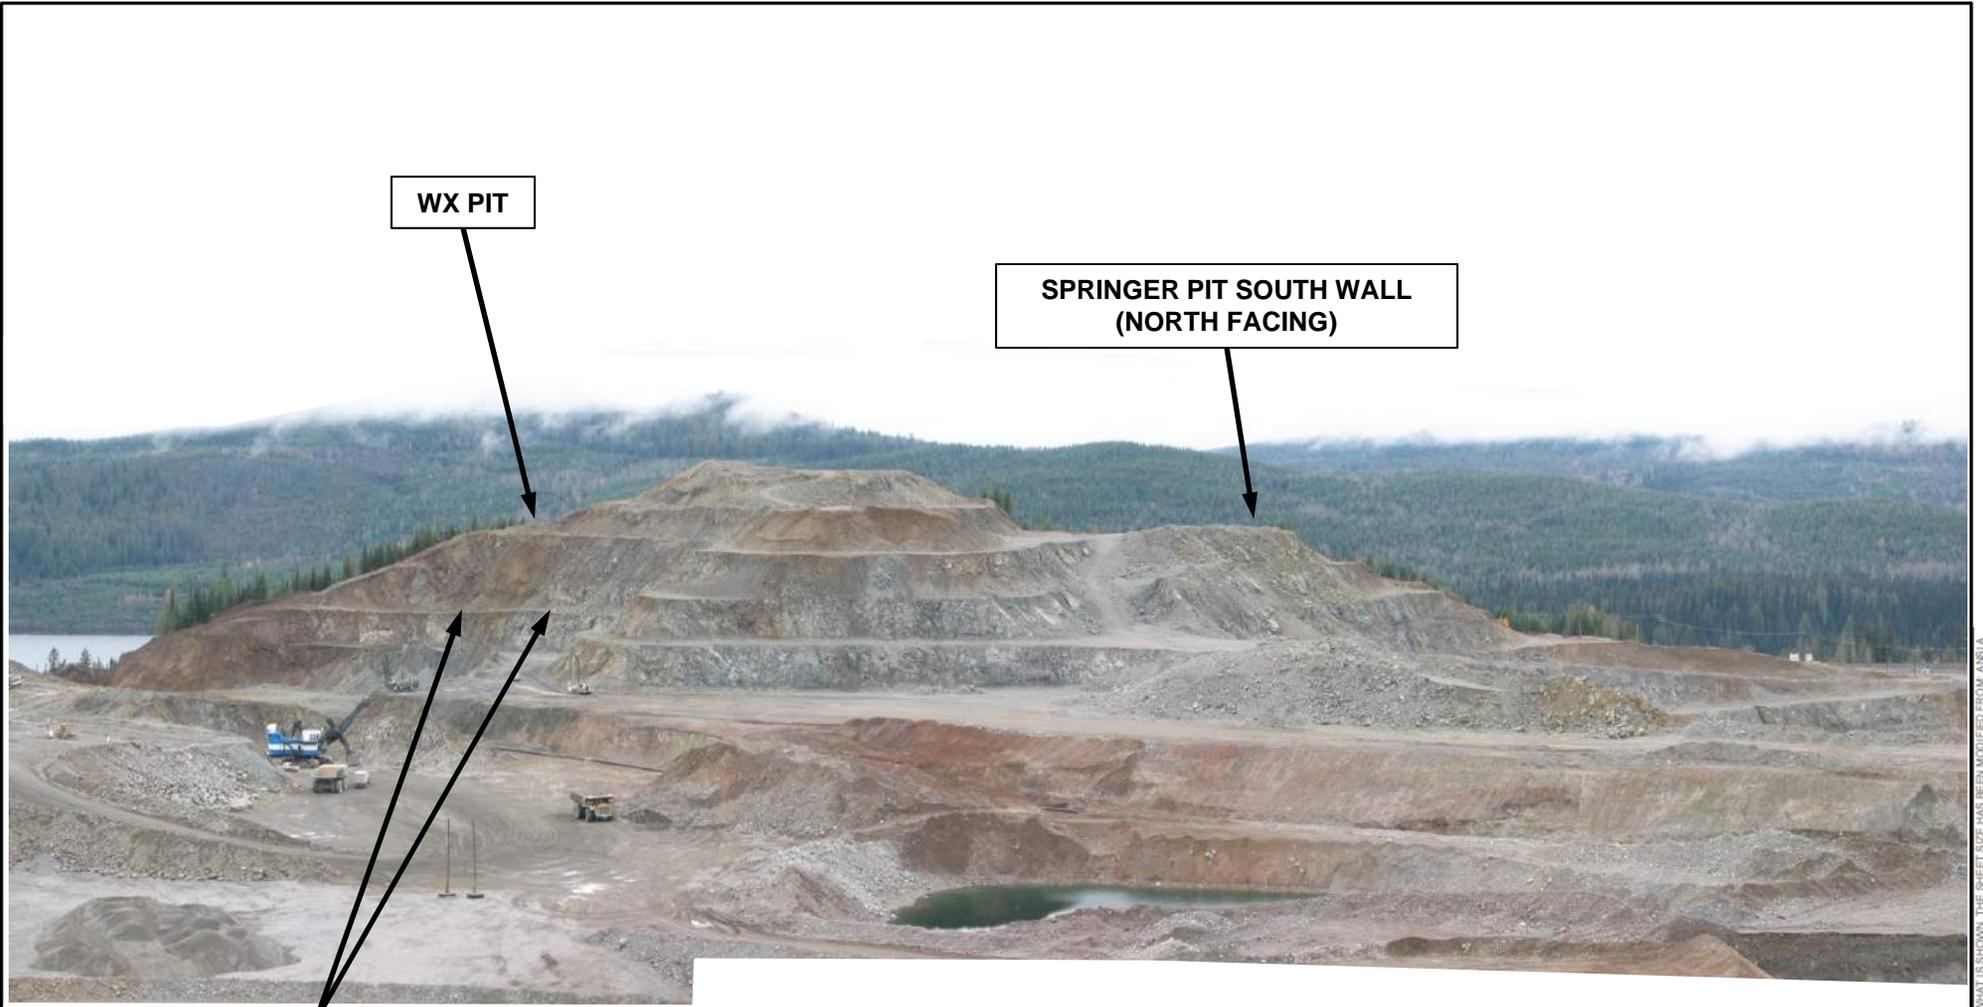
LIMITED CATCHMENT ALONG NORTHEAST-FACING BENCHES

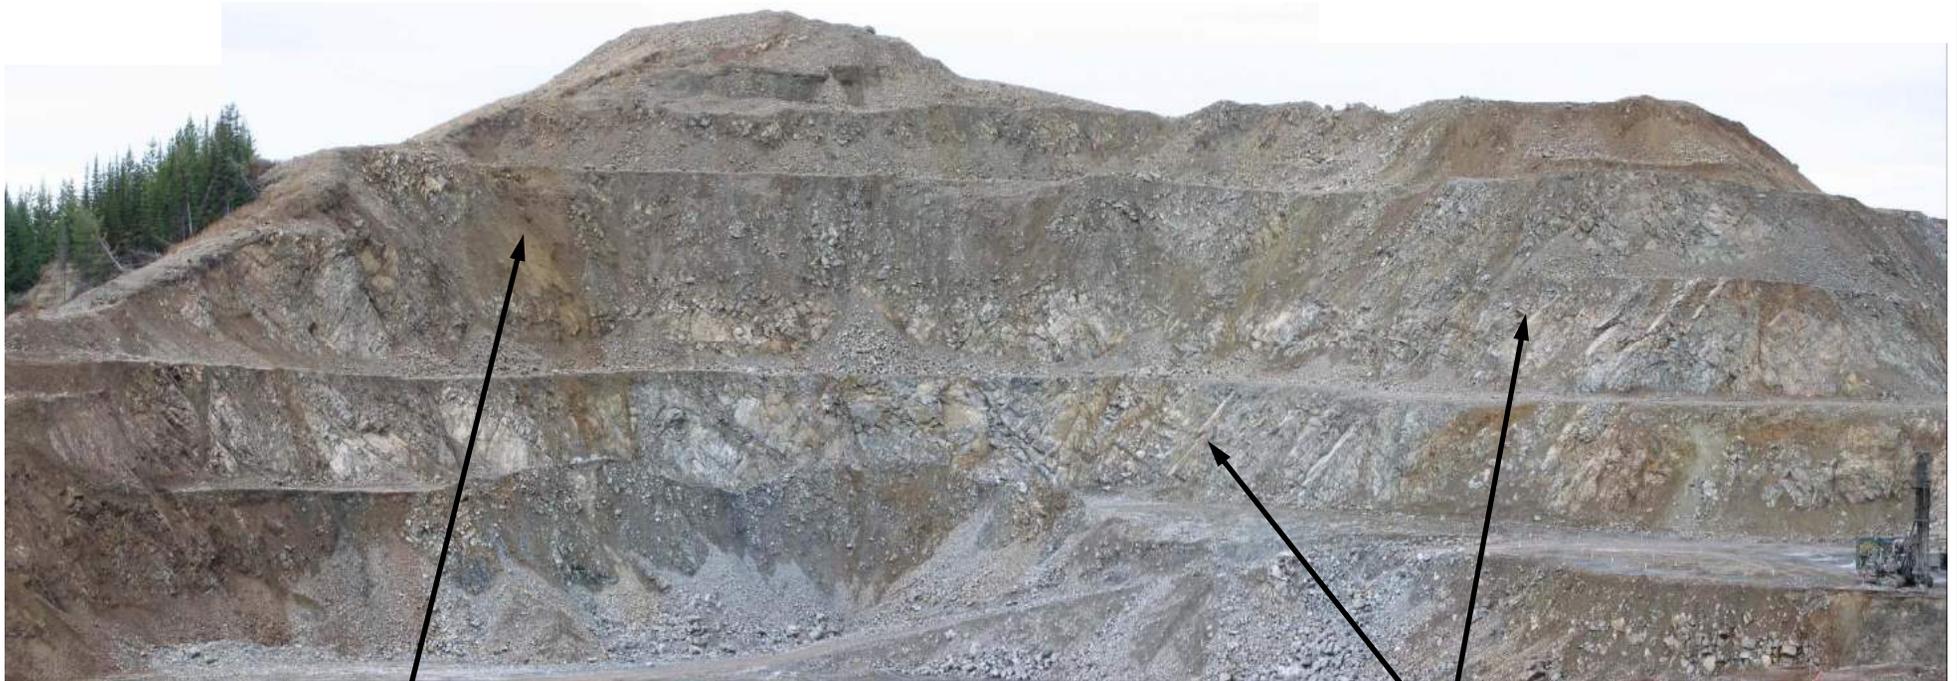
The rock mass exposed in the South Wall is highly fractured and blocky. This resulted in extensive ravelling along the slope. The ravelling was exacerbated by bench scale planar and wedge failures that occurred along the northwesterly dipping structures exposed in the South Wall (Photograph A-14). However, the continuity of these structures is disrupted by offsets along the more continuous east to southeasterly dipping structures and by southwesterly dipping structures. This limited the continuity of the individual planar failures along the northwesterly dipping structures. The southeasterly dipping structures and the southwesterly dipping structures acted as release surfaces and backscarps for the planar and wedge failures along the northwesterly dipping structures.

**PLANAR FAILURES OCCURRING ALONG
NORTHWESTERLY DIPPING JOINT SETS**

**PLANAR FAILURES OCCURRING ALONG
SOUTHEASTERLY DIPPING JOINT SETS**
