Mount Polley Mining Corporation

April 23, 2015

WEEKLY POST-TSF BREACH REPORT – WEEK OF APRIL 15 – 21, 2015

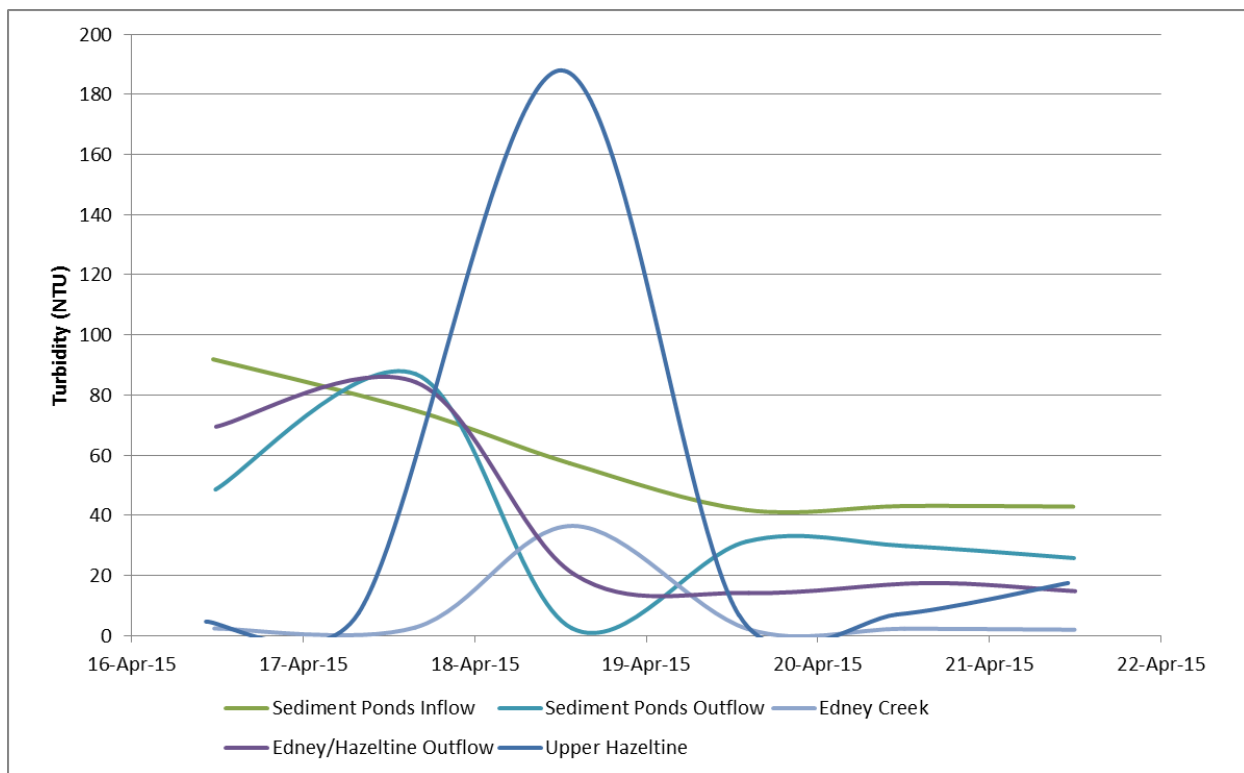
Figure 1. Time series graph for April 16th to 21st showing turbidity levels at monitoring locations in Hazeltine and Edney Creeks

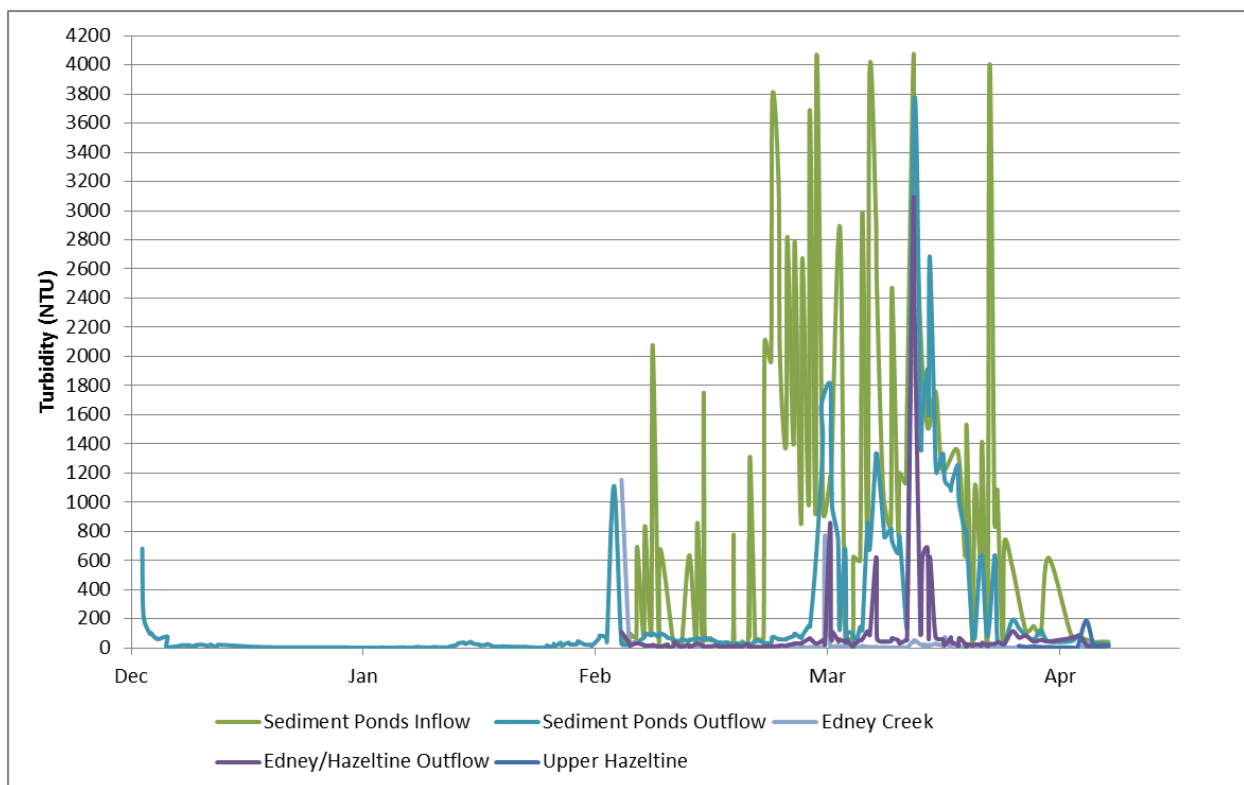
Figure 2. Time series graph for December 12th to April 21st showing turbidity levels at monitoring locations in Hazeltine and Edney Creeks

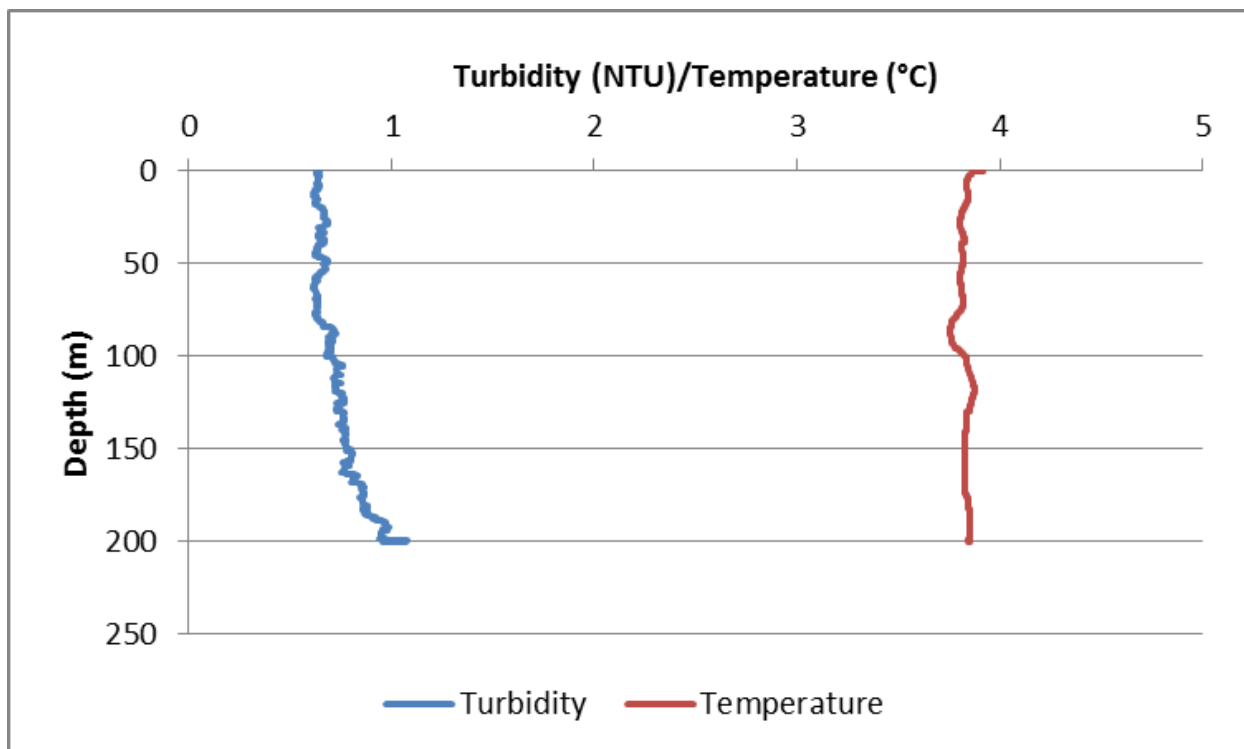
Figure 3. Turbidity and temperature profiles at station QUL-120 from April 21st

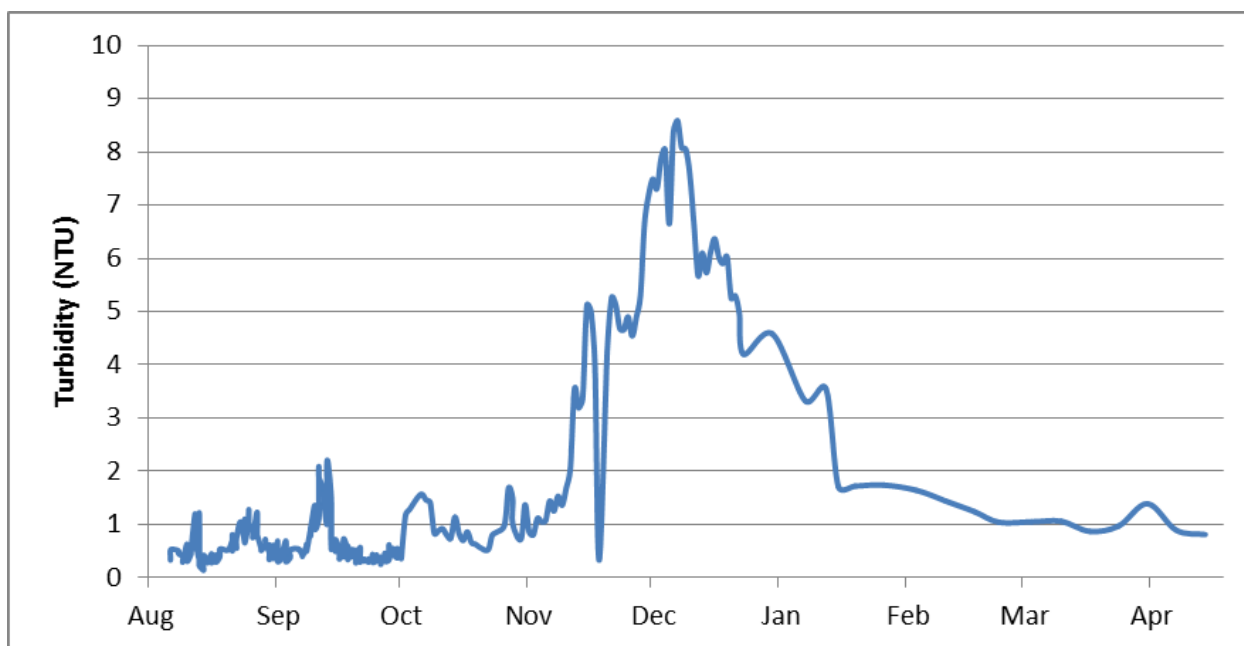
Figure 4. Turbidity time series at station QUR-1 (August 6th – April 14th)
