Mount Polley Mining Corporation

December 18, 2014

WEEKLY POST-TSF BREACH REPORT - WEEK OF DECEMBER 10 - 16, 2014

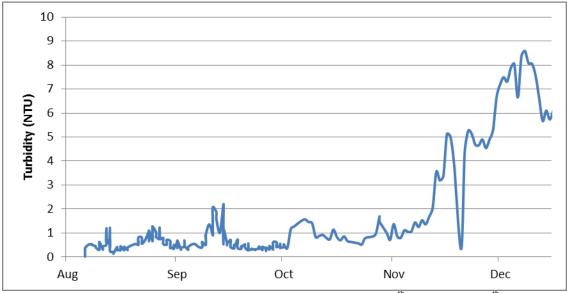
Figure 2. Turbidity time series at sample location QUR-1 (August 6th – December 9th)

Figure 2 shows a time series graph of turbidity results from sample location QUR-1 on Quesnel River (at the Quesnel River Research Centre). The turbidity data is from laboratory analysis completed by ALS Environmental.
