Mount Polley Mining Corporation

December 5, 2014

WEEKLY POST-TSF BREACH REPORT - WEEK OF NOVEMBER 26 - DECEMBER 2, 2014

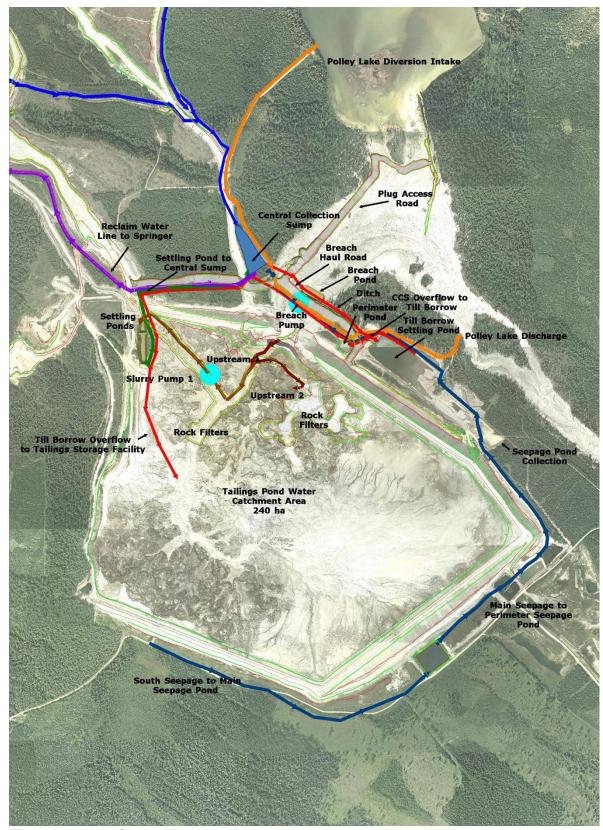
Figure 1. Tailings Storage Facility construction works

Polley Lake Dewatering Breaches	Polley Lake water elevation = 921.59 m (December 1 st) Pumps previously used to lower the Polley Lake water level and maintain the water level within its natural range were removed on November 27 th . The lake is now frozen. Design work for a weir structure at the outlet of Polley Lake is in the final stages. No breaches of the water management system containing water flow from the Tailings		
	Storage Facility (TSF) occurred this week.		
TSF and Water Management Structures	within its natural range were removed on November 27 th . The lake is now frozen. Design work for a weir structure at the outlet of Polley Lake is in the final stages.

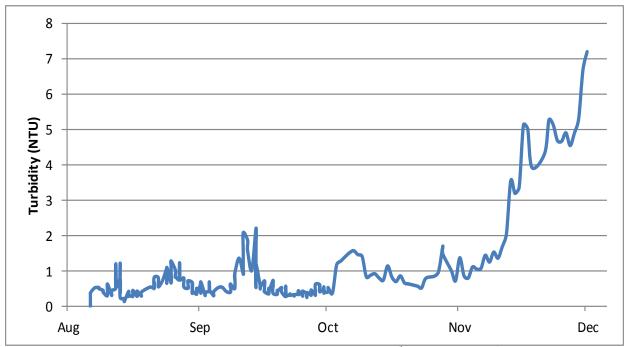
Figure 2. Turbidity time series at sample location QUR-1 (August 6th – December 1st)

Figure 2 shows a time series graph of turbidity results from sample location QUR-1 on Quesnel River (at the Quesnel River Research Centre). The turbidity data is from laboratory analysis completed by ALS Environmental.
