Mount Polley Mining Corporation

February 26, 2015

WEEKLY POST-TSF BREACH REPORT - WEEK OF FEBRUARY 18 - 24, 2015

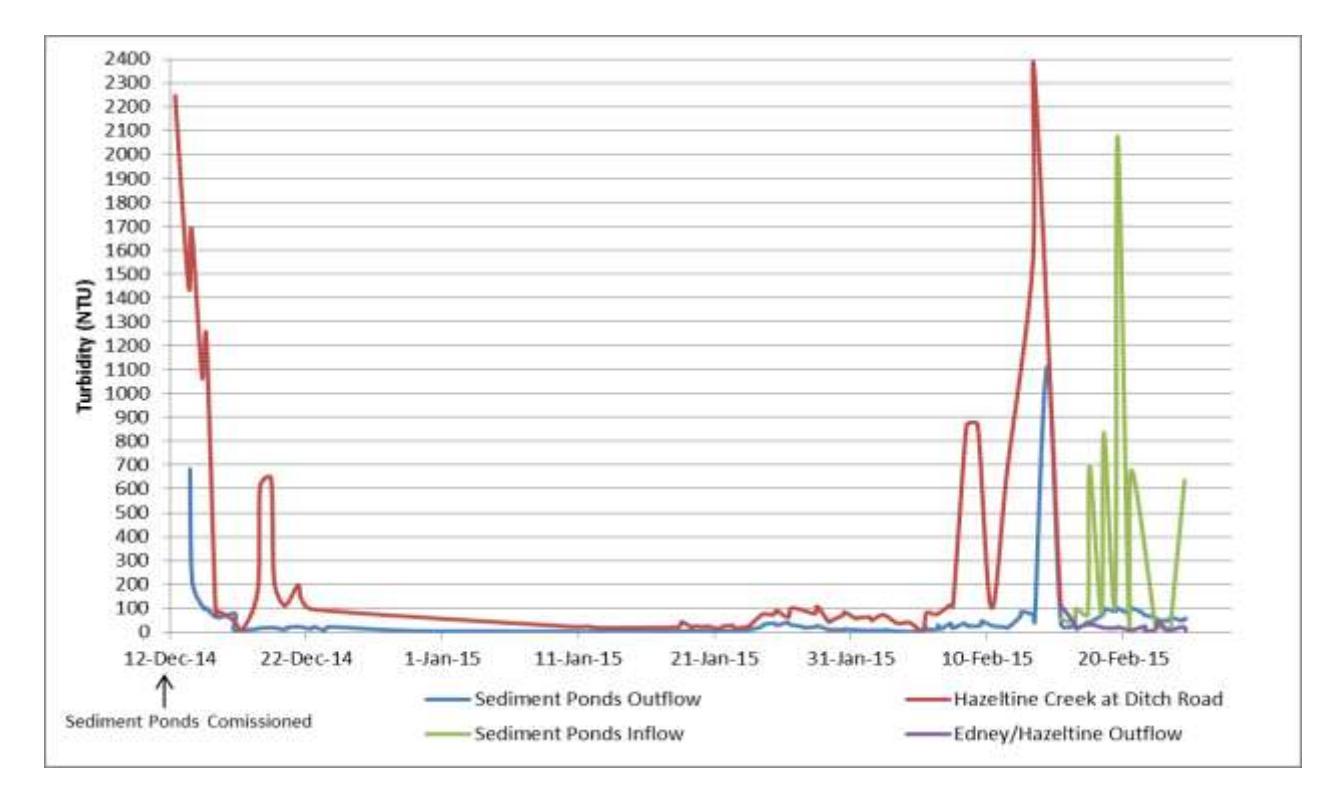
Results	Figure 1 shows a turbidity time series graph for Lower Hazeltine and Edney Creeks. Sites presented from February 15 th onward are different to reflect the fact that Edney Creek was diverted from the sedimentation ponds into its new channel.
	Figure 2 shows a time series graph of turbidity at site QUR-1. Turbidity data up to December 23 rd are from laboratory analysis completed by ALS Environmental. Data from December 24 th onward are laboratory turbidity values from weekly samples supplemented by field data.

Figure 1. Turbidity time series graph for: Hazeltine Creek at the Ditch Road (December 12^{th} – February 15^{th}); inflow of the Lower Hazeltine Creek sedimentation ponds (February $15^{th} - 24^{th}$); the outflow of the Lower Hazeltine Creek sedimentation ponds (December 12^{th} – February 24^{th}); and the combined Edney/Hazeltine Creek outflow into Quesnel Lake (February $15^{th} - 24^{th}$)

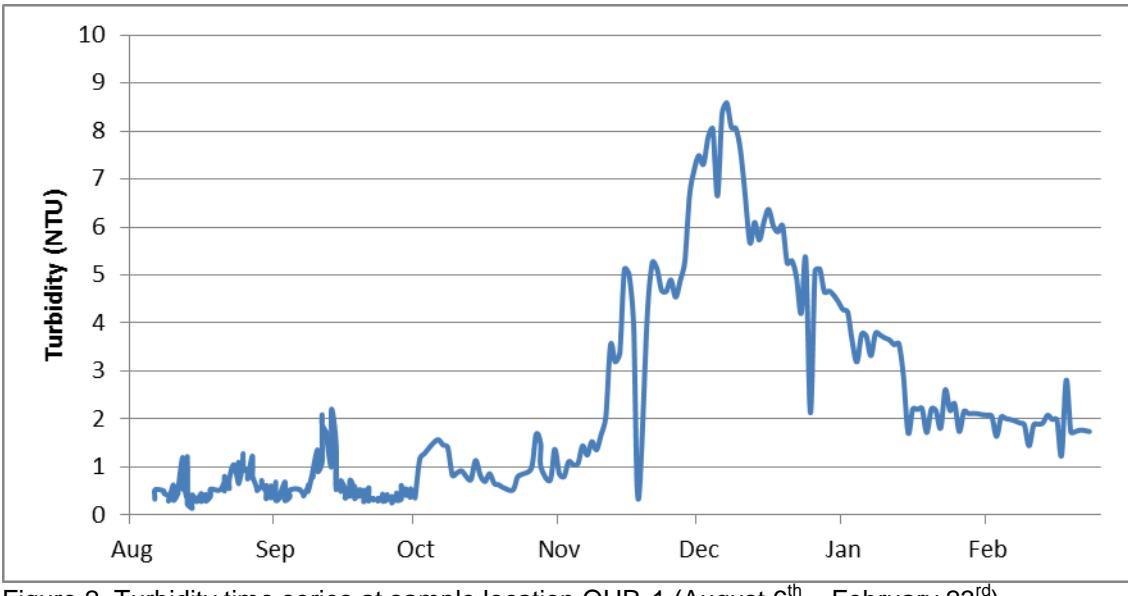
Figure 2. Turbidity time series at sample location QUR-1 (August 6th – February 23rd)
