Mount Polley Mining Corporation

Community Update

Mount Polley Mine 2018 Summary

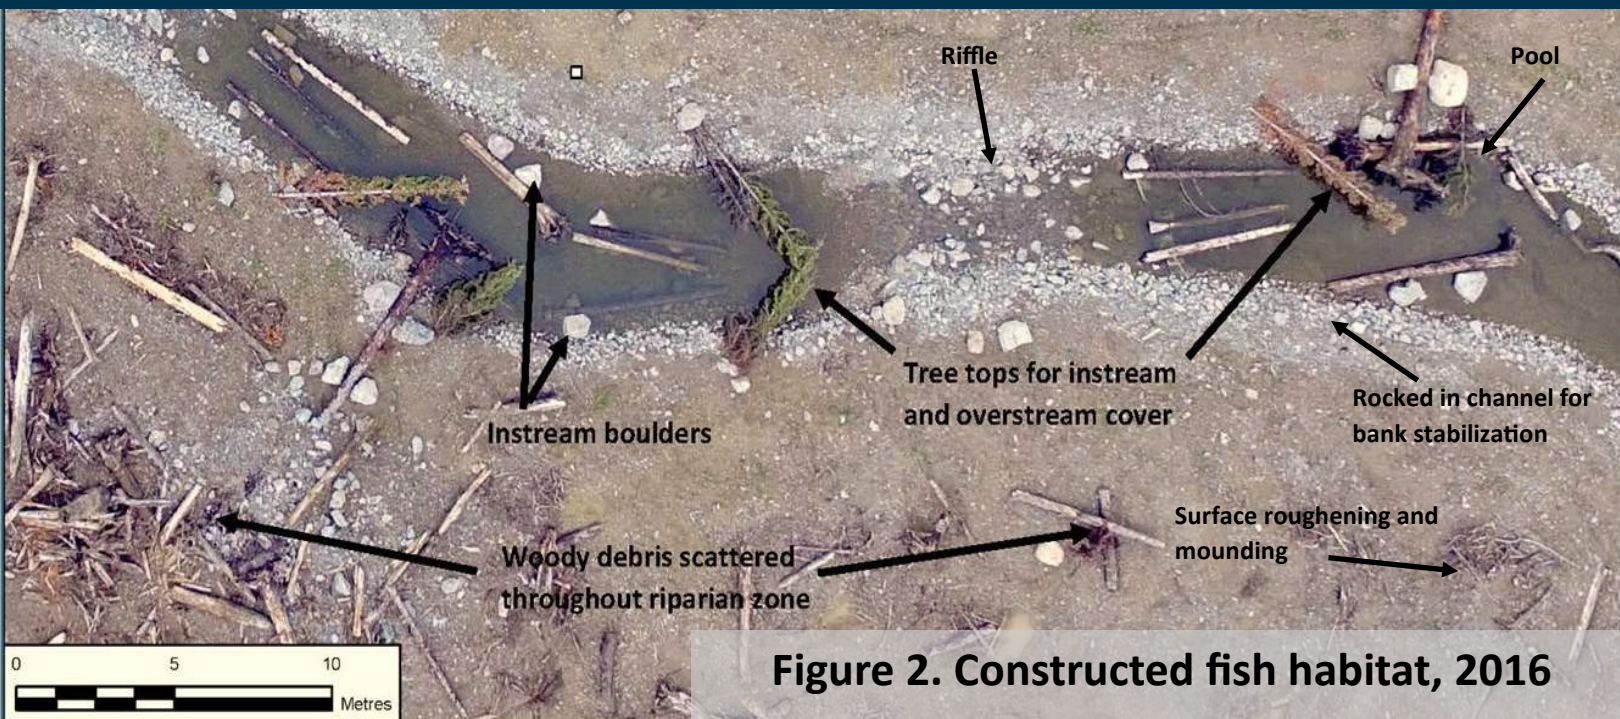
Figure 2. Constructed fish habitat, 2016

Figure 2 below depicts a section of Hazeltine creek (with a meander) that was constructed in 2016 with fish habitat features as described above. The same design replicated throughout the creek in 2017 and 2018 in upper Hazeltine to 1km downstream of the Gavin Lake bridge. In Figure 1 above, shows 2 years of vegetation growth in the riparian areas, and that the reintroduced fish are utilizing the habitat provided (ie. cover of the deep pools and instream logs).

A lot of work goes into rebuilding a creek. While it may look like the woody and rocky debris are scattered in haphazard manner, a lot of science and engineering are behind those ‘messy’ placements. Nature rarely builds things neatly, so when it comes to rebuilding a creek, experts must take that into account.

Creeks and rivers naturally bend or ‘meander’ (rarely do water bodies flow in a straight line) to form ‘S’ curves. Common features of these creeks are riffles and pools. Riffles are piles of rocks that are built up to control flow rates and aerate the water. Pools are deeper sections of creeks, and in addition to instream and overstream boulders and logs, provide shelter for fish.

The riparian areas, the parts adjacent to the creek, are just as important. In Hazeltine Creek, the sides of the channel have been rocked in to provide stream stabilization to prevent erosion. The earth has been moved (roughened and loosened) and mounded to allow for planting; this will give the roots more room to establish compared to compacted ground. Deeper roots will also help prevent erosion of the stream bank. The vegetation will provide additional cover for fish. The woody debris and upturned trees provide avian and small mammal habitat, and eventually, additional nutrients for the soil during decomposition.

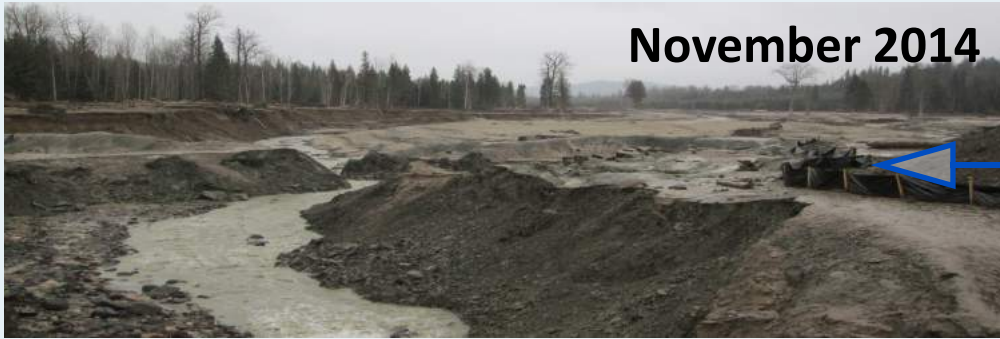
November 2014

Sediment and erosion control fencing to prevent native material from entering creek

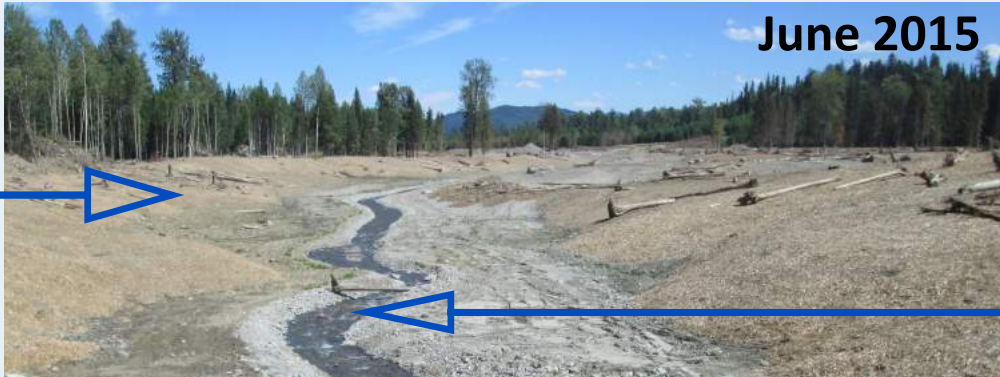
June 2015

Tailings in and adjacent to creek removed. Wood chips and woody debris added to banks for additional nutrients on both banks

Channel rocked in for stability with meanders

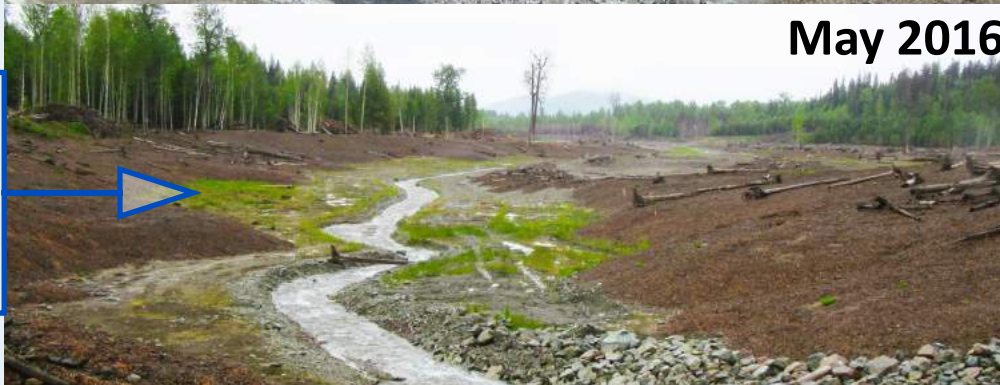
May 2016

Grass seeding and planting willow stalks for additional erosion control on both floodplains and upper banks

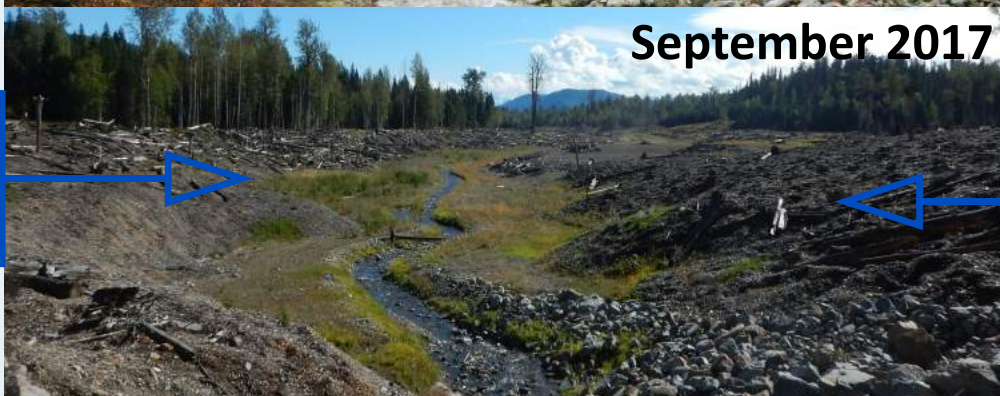
September 2017

Continued growth of willows, shrubbery and grasses along the banks

Surface roughening and mounding for planting native shrubs (eg. Prickly rose)

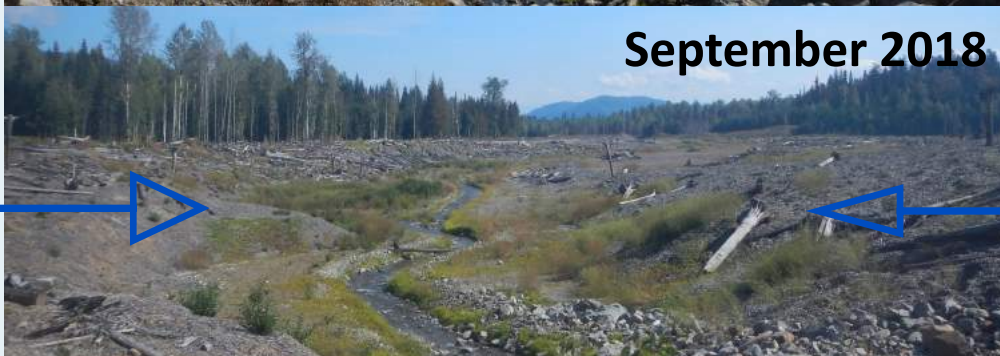
September 2018

Continued growth of willows, shrubbery and grasses along the banks

Surface roughening and mounding providing root strength for continuous growth. Coniferous tree plugs planted. Ongoing remediation planned for 2019-2020.
