COMMUNITY UPDATE Q3 2021

Mount Polley Mining Corporation
an Imperial Metals company
Box 12, Likely, BC V0L 1N0
T 250.790.2215

MOUNT POLLEY MINE: CARE AND MAINTENANCE

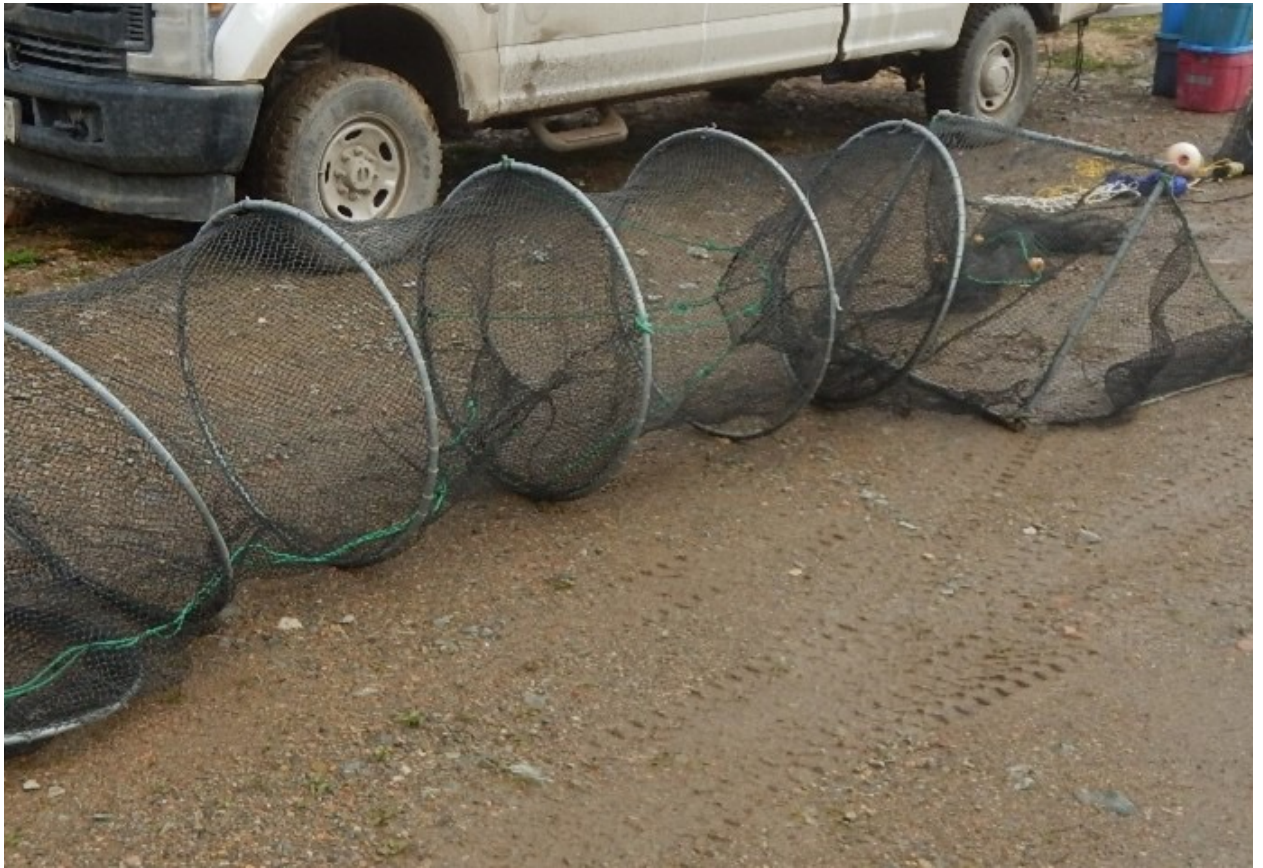
Figure 1 Hoop nets being prepared for deployment into Polley Lake during fish population field work

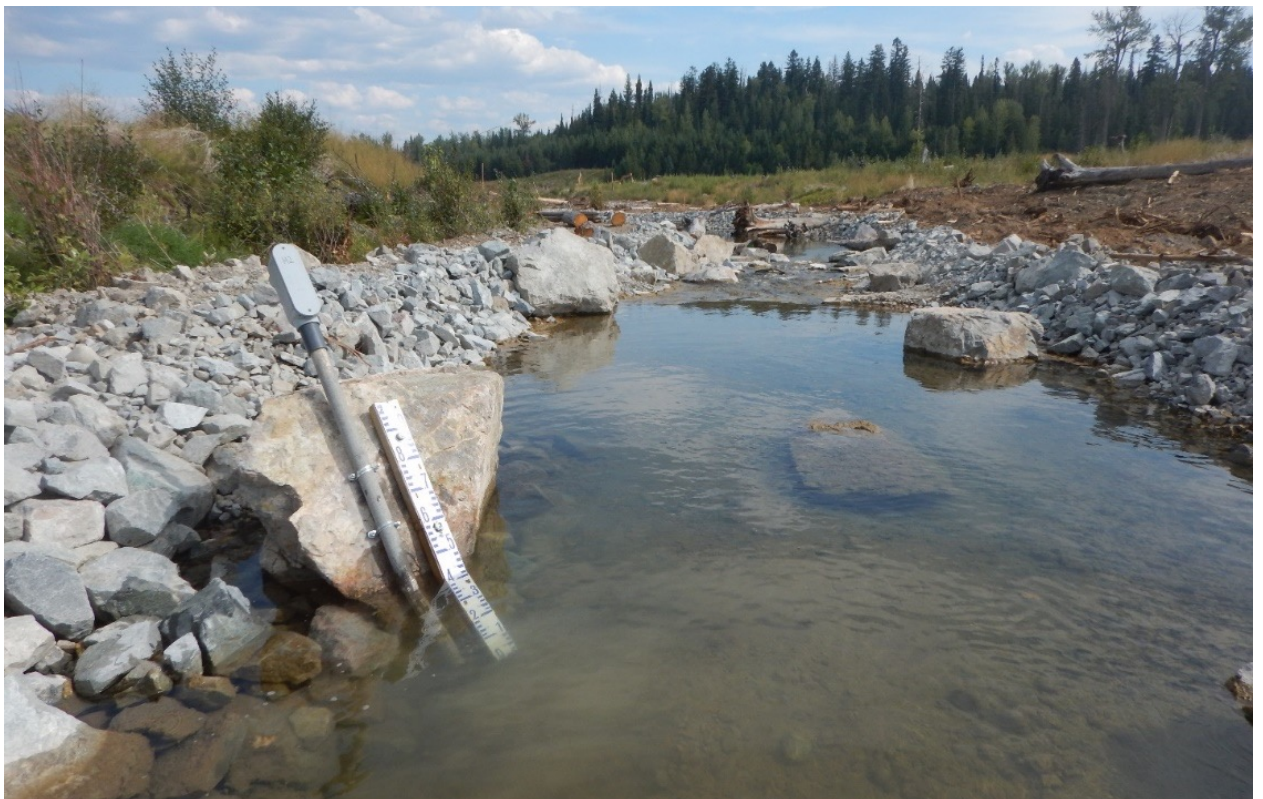
Figure 2 Newly installed H2 hydrological monitoring station. The original station was removed to facilitate instream remediation

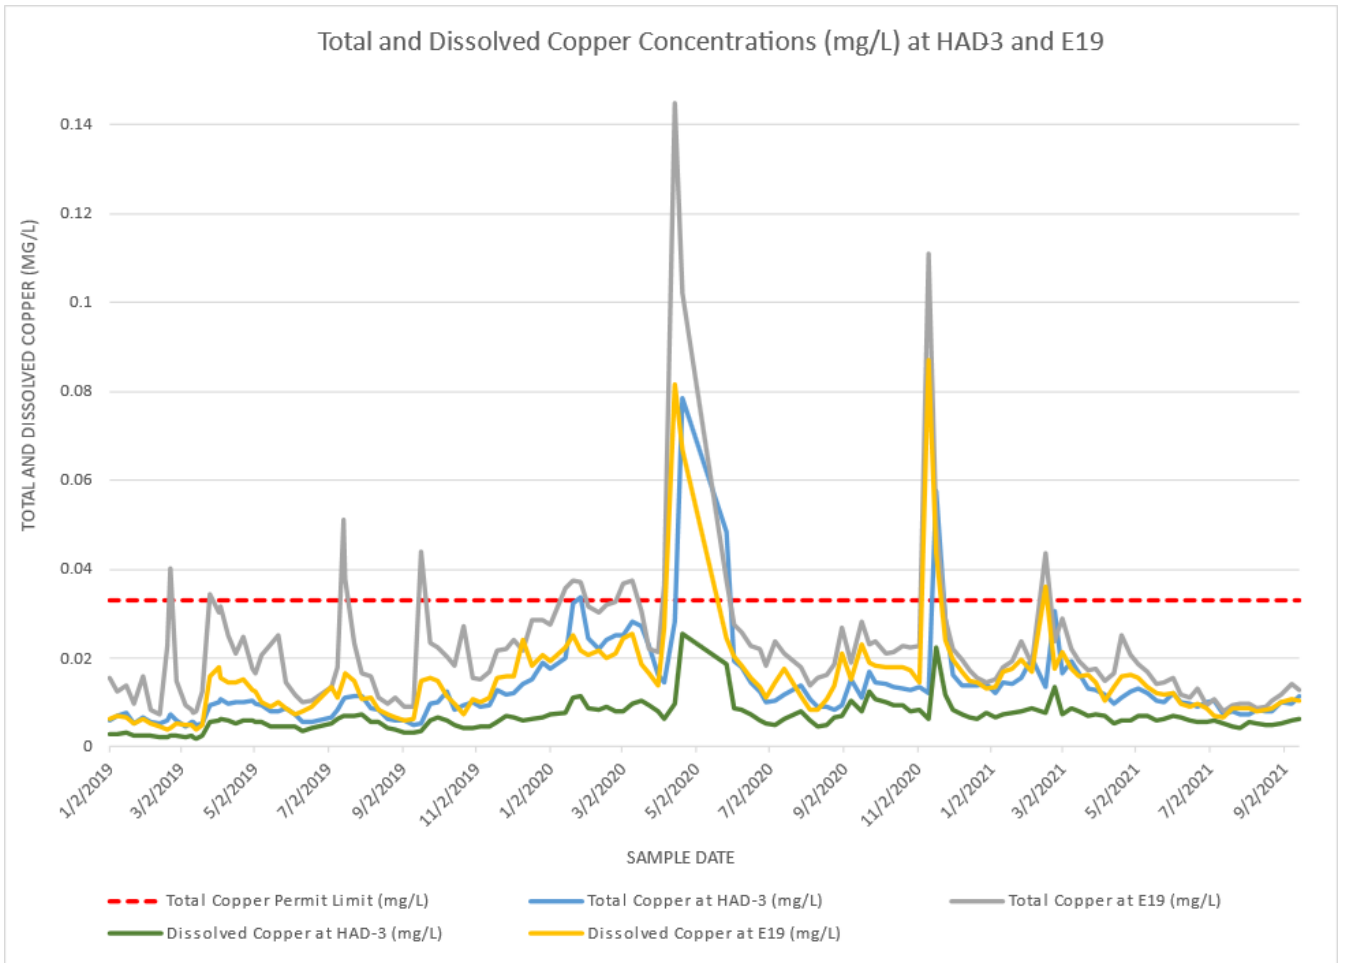
Figure 4 Copper concentrations at the water treatment plant. Improved handling water systems installation occurred at the beginning of March 2021, yielding better results with lower copper concentration.

The plant operated continuously for most of Quarter 3. Water quality samples were collected weekly at the Water Treatment Plant (WTP) influent (E19) and effluent (HAD-3) sites throughout the quarter.

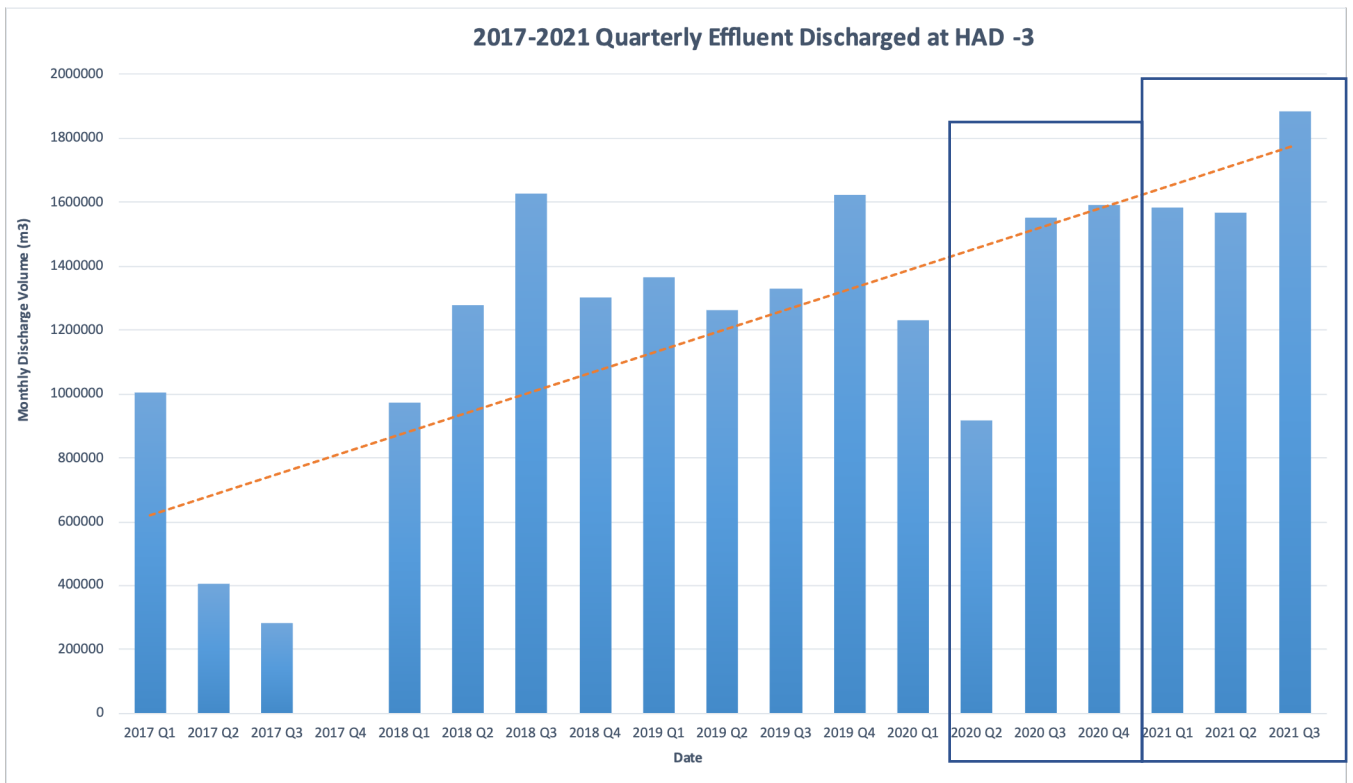
Figure 5 Quarterly effluent discharge volumes. Improved water handling system enabled water treatment plant to operate virtually continuously in 2021. Hence, should be able to discharge 6.5Mm³ in 2021 compared to 5.0Mm³ in 2020.

In Quarter 3, the total treated water discharged to Quesnel Lake was $\sim 1,882,460 \text{ m}^3$ with an average discharge rate of $\sim 0.243 \text{ m}^3/\text{second}$ and an average of $\sim 20,462 \text{ m}^3/\text{day}$.

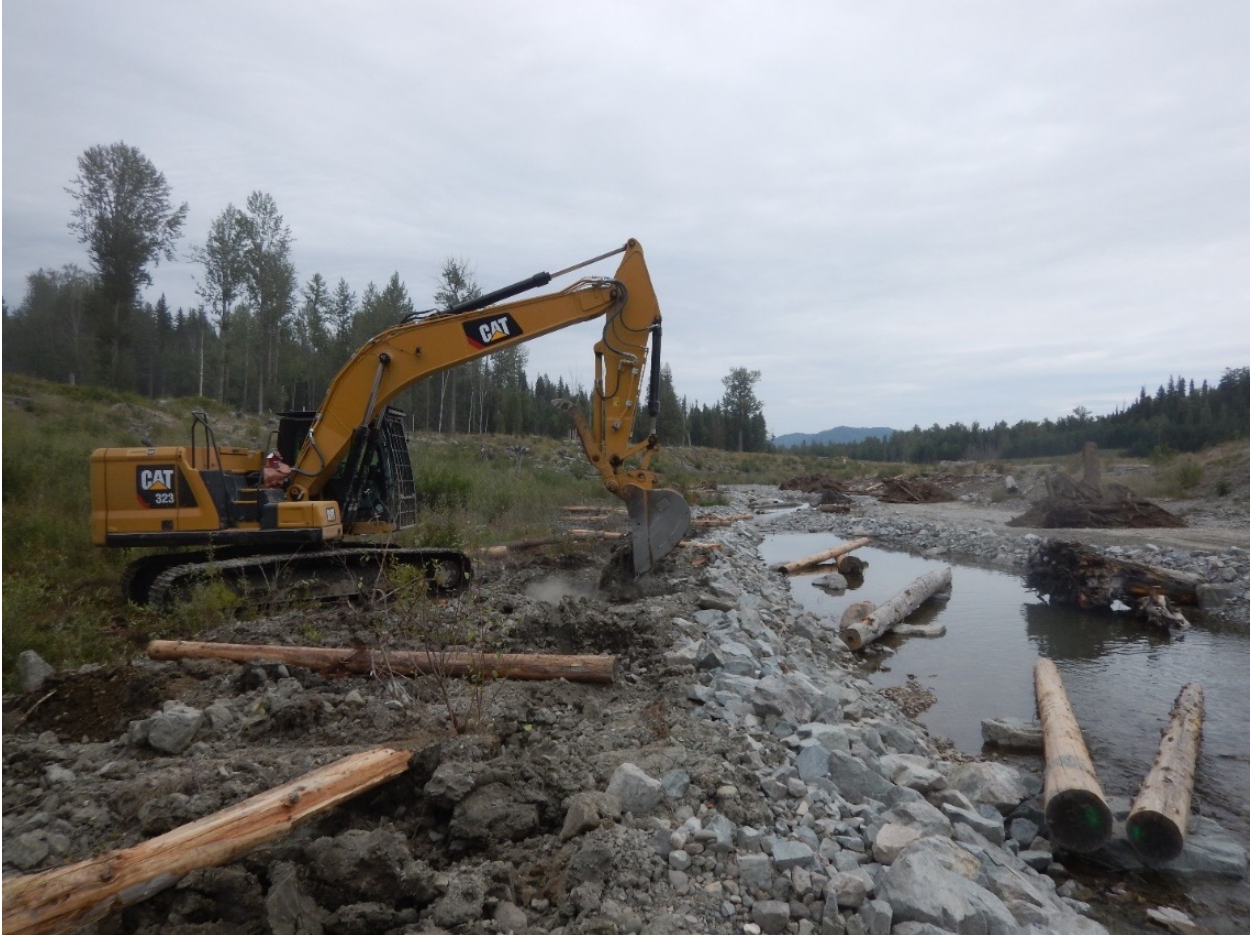
Figure 6 Surficial roughening treatment on the lower floodplains in Reach 5 of Hazeltine

Instream construction in Hazeltine and Edney Creeks was completed and finished in Q3 2021. The work marks an important milestone for the remediation project, all instream work is now completed. The work was completed in time for the annual salmon migration in the region and salmon did arrive in Hazeltine Creek in mid-September. A total of 206 sockeye salmon were observed on September 22 and the fish appeared to be using the habitat as intended. The presence of sockeye salmon and various other fish species is indicating that the remedial work is restoring ecological function. This is not only evident in the aquatic environments but also evident across the terrestrial landscape where plant communities are developing and abundant wildlife is observed. It is expected that as both the aquatic and the terrestrial ecosystems mature, further ecological function will emerge and the site will host an even broader array of organisms.

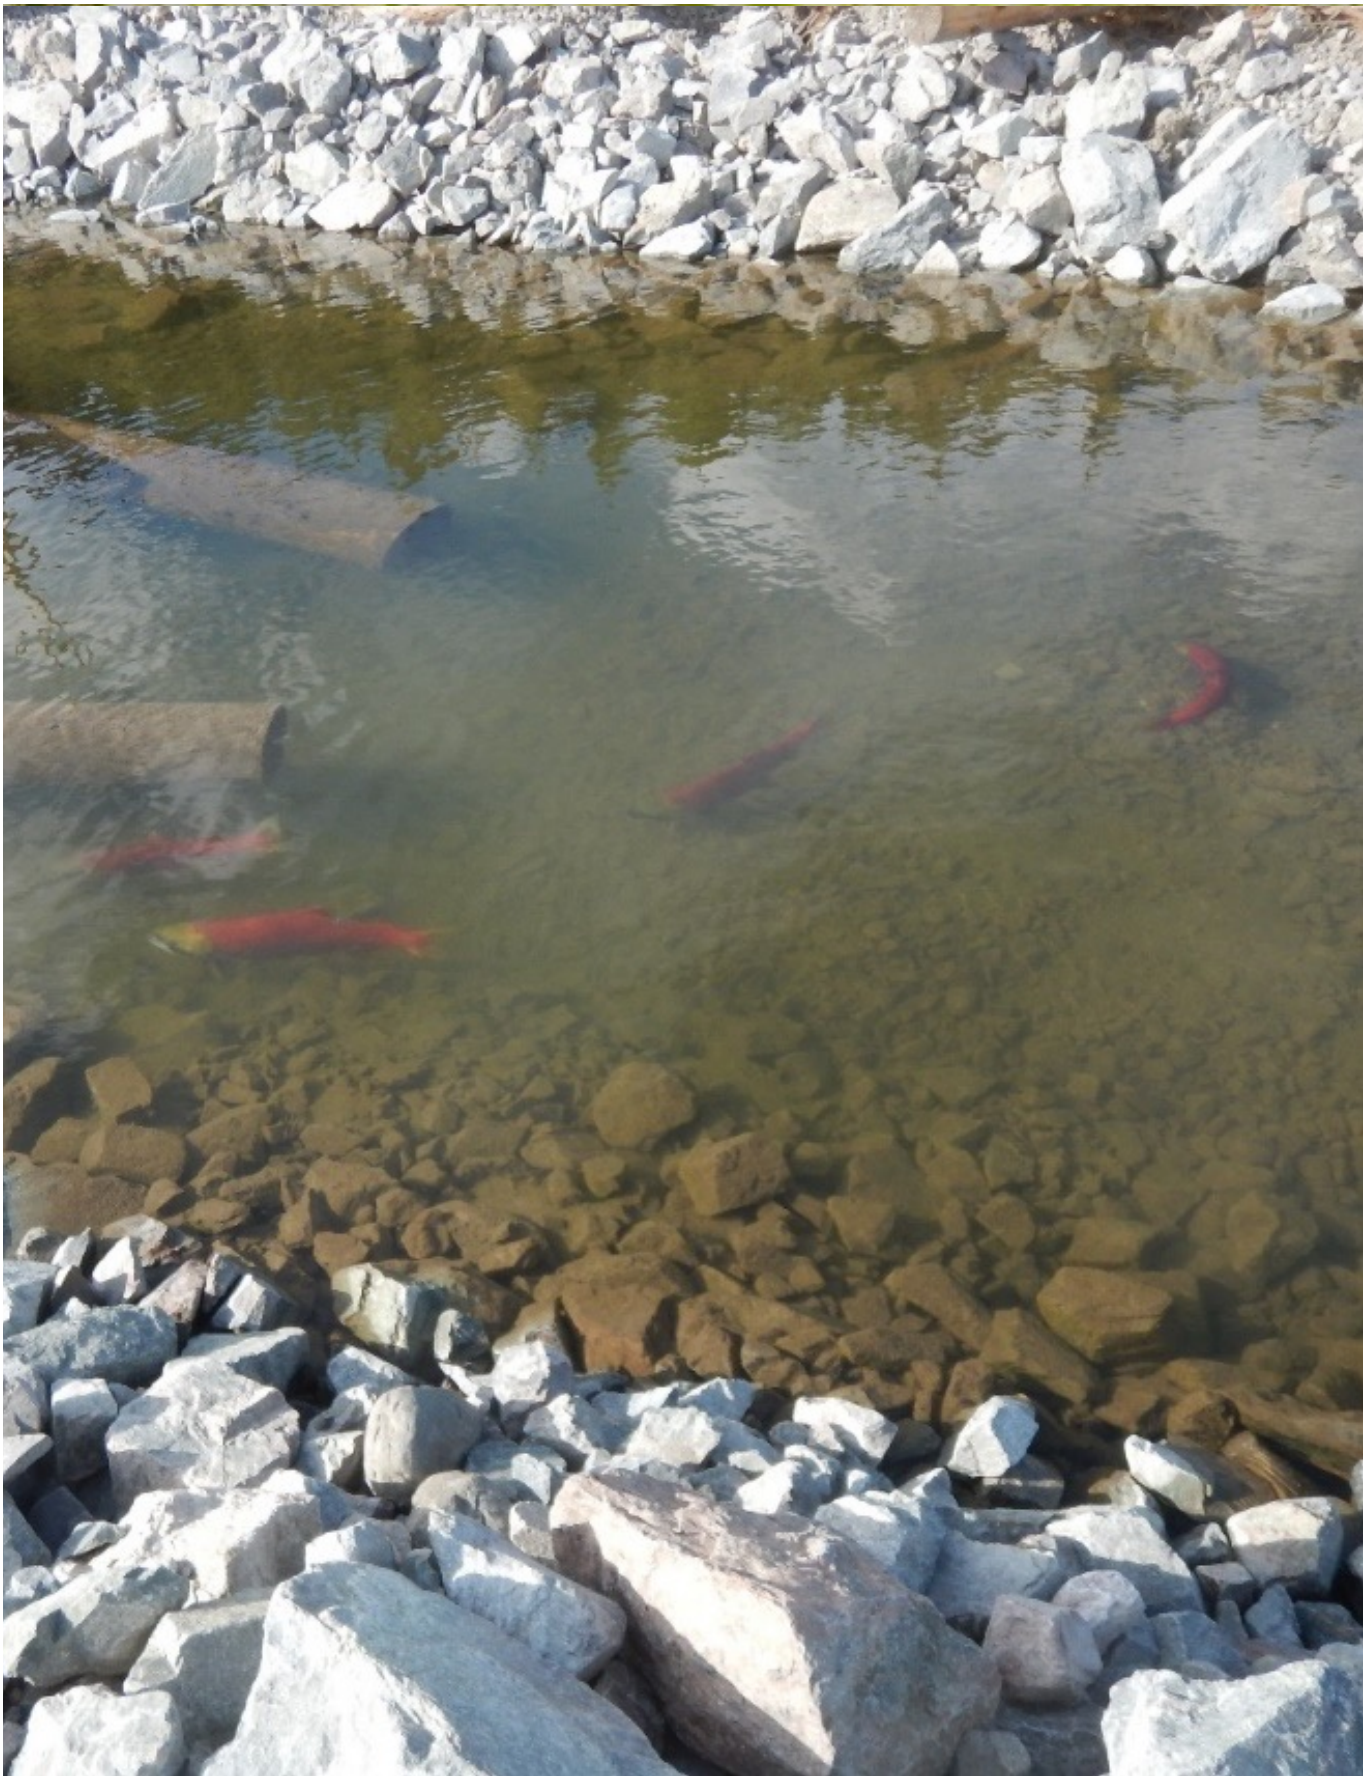
Figure 8 Sockeye salmon using newly constructed Hazeltine Creek channel in Reach 5

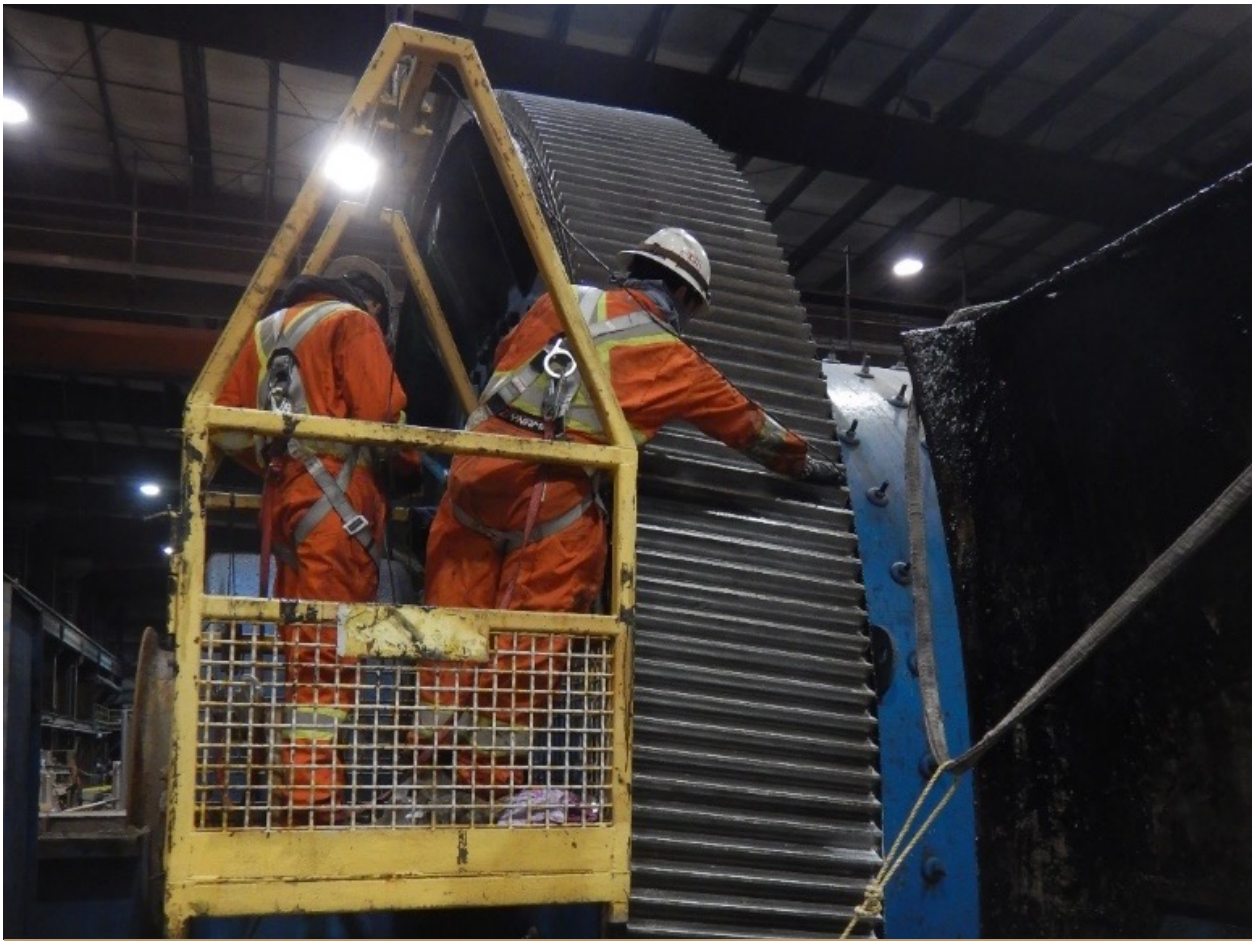
Figure 9 Staff assessing mill gear teeth

At peak production, MPMC employed approximately 390 employees. In Care & Maintenance, MPMC employs 15 full time staff, including three Environmental Technicians. Currently there are several contractors working at site on electrical maintenance and upgrades, mobile equipment servicing and upgrades and mill assessment, maintenance and refurbishing. We expect to begin some mining work in the Springer pit in Q4.

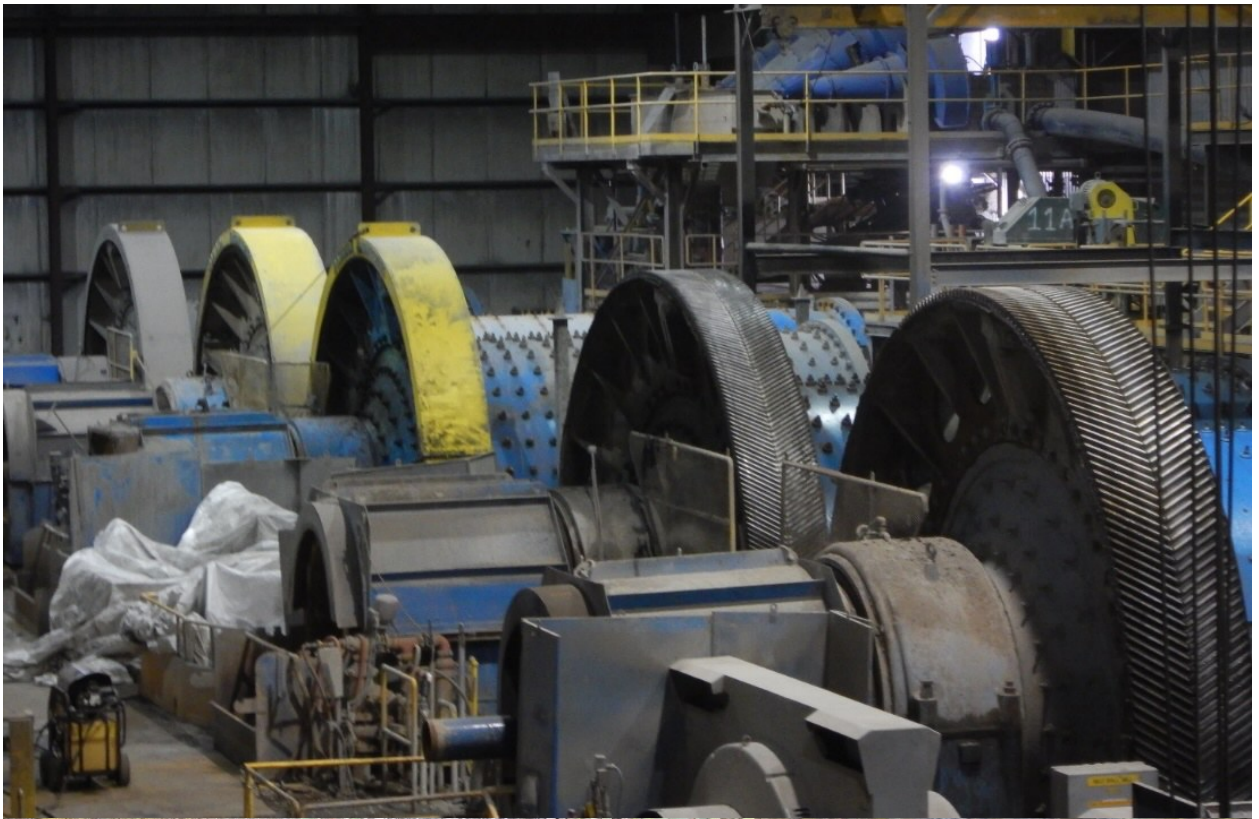
Figure 10 Mill maintenance is underway at Mount Polley Mine

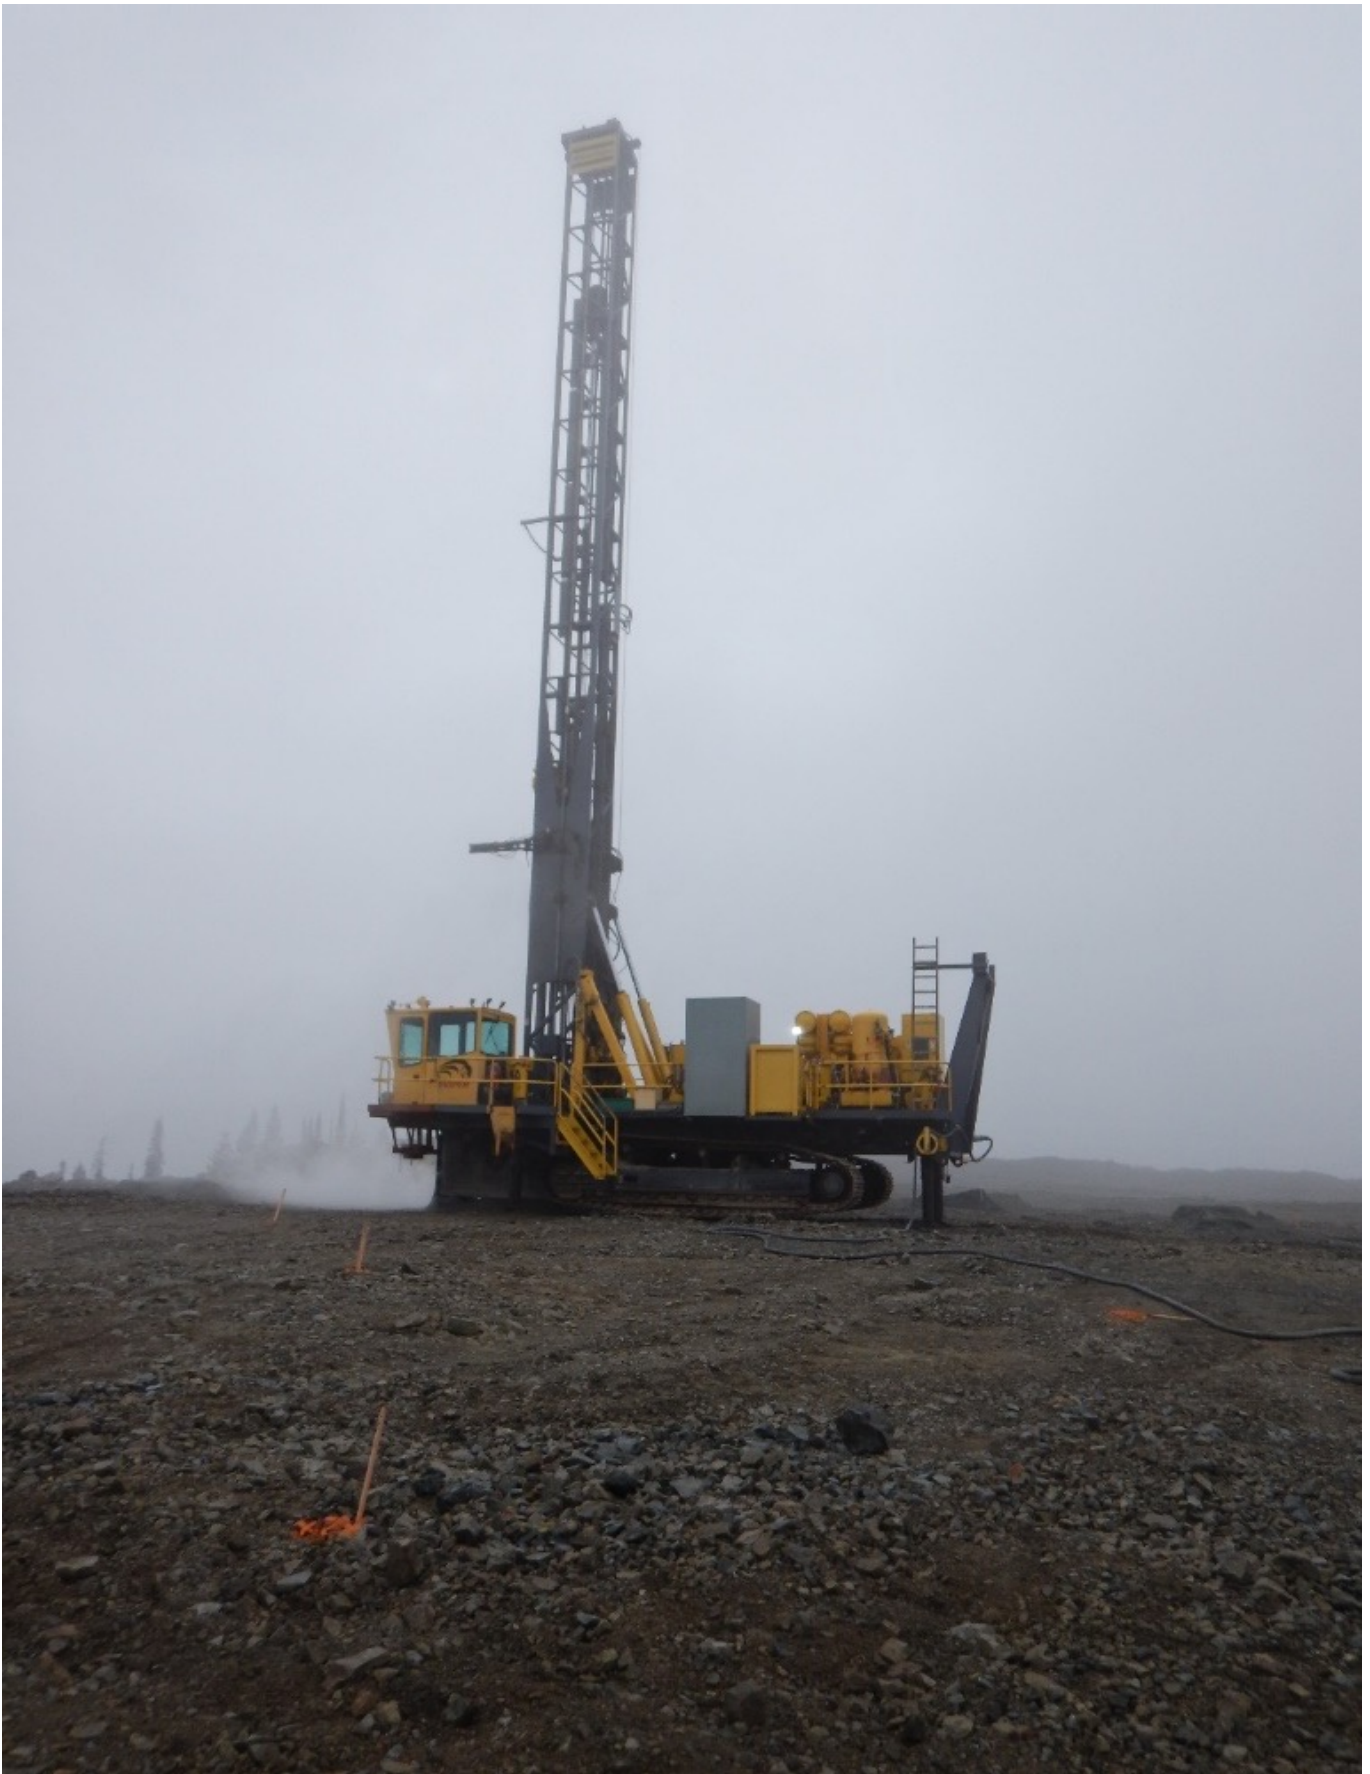
Figure 11 Drill at work, the first holes since 2019.
