COMMUNITY UPDATE Q4 2021

Mount Polley Mining Corporation
an Imperial Metals company
Box 12, Likely, BC V0L 1N0
T 250.790.2215

MOUNT POLLEY MINE: RESTART

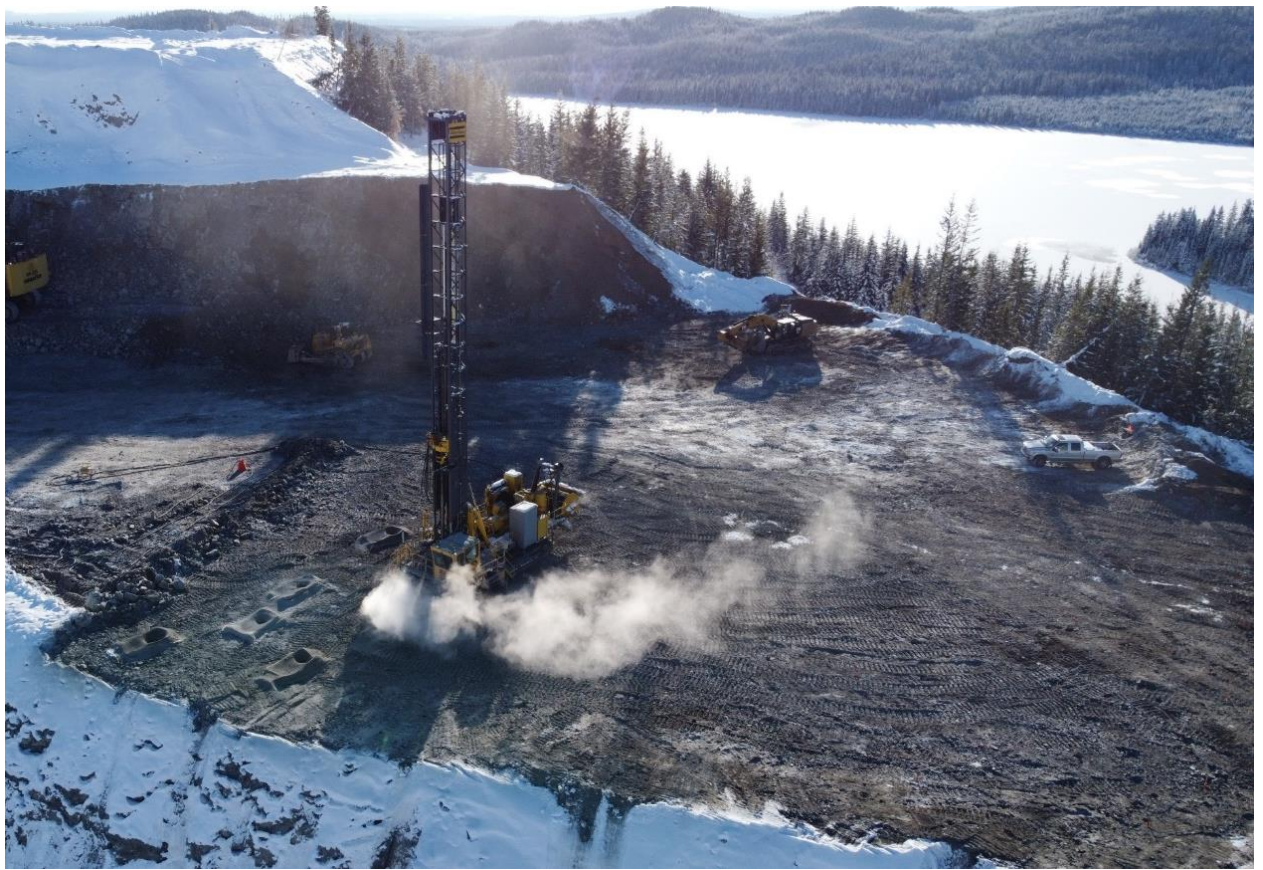
Figure 1 Limited pit operations have resumed in the Springer Pit.

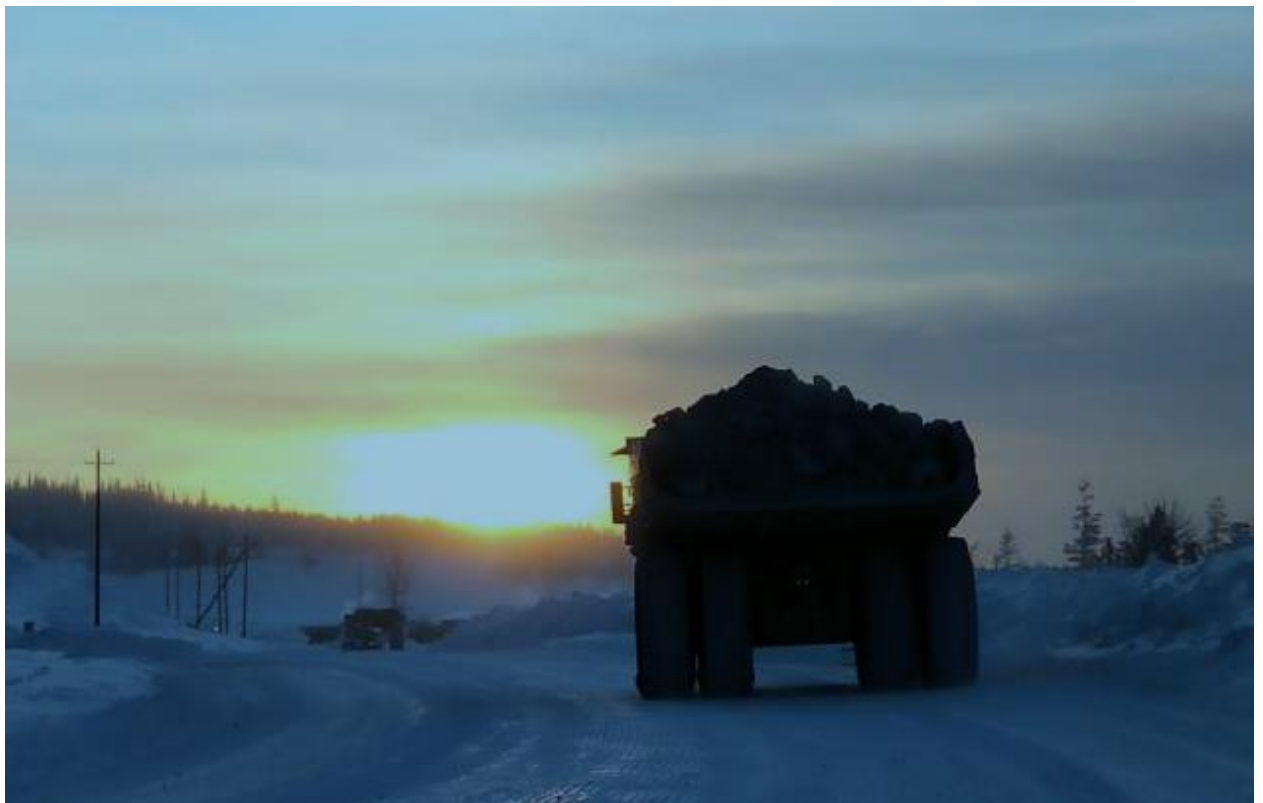
Figure 2 Truck hauling ore to the stockpile

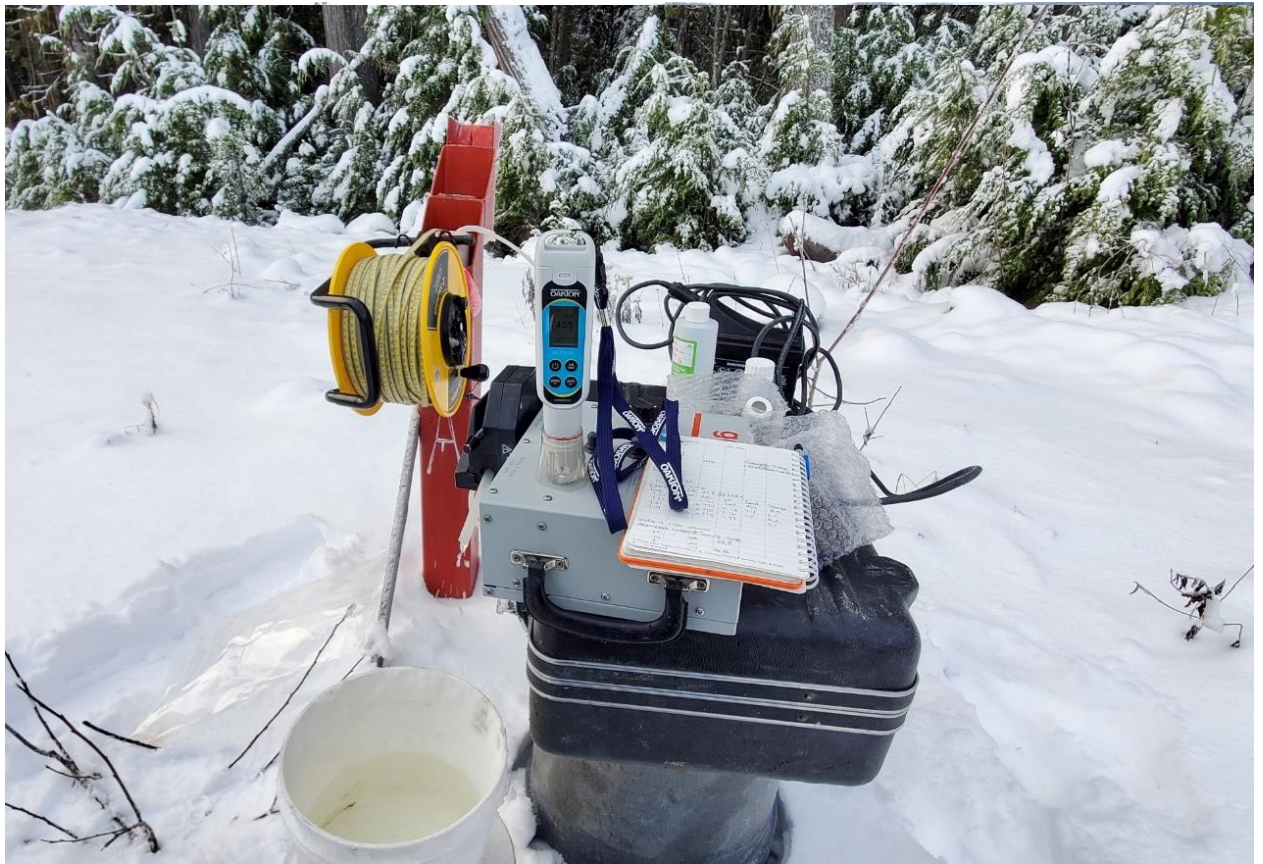
Figure 3 Ground water sampling equipment

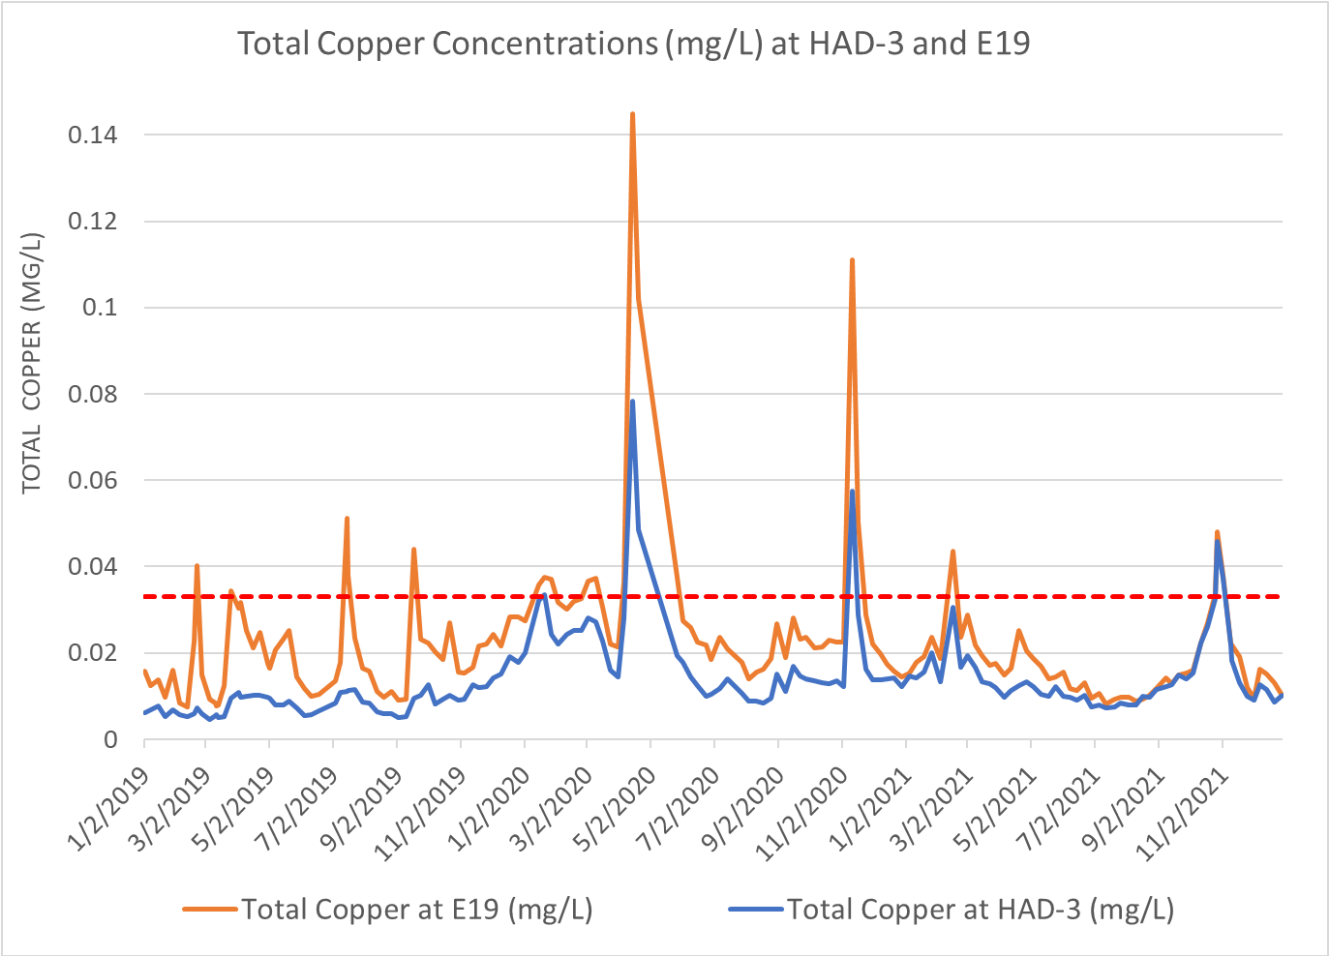
Figure 5 Total copper concentrations in parts per million (mg/L) in the influent and effluent of the Actiflo® water treatment plant

On October 27, 2021 a total copper exceedance was observed at the end of pipe sample location HAD-3, triggering a plant shut down and investigation. The root cause was found to be a combination of water chemistry changes in the source water and high throughput at the plant. The event triggered a response under our Annual Discharge Plan that included a plant shut down, placing the plant in recirculation mode (not discharging to the environment), requiring additional sampling and further investigation. Sampling was conducted in Quesnel Lake on the same day and the results indicated that the waters met the BC Water Quality Guidelines for drinking water and aquatic life.

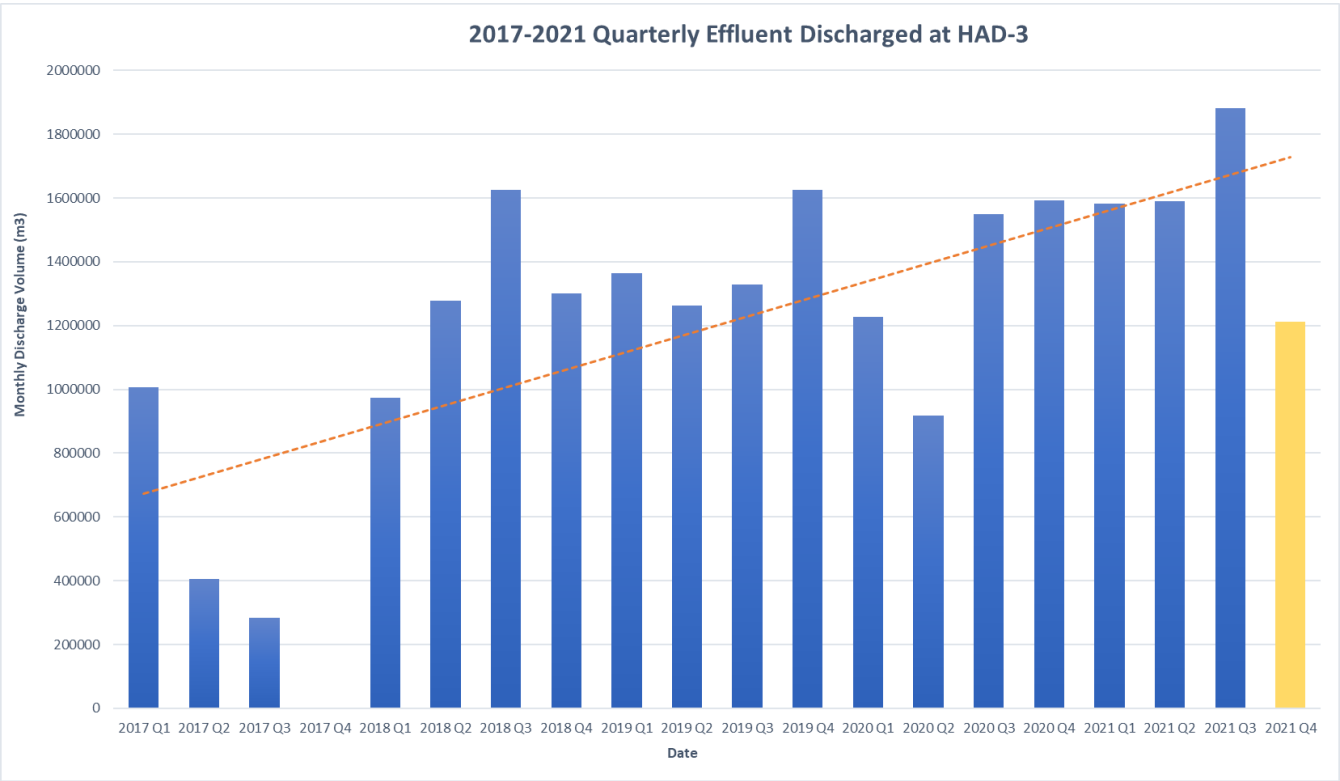
Figure 6 Effluent discharge volumes in cubic meters per quarter from the Actiflo® water treatment plant

In 2021 Quarter 4, the total treated water discharged to Quesnel Lake was $\sim 1,680,605 \text{ m}^3$ with an average daily discharge of $\sim 18,267 \text{ m}^3/\text{day}$.

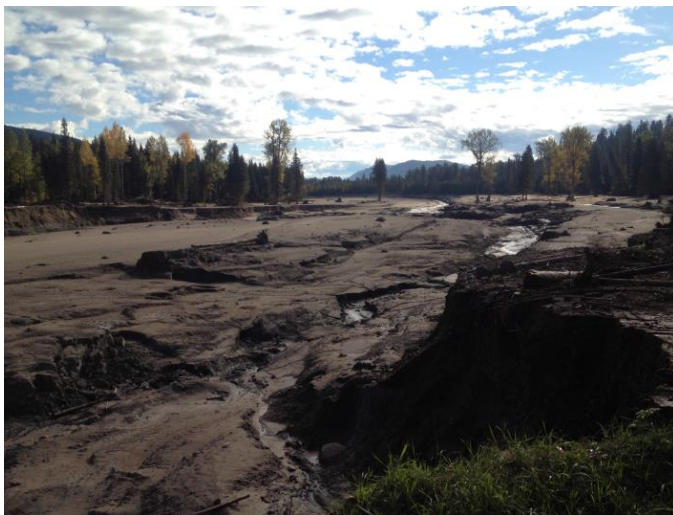
Downstream of Ditch Road bridge - before

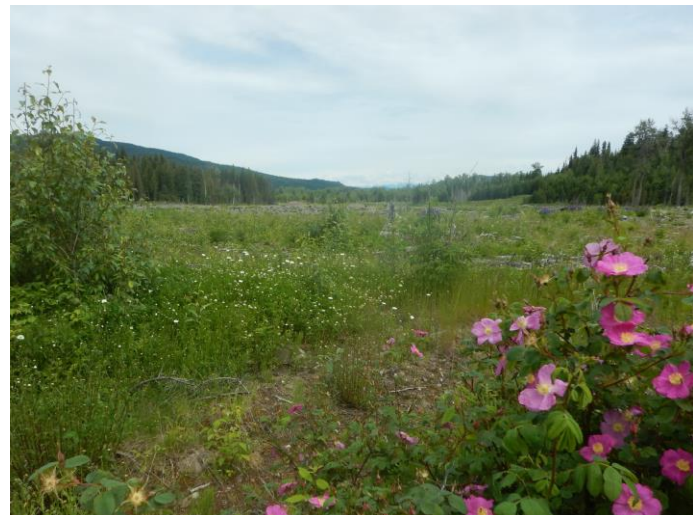
Downstream of Ditch Road bridge - after

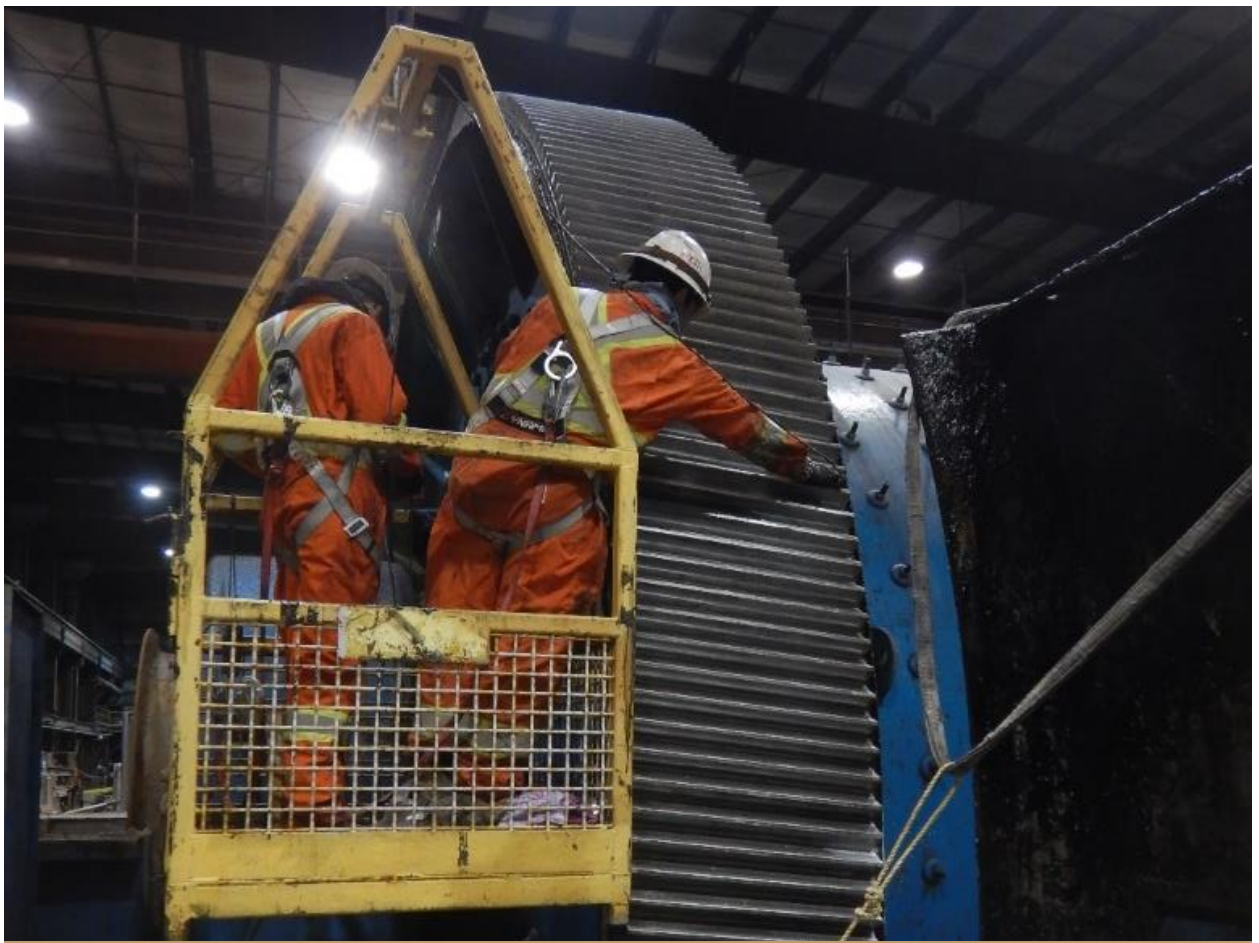
Figure 7 Staff assessing mill gear teeth

The grinding mills have been disassembled and inspected. Repair work will be completed in preparation for the mine restart in the second quarter of 2022.

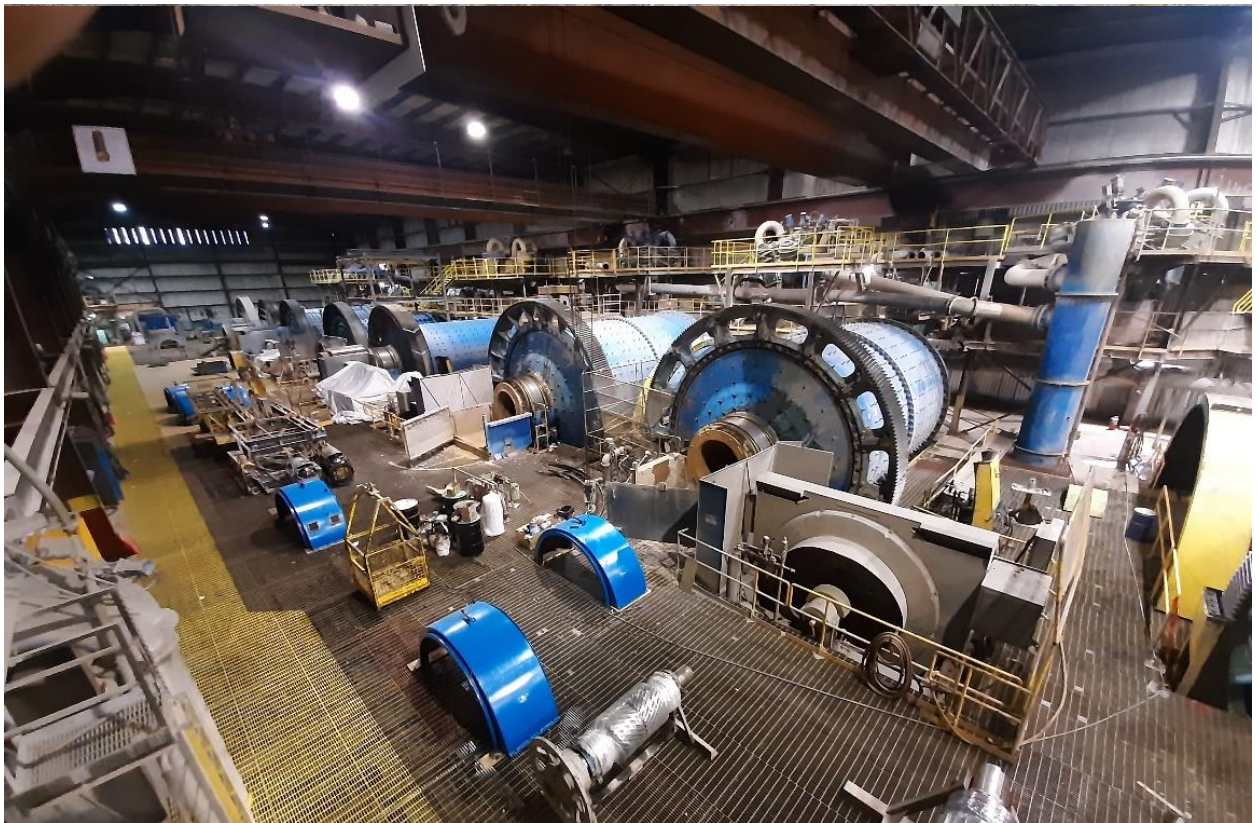
Figure 8 Disassembled grinding mills
