Mount Polley Mining Corporation

June 2016 Update

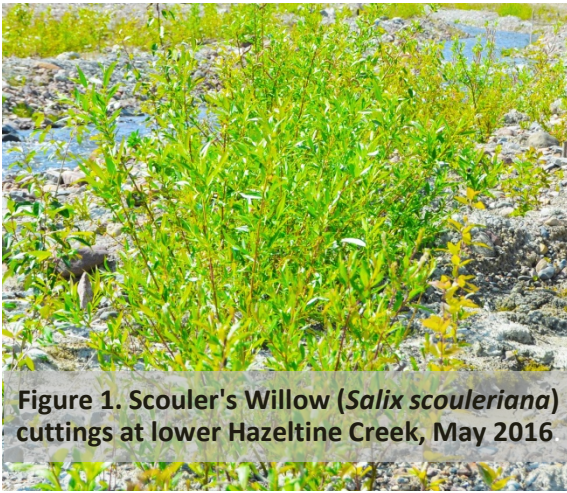
Figure 1. Scouler's Willow (*Salix scouleriana*) cuttings at lower Hazeltine Creek, May 2016

In March, a crew from the Soda Creek First Nations collected willow cuttings around the mine site. They are currently planting these cuttings as part of the Hazeltine Creek revegetation. The goal of the 2016 revegetation program is to complete 70% of the initial phase planting for mid to lower Hazeltine Creek. The recontouring and surface texturing of the creek banks as well as the spreading of woody debris has started in this area. Scouler's Willow wattles planted last spring have leafed (see Figure 1) and the Prickly Rose bushes (see Figure 2) are flowering at Lower Hazeltine.

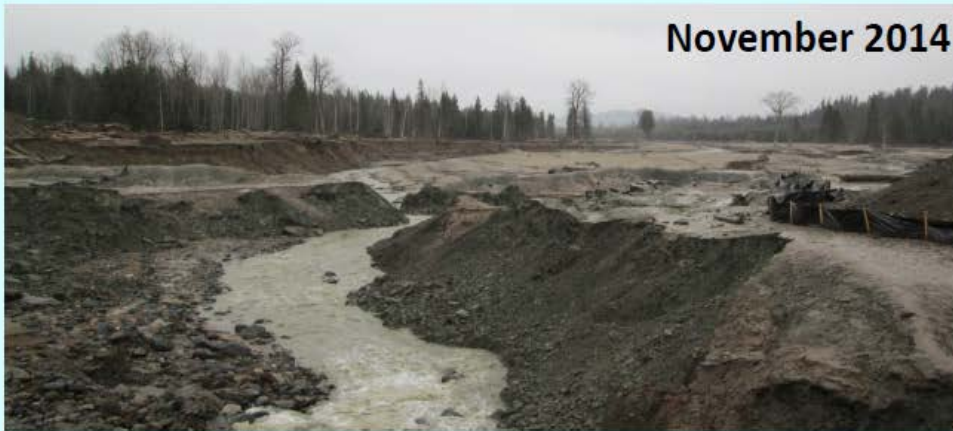
November 2014

Figure 3. Lower Hazeltine Comparison (downstream view from the Ditch Road Bridge). Top picture was taken November 2014, middle picture was taken June 2015, and bottom picture was taken May 2016.

In the almost two years since the breach occurred, rehabilitation of the affected areas has progressed significantly. As Figure 3 demonstrates, lower Hazeltine Creek has evolved from its initial disturbance in 2014. In 2015, the creek was recountoured to prevent erosion; soil and coarse woody debris were spread around the upper banks for nutrient addition and habitat, and rocks were placed along the banks for stability. Native trees and shrubs were planted along the banks for erosion control during the spring and fall. The green in the picture from May 2016 shows the plants growing along the channel and the start of the new landscape of lower Hazeltine Creek.
