Mount Polley Mining Corporation

COMMUNITY UPDATE

Quarter 1 2020

MPMC Water Treatment Plant (WTP) Update

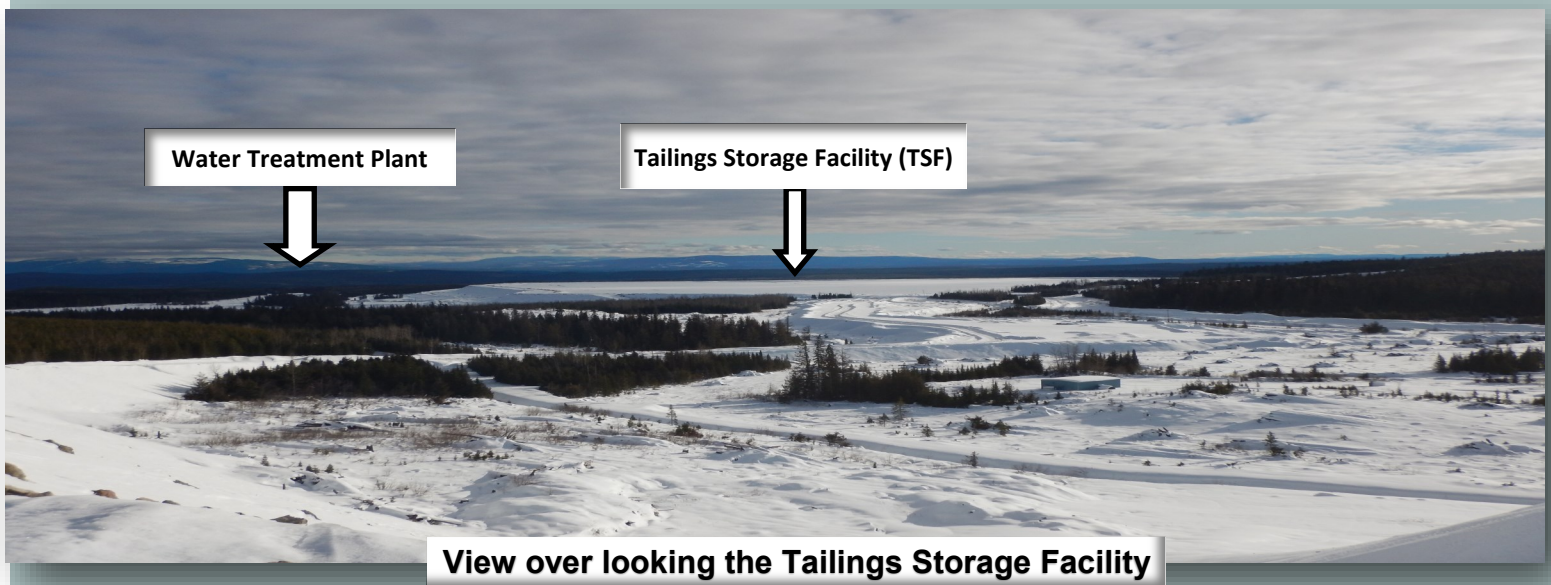
The WTP measures turbidity in Nephelometric Units (NTU) at the discharge in semi-real time, the instrument is calibrated and corrected to report in Total Suspended Solids (TSS) to reflect permit requirements for continuous monitoring. At the beginning of January, after numerous power outages in December & January, the TSS sensor failed which required the sensor to be replaced.

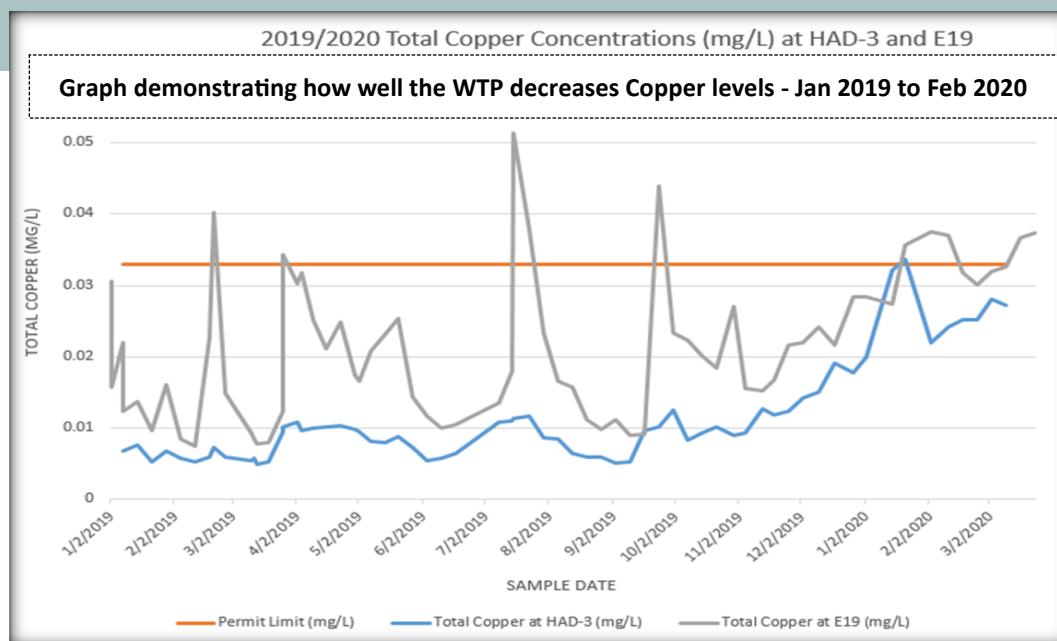
A copper exceedance occurred at the WTP effluent (HAD-3) on January 21, 2020 which was resolved following investigation (re-sampling and data review). Total copper at HAD-3 was within 80% of the permit limit on March 10, 2020 and the cause is still under investigation. MPMC's responses were in accordance with the Trigger and Response Plan included in the Annual Discharge Plan (ADP). Total Copper spikes are reduced by the WTP as shown in the graphs below.

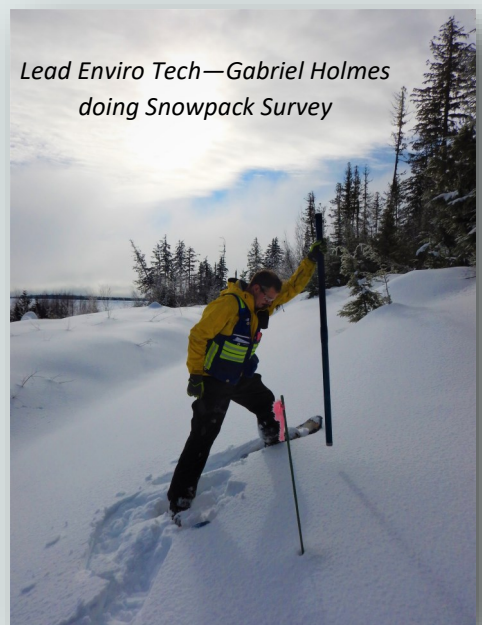
Lead Enviro Tech—Gabriel Holmes doing Snowpack Survey
