DATE February 18, 2016**REFERENCE No.** 1520790-014-TM-Rev0-3000**TO** Ryan Brown
Mount Polley Mining Corporation**CC** Jetzen Loo and Richard Goodwin**FROM** Donald Tolfree and Darren Kennard**EMAIL** Donald_Tolfree@golder.com;
Darren_Kennard@golder.com**MOUNT POLLEY UNDERGROUND STOPE STABILITY REVIEW****1.0 INTRODUCTION**

This technical memorandum presents a summary of a site visit and underground inspection performed by Donald Tolfree of Golder Associates Limited (Golder) to the Mount Polley Mine – Boundary Zone underground (Mount Polley) from July 27 through July 30, 2015. The results of a stability back-analysis of the current open stope (Block A), and recommendations for future stope mining adjacent to Block A are also presented.

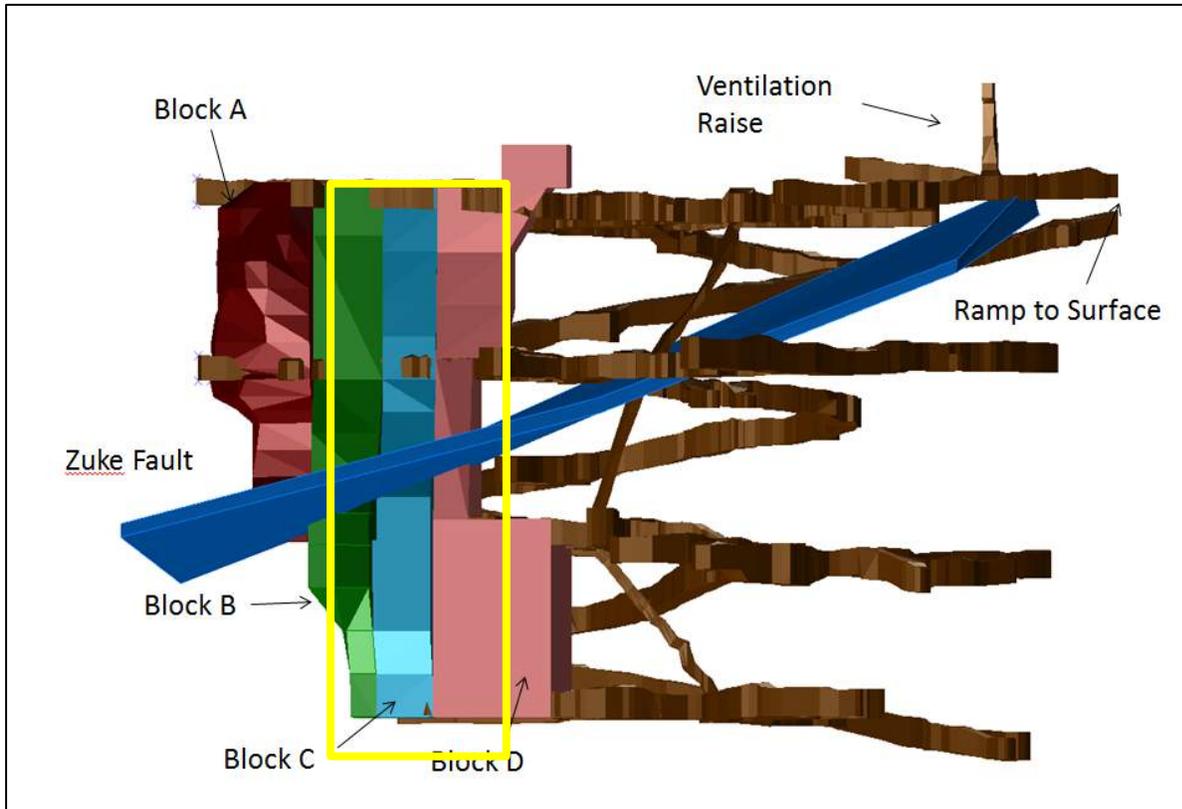
Figure 1: Longitudinal Section of the Boundary Zone Showing the Stopping Blocks and Development

The stoping area in the Boundary Zone is approximately 63 m long, 20 m wide and 100 m high and is approximately 200 m below ground surface (to the top of the stopes). The stoping area was initially separated into four blocks (A, B, C and D) as shown in Figure 1. The original mine plan assumed a standard bottom-up panel retreat stoping sequence with stopes that were approximately 30 m high, and cemented rockfill as backfill after each lift, to maintain regional stability. A mine design update combines Blocks B and C and a portion of Block D into one stope Big Block B, outlined in yellow in Figure 1.

A predictive Potvin analysis was carried out for the scenario of Big Block B (see Figure 1). The modified stability number inputs for the Potvin method for excavation of Big Block B are summarized in Table 4 and plotted on the empirical stope stability guidance chart for the back, sidewalls and end walls in Figure 10.

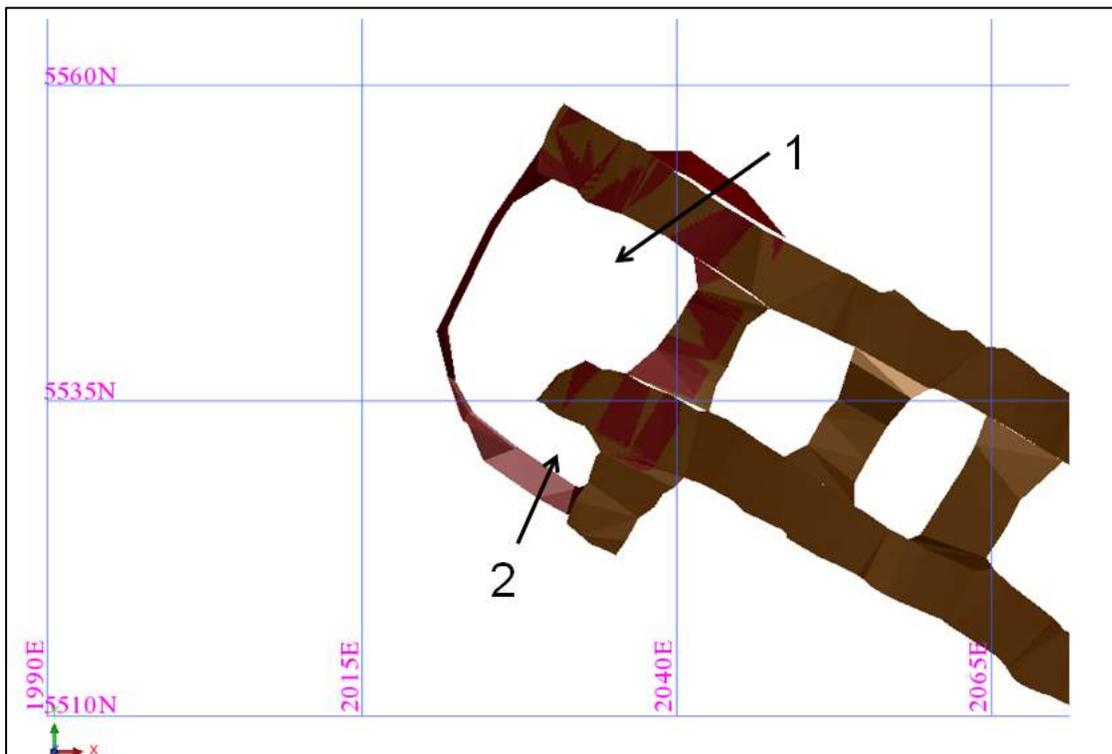
Figure 2: Plan View of the Location of the Pictures Taken Underground

At the time of the visit the back of Block A seemed stable. However, there is evidence that could suggest the installed ground support is taking load. Figure 2 shows the approximate location of photographs that show various cable bolts that may be taking load and are shown in Photographs 1 and 2. Untwisting of a cable bolt is indicative of the bolt taking load and observations suggest this may be the case for these cables. Such loading can be indicative of loss of confinement (tension) in the stope walls and localised block movement.

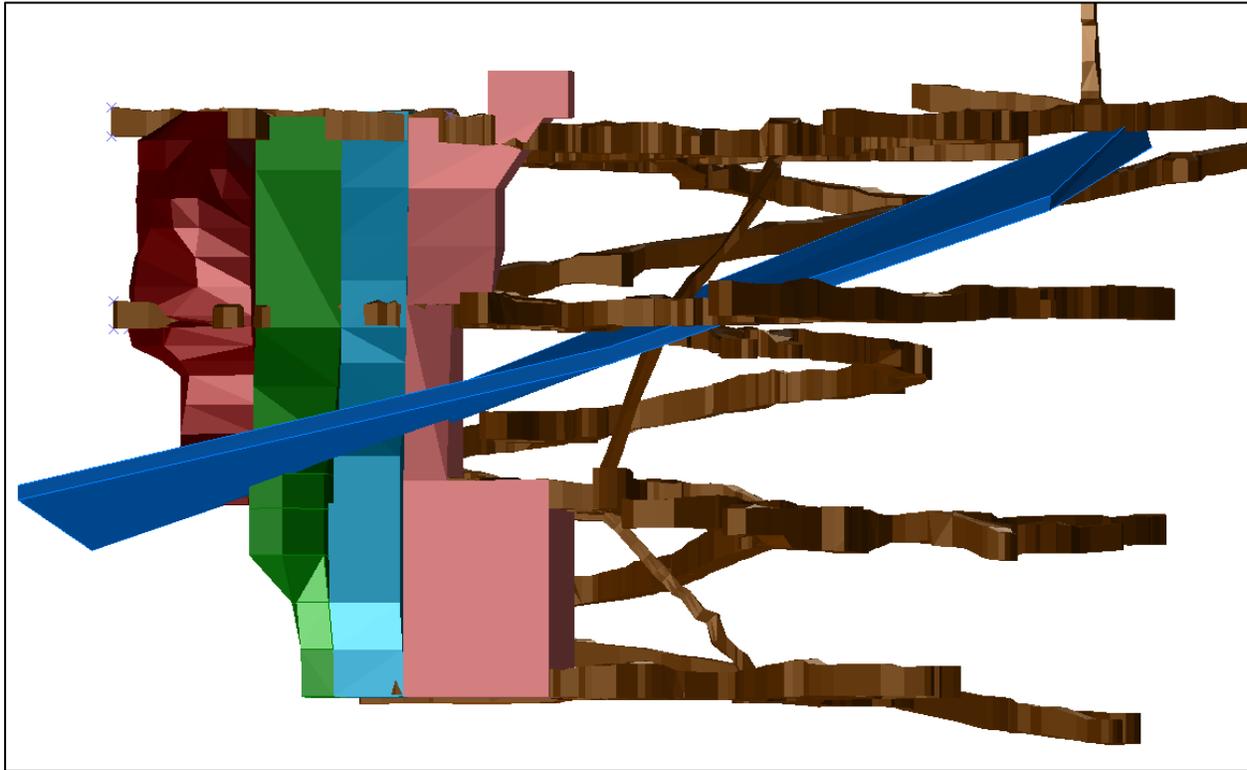
Figure 3: Longitudinal Section Showing the Location of the Zuke Fault Relative to the Stopping Blocks

The Zuke fault is moderate to shallow dipping, and impacts the lower portion of Block A, and midpoint of Blocks B through D (Figure 5). The fault was observed on the 812 Level (Figure 6) where it is characterized as gouge filled and at a minimum 30 cm thick and at a maximum greater than 1 m thick (see Photograph 3).

Finally, the Zuke fault will have an increasing influence on stope stability. Projections of the fault show that it may intercept the remaining stoping blocks between the 782 and 812 Levels, possibly complicating efforts to support stope walls near it. If failure does occur around this geological feature it is possible that the failure will precipitate up around the upper workings.

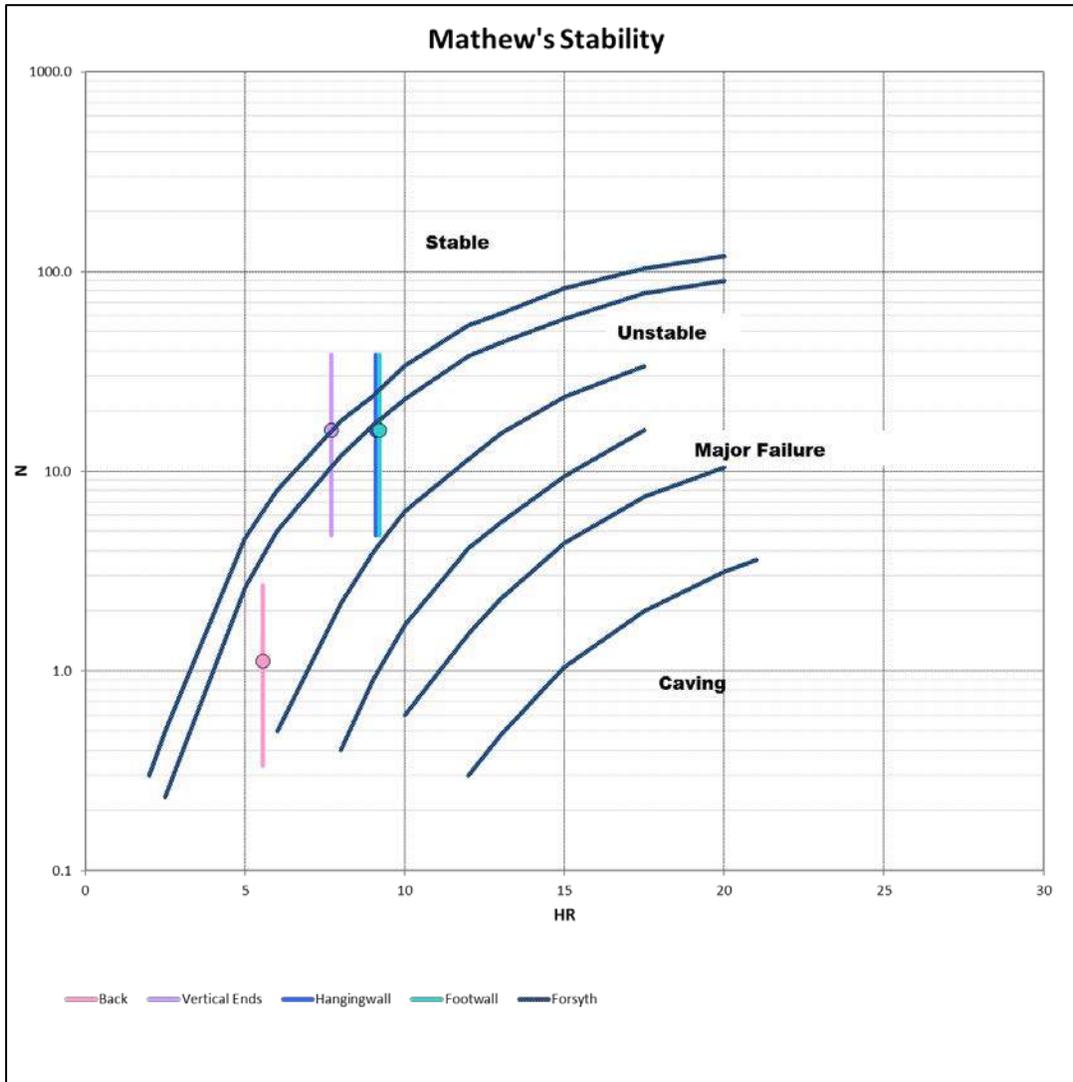
Figure 5: Plot of Block A on the Mathews Stability Graph (Assumes Unsupported Slope Walls)

Figure 5 shows that the back of an unsupported Block A plots in the unstable zone, and the vertical walls plot in the transition zone between stable and unstable zones. The stress factor A for the Back and the Sidewalls suggests that these stope surfaces will be subject to relaxation when the span / width ratio exceeds about 2.5 for the Backs, and width / height ratio that exceeds about 2.5 for the Sidewalls.

Definitions of stable, unstable, and major failure are shown on the design charts, (Stewart and Forsyth, 1995). Stope surfaces plotting in the stable zone would generally be considered stable in an unsupported condition over the long term. Surface plotting in the unstable zone would typically be supported with regular cable bolts to ensure long term stability. Surfaces plotting in the major failure zone would exhibit larger scale failures that may eventually reach a stable configuration. Surfaces plotting in the caving zone could exhibit an uncontrollable caving situation that could propagate to surface under certain conditions.

Given the state of overall stability in Block A and the observed local ground support loading (untwisting cables), the predicted Unstable condition of the stope backs appears suitable. This provides confidence that the input parameters chosen and the empirical guidance on anticipated open stope stability are reasonable and can be used to comment on the feasibility of excavating stopes larger than Block A. Such relaxation increases the probability of localised wedge movement and unravelling around cable bolts. This failure mode is offset in Block A by the step in the stope wall on the 812 level and the presence of the cable bolts.

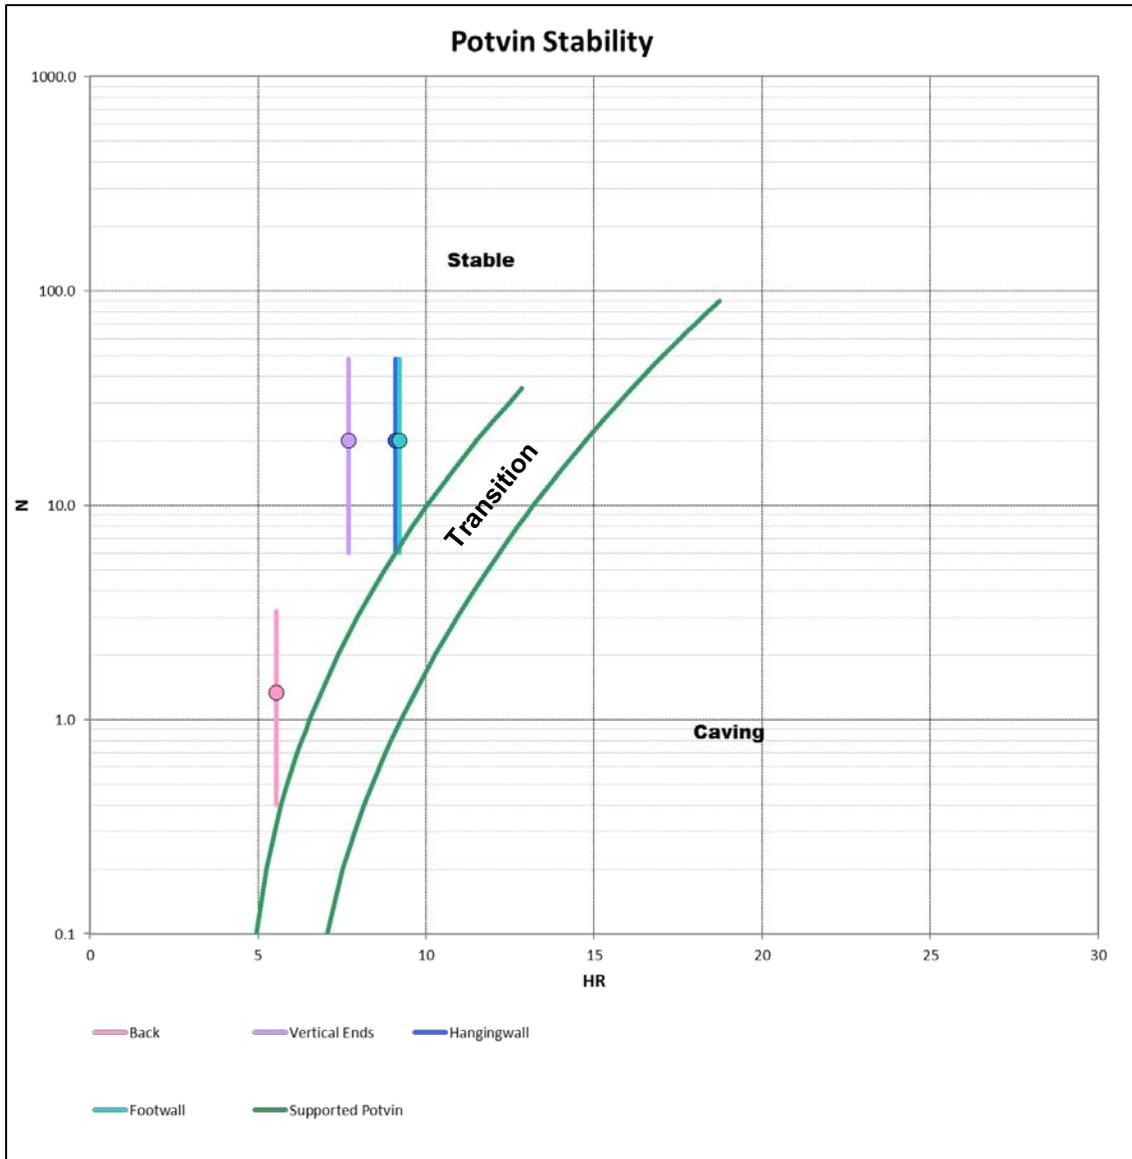
Figure 6: Plot of Block A on the Potvin Stability Graph (Assumes Supported Stope Walls)

The various regions of the Potvin chart provide empirical guidance on whether stopes can be expected to be stable or caving when supported with cable bolts.

The analysis suggests that for Block A, all stope walls can be expected to be stable, but localised regions of reduced rock mass quality plot in the transition zone between stable and caving and can be expected to show some signs of distress. This is consistent with the observed performance of the walls of Block A and the cable bolt support installed, adding confidence to the application of the input values and the overall approach to use in this assessment.

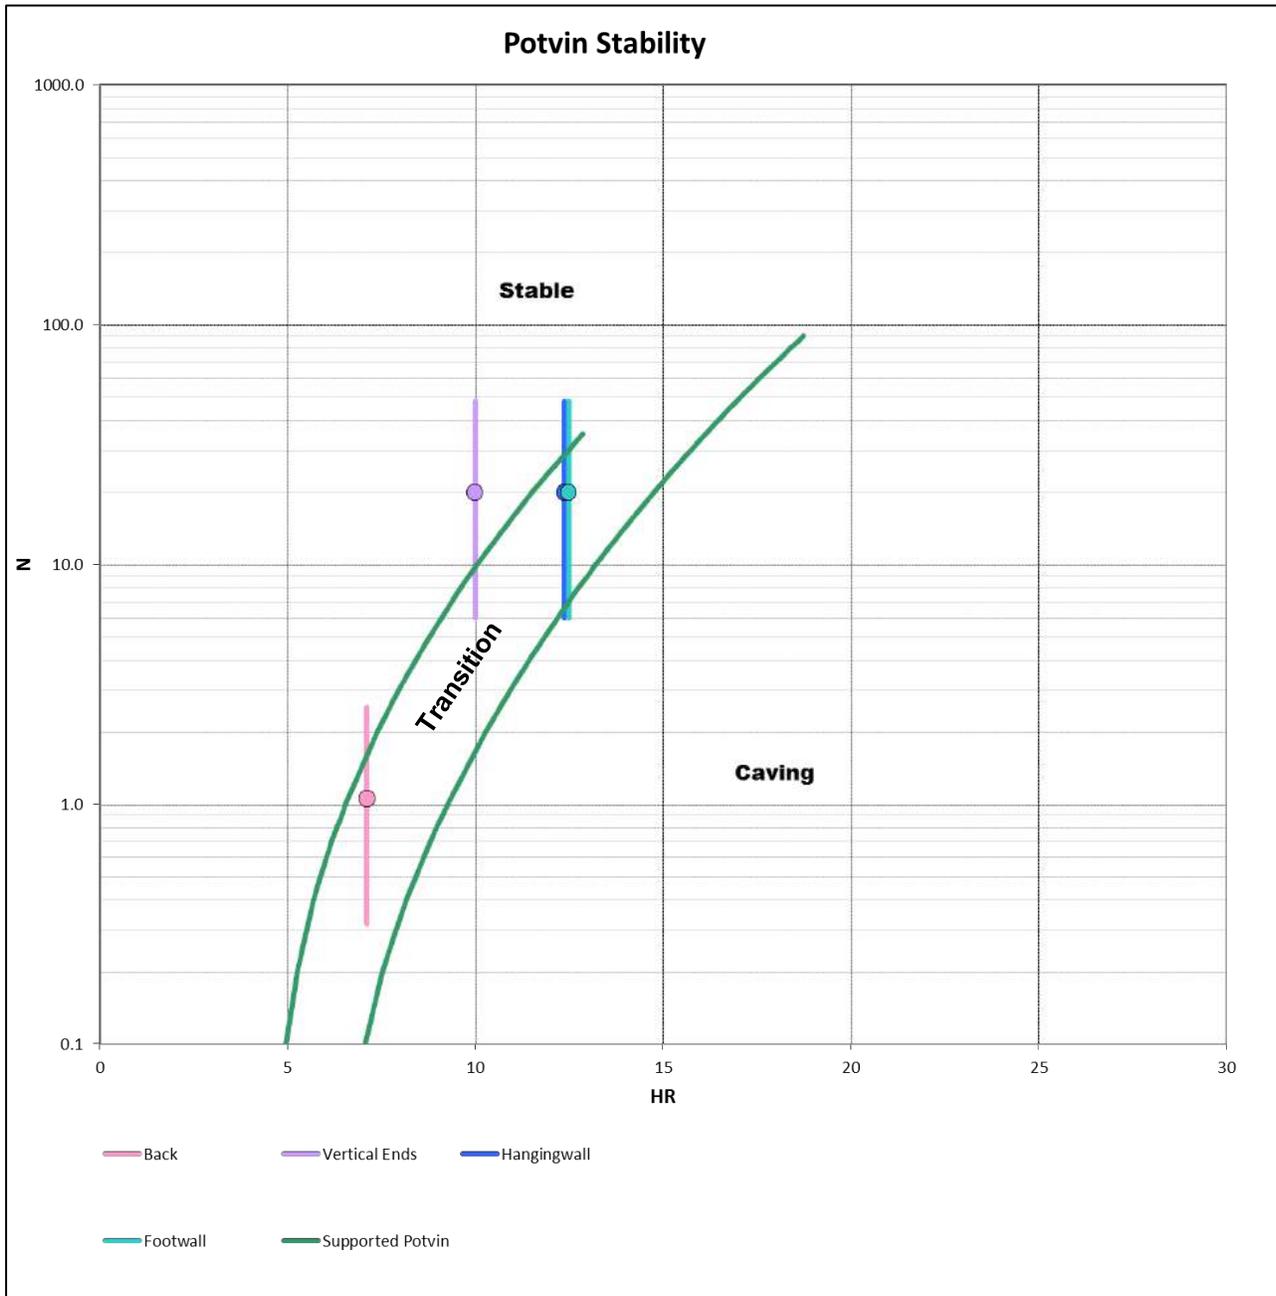
Figure 7: Plot of Block B and C Mined Together on the Potvin Stability Graph (Assumes Supported Slope Walls)

The analysis predicts that both the back and the sidewalls (hangingwall and footwall) plot in the transition zone between stable and caving for cable bolted stopes. Mining Big Block B would likely result in significantly worse ground conditions than observed in Block A or if Block B and C were mined separately. Creating an opening that plots in the transition zone could lead to significant dilution, production interruptions, loss of ore and generally localized failure.

Therefore, it is recommended that the future stopes be supported as previously recommended and have maximum dimensions similar to Block A. Back analysis suggests that a bigger stope could be opened, in isolation. However, future voids will be next to existing stopes and the side walls of these voids will possibly behave worse than the back analysis suggest increasing the risk of dilution and production difficulties.

Tight filling is recommended for back stability. If tight filling is not employed then the back of the stope will get progressively bigger as additional stopes are extracted which increases the likelihood of a large back failure. The impacts of such a failure could be limited to the immediate back of the stope in the form of large loose which could potentially fall on equipment working in the stope, or the failure could also destabilize the surrounding infrastructure including the 842 level, upper ramp and ventilation access, and possibly propagate to surface.

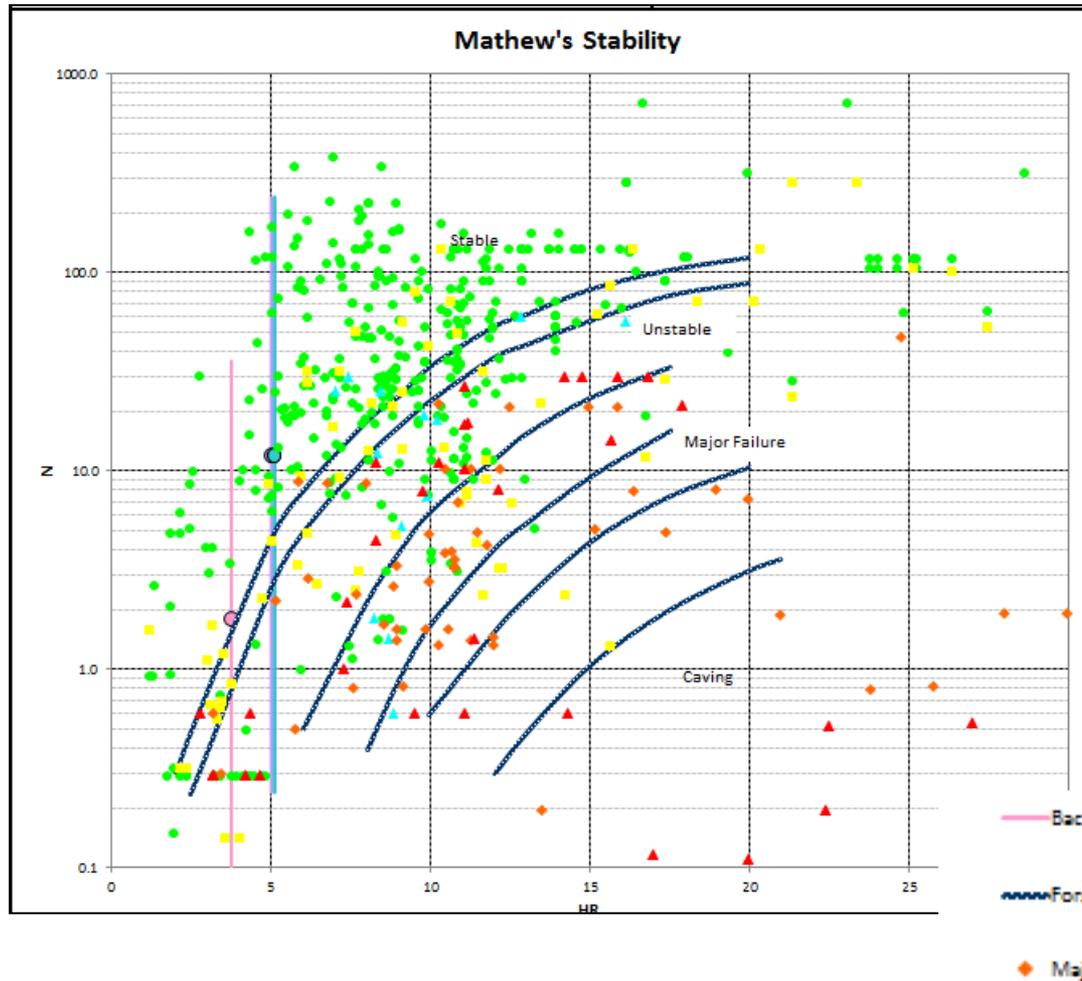
Little Block A

VERT HT(m)	30	m
DIP HT(m)	30.0	m
SPAN(S)	15	m
LENGTH*(L)	15	m
DIP (D)	30	deg.

- Mathews method is an empirically based analysis
 - Lines plotted don't include support
 - Cables are providing support
- A Factor governed by insitu stresses, stope sizes, and rock strength
 - Estimates for these have been used and may change the results notably the tension in the vertical walls

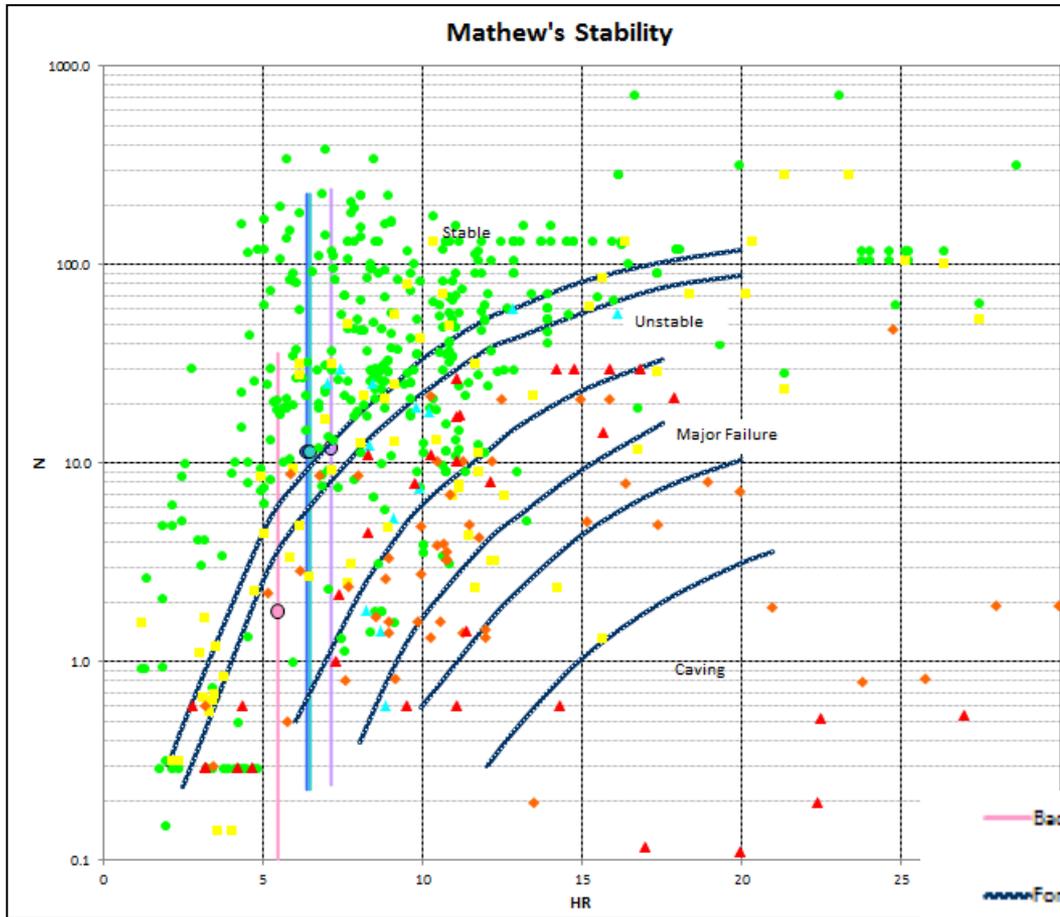
Big Block A

VERT HT(m)	35	m
DIP HT(m)	35.0	m
SPAN(S)	24	m
LENGTH*(L)	20	m
DIP(D)	30	deg.
* - alongstrike

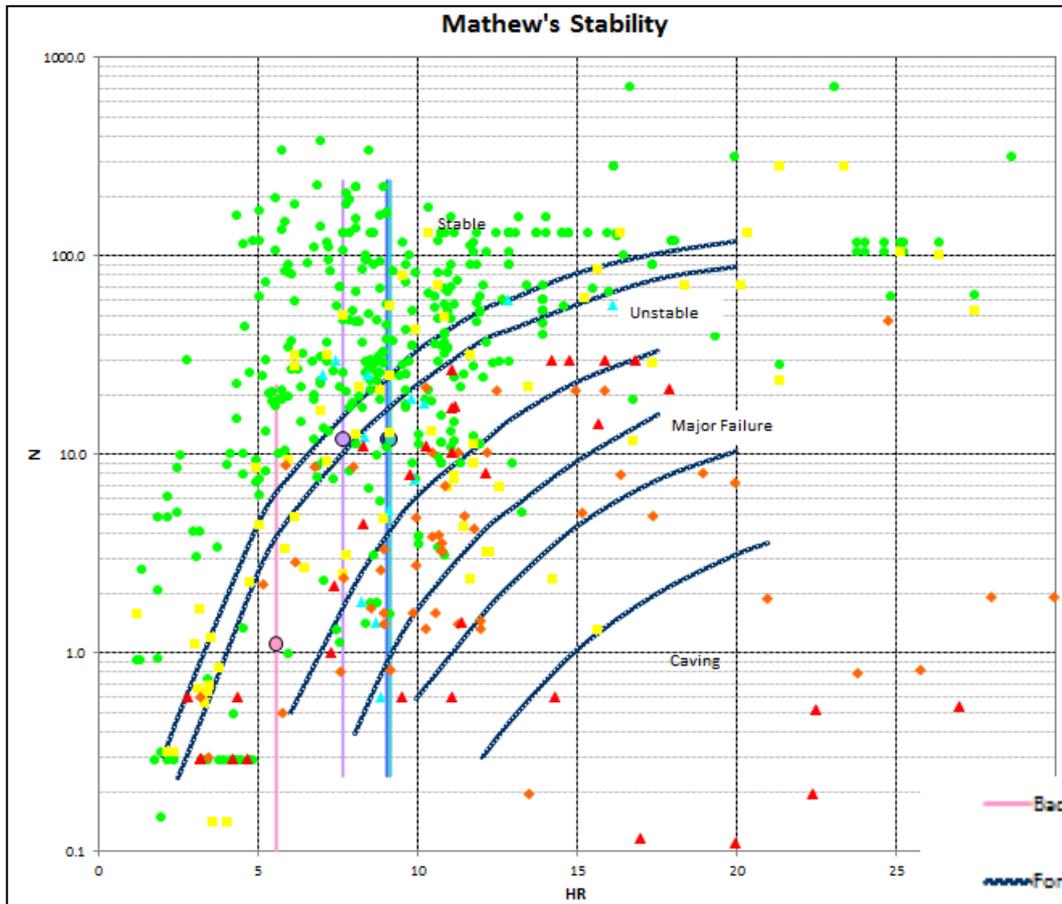
All Block A

VERT HT(m)	65	m
DIP HT(m)	65.0	m
SPAN(S)	20	m
LENGTH*(L)	25	m
DIP(D)	30	deg.

Vertical walls may be in tension
