Mount Polley Mining Corporation

December 31, 2014

WEEKLY POST-TSF BREACH REPORT – WEEK OF DECEMBER 23 – 30, 2014

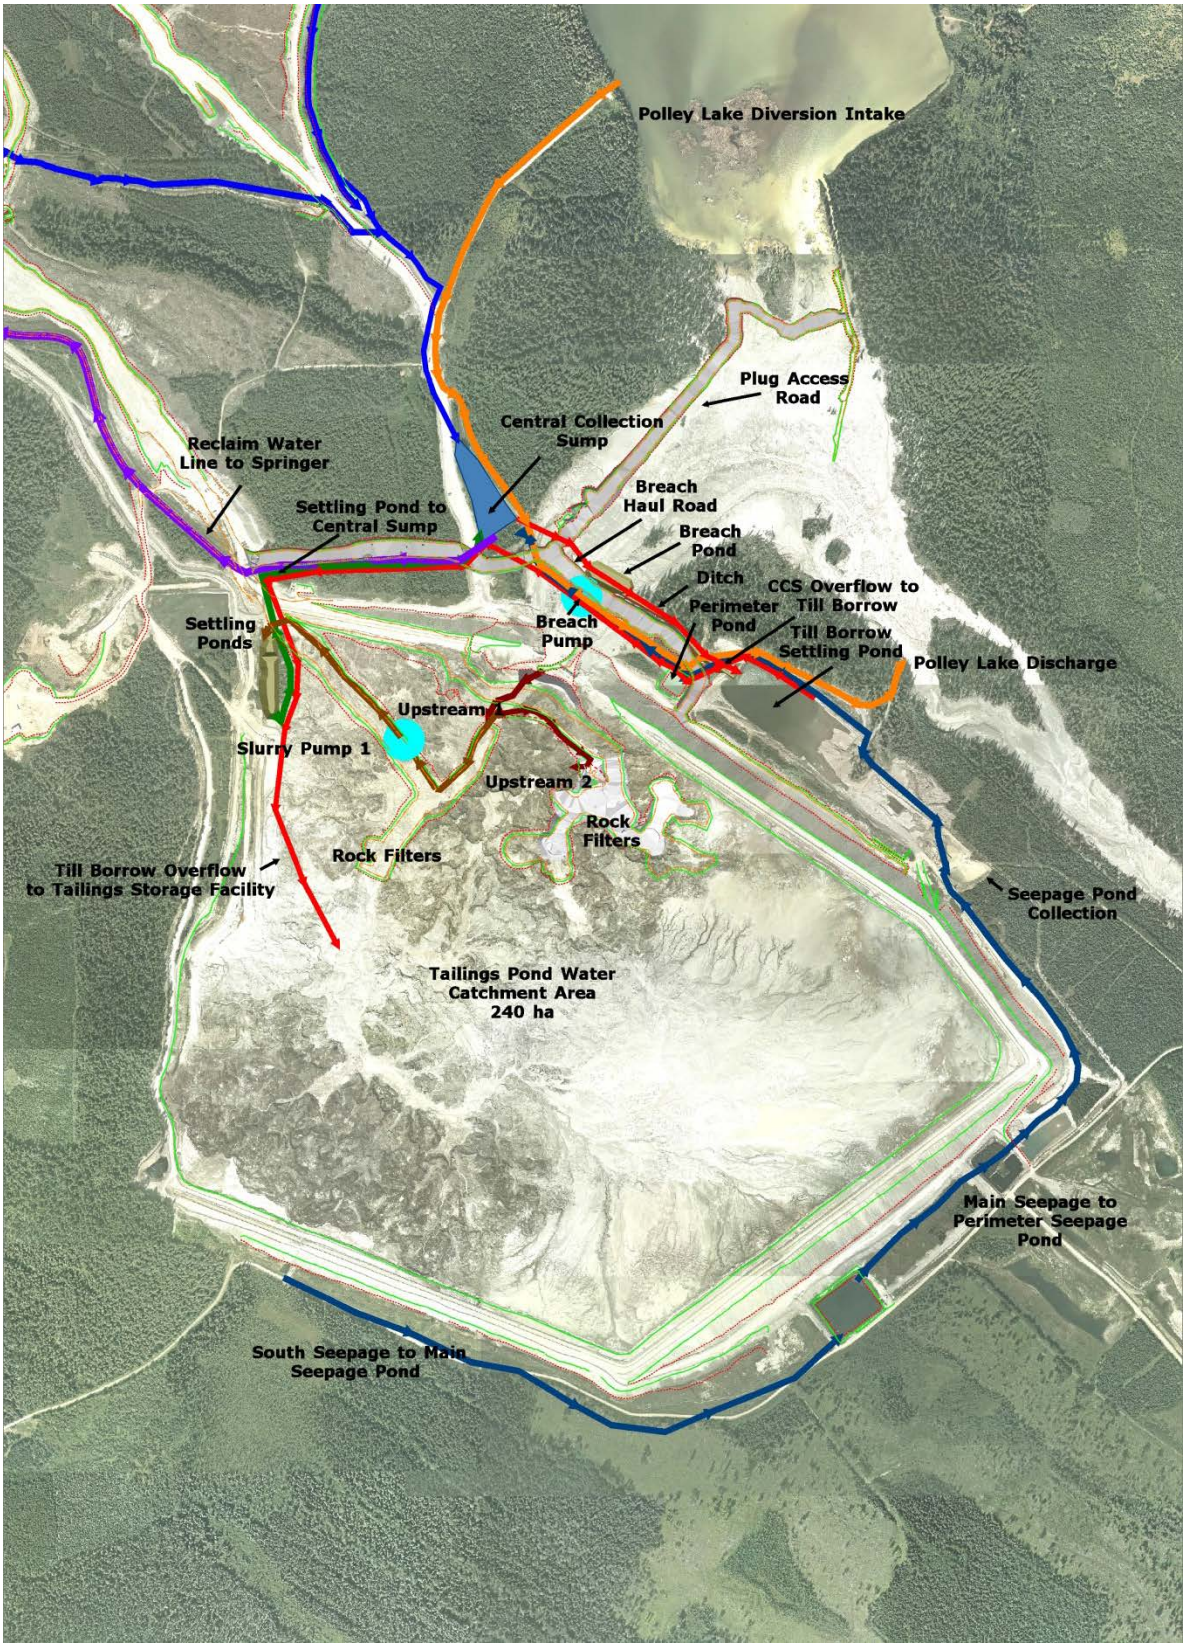
Figure 1. Tailings Storage Facility construction works

Polley Lake Dewatering	Polley Lake water elevation = 921.77 m (December 30th) Water levels are currently within the typical range. Polley Lake is now frozen and all pumping infrastructure was removed in late November.
Breaches	No breaches of the water management system containing water flow from the Tailings Storage Facility (TSF) occurred this week.
TSF and Water Management Structures	The amendment to permit M-200 approving repair of the TSF breach to manage 2015 freshet was received from the Ministry of Mines on December 17th. Ongoing work being completed under this approval includes: • Bulk excavation of the North and South Abutments (the embankments to the north and south of the breach) - Completed • Foundation preparation for Perimeter Embankment buttressing is progressing and 45% completed. • Foundation preparation for the Cut-Off wall is ongoing and the first priority until completion. Refer to Figure 1 for a map of the TSF area and associated works. All water from TSF water collection systems is currently transferred to the Springer Pit via the Central Collection Sump. Water flow from the breach location is now transferred from the Breach Sump via pumps to Upstream #1 sump then to the settling pond and the Central Collection Sump. The red line on Figure 1 showing transport of water from the Till Borrow Pit to the TSF is contingency infrastructure that is being considered, but is not currently in place.

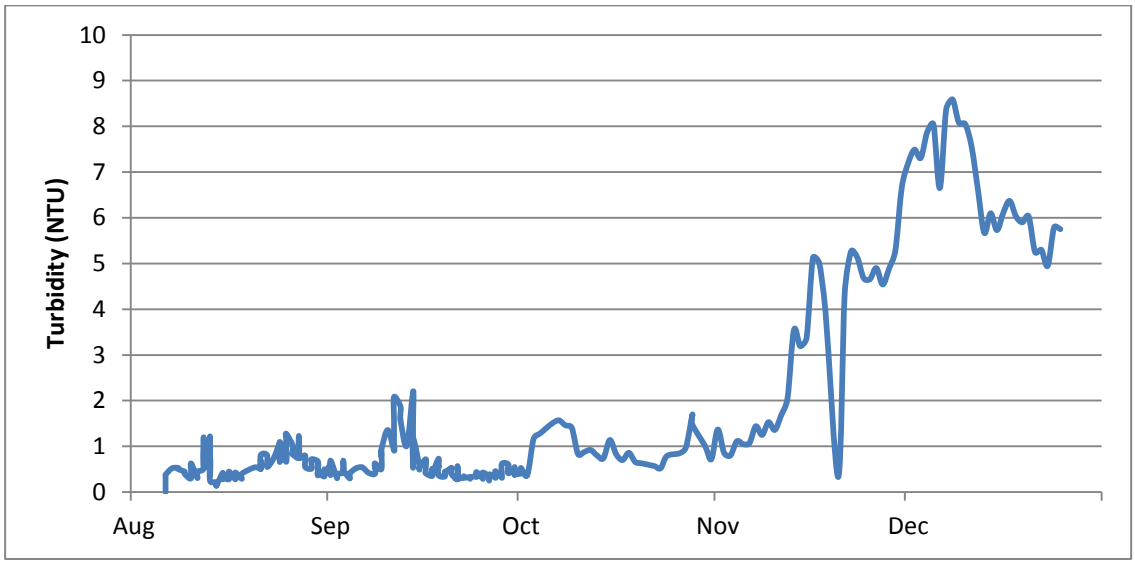
Figure 2. Turbidity time series at sample location QUR-1 (August 6th – December 22nd)

Figure 2 shows a time series graph of turbidity results from sample location QUR-1 on Quesnel River (at the Quesnel River Research Centre). All turbidity data is from laboratory analysis completed by ALS Environmental, except for data from December 24th to 30th, which is from the continuous monitoring sonde. The data sonde stopped recording on December 26th at 17:27 and field staff are currently trouble shooting the issue. Daily ntu samples from December 24th to 30th were collected however the data has not been received from the sampler at this time.
