## Mount Polley Mining Corporation

# Community Update

## Public Liaison Committee Tour and Meeting Report

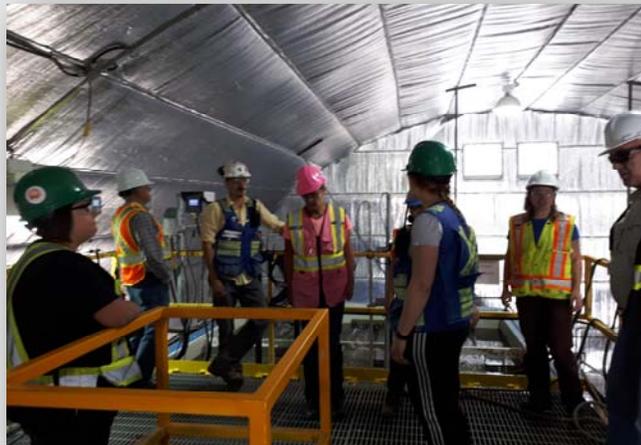
Tour group with additional MPMC environmental field staff explaining the different components of the WTP on top of the cells at the plant.

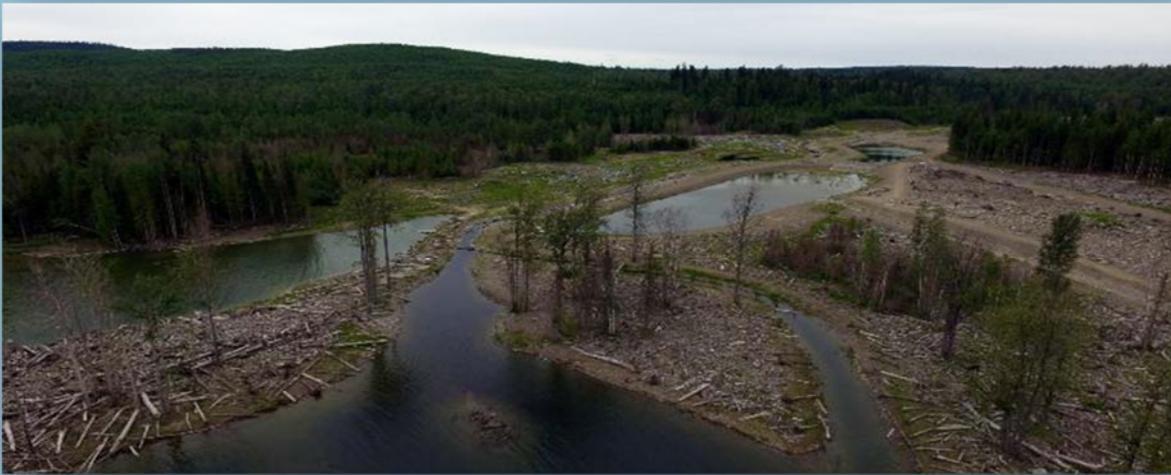
Edney Creek Delta, August 2017

- 1) The photo used to illustrate the letter was of Hazeltine Creek delta immediately after the breach in August 2014. Don provided a more recent photo showing the cleaned up and replanted delta.
- 2) The letter refers to the mine discharging “untreated” effluent. This is incorrect. The mine has been operating the WTP for about 3.5 years. The WTP is a Veolia ACTIFLO™ system, which **actively** treats the water with

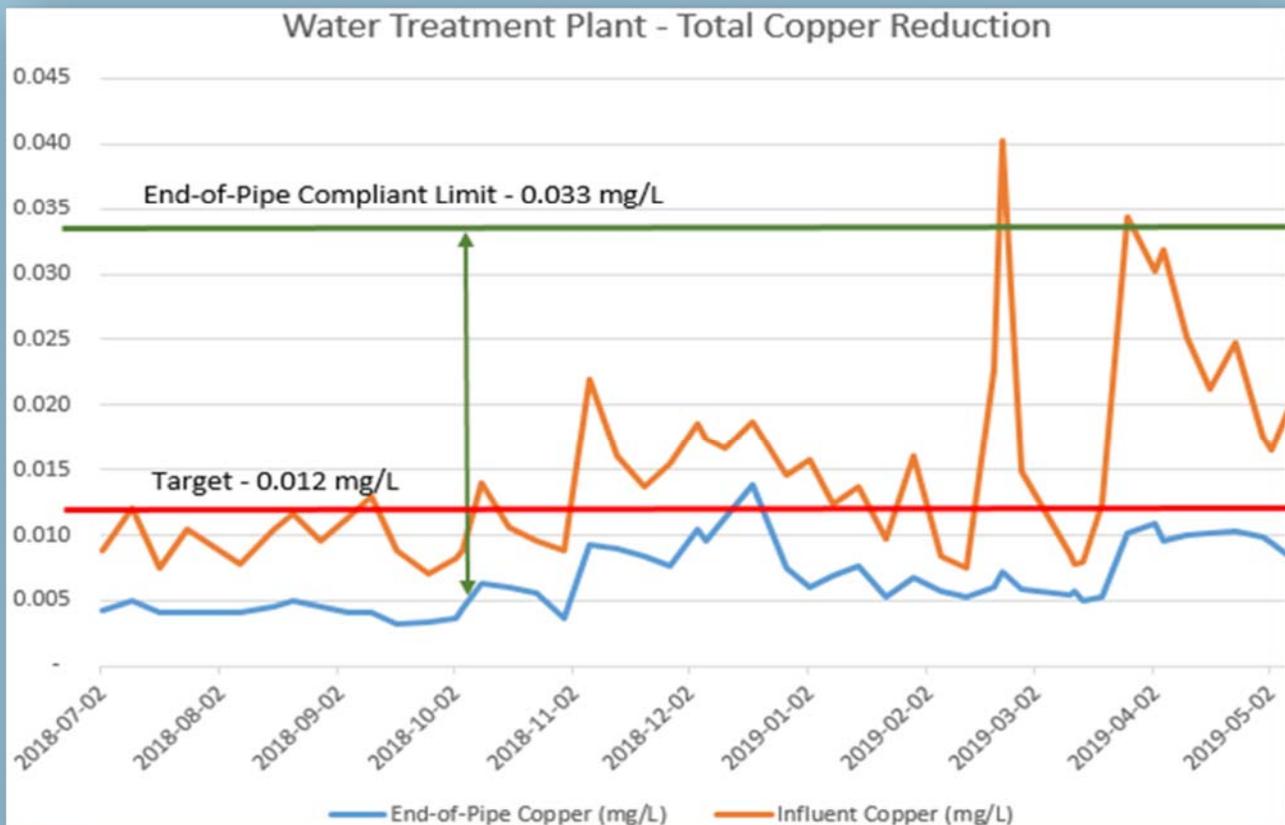
Copper concentrations at the influent and end-of-pipe (HAD-3), July 2018-May 2019

coagulant, flocculant, and microsand. The operating permit requires assessment and optimization of the treatment plant. A new system for enhanced copper treatment was tested during freshet in 2019, however, copper levels were so low that the additional treatment was not required. The system was installed in case the treatment is ever required. The mine's discharge permit limit is 0.033 mg/L, however, ENV requested that the mine attempt to meet a more ambitious target of 0.012 mg/L. The graph above shows that since July 2018, the treated discharge has only once been above this target, and this was still well below the mine's permit level of 0.033 mg/L.

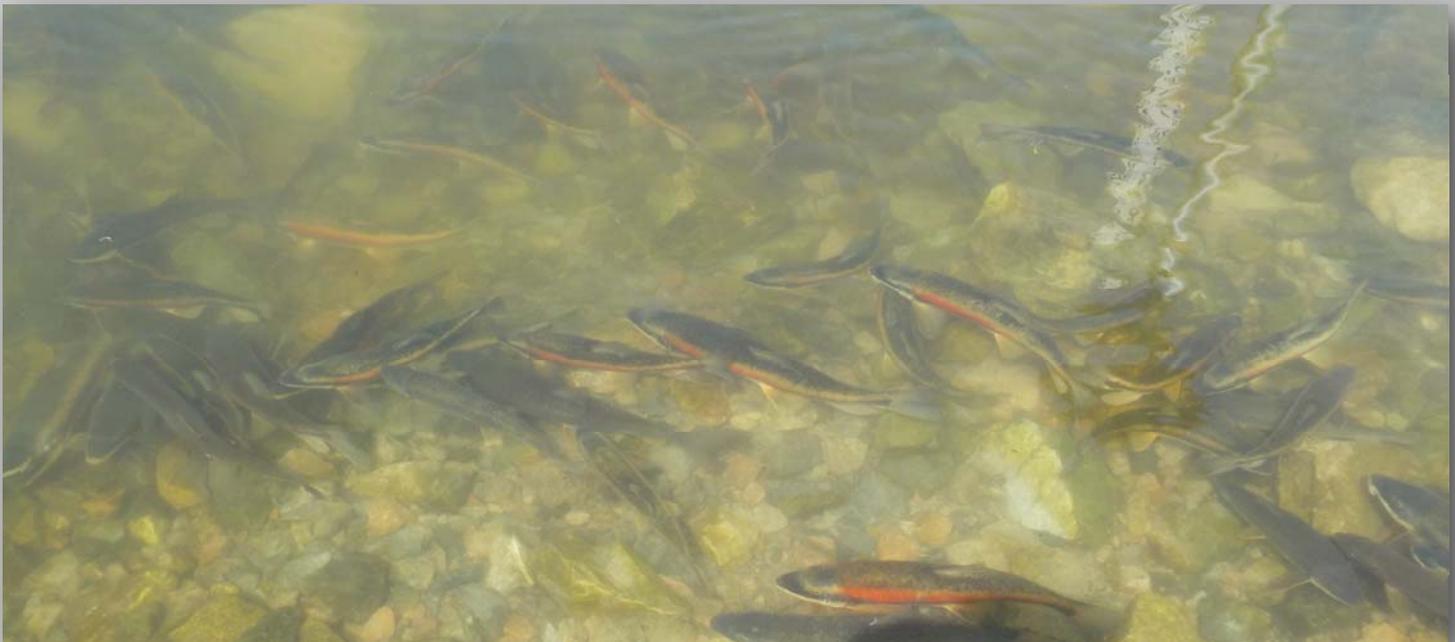
Spawning fish in remediated area of upper Hazeltine Creek (Reach 1), May 2019
